修士論文

Mechanical Assessment of Fire Damage of the Ancient Greek Temple of Marble Stone

三重大学大学院工学研究科
建築学専攻
山田 眞生

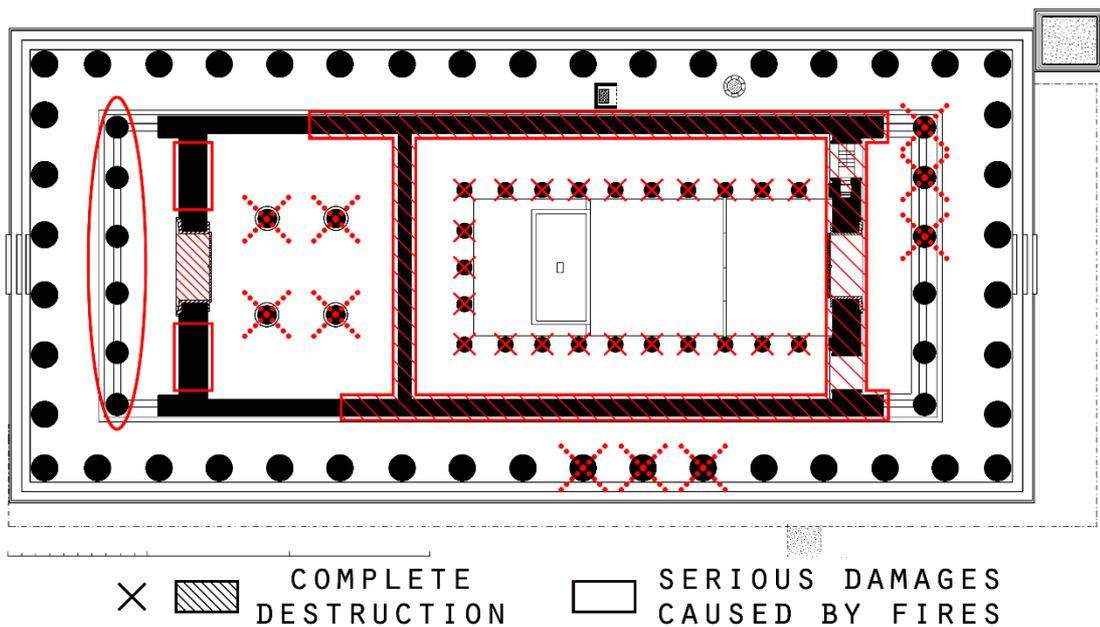
Fig.1-4: Present plan of damage area by fire

We drew a damage state map in order to grasp fire damages. (See Fig.1-4) We observed the characteristic damage that the marble specimen surface exfoliated. In addition, we expect that the crystal of marble stone influence on direction of the cracking. The columns of western side looks so similar than the failure mode of marble specimens heated at the high temperature. (See Chapter 2) Hence, we judged that almost of these damages is caused by historical fires.

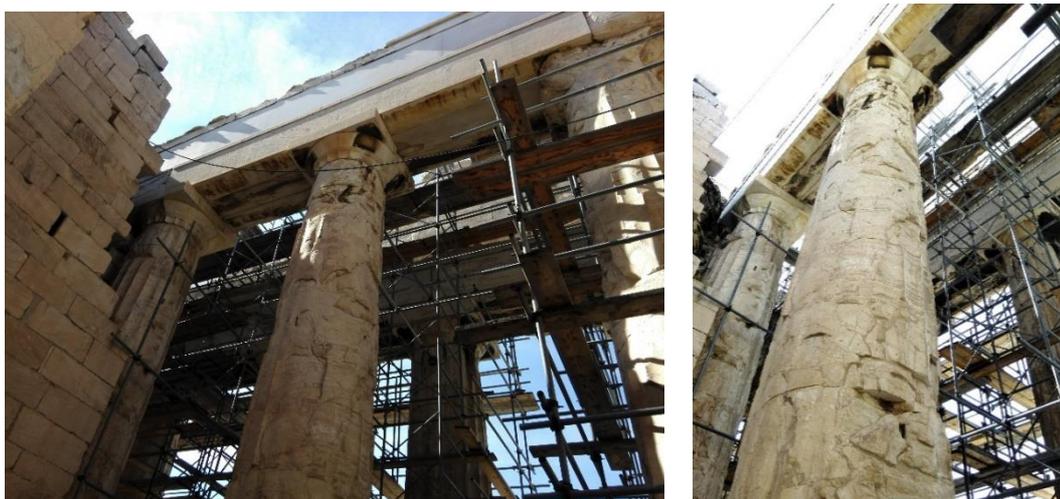
Fig.1-5: Internal column damaged by historical fires on the west side

Fig.1-5 and Fig.1-6 show that the marble column and marble wall on west side might have especially large damages caused by historical fires. The surface of almost columns on west side is peeled off, and the depth of those cracks is about 20 cm from the surface. The literature⁽¹⁾ suggests that the Venetian bombed on the northeast side of the Parthenon intensively. In addition, the damages caused by bomb are not recognized from the appearances of marble columns on west side. Thus, taking into consideration the factors mentioned above, the fire caused by the arson of the Heruli was the main cause of the damages that those marble members on west side of the Parthenon have.

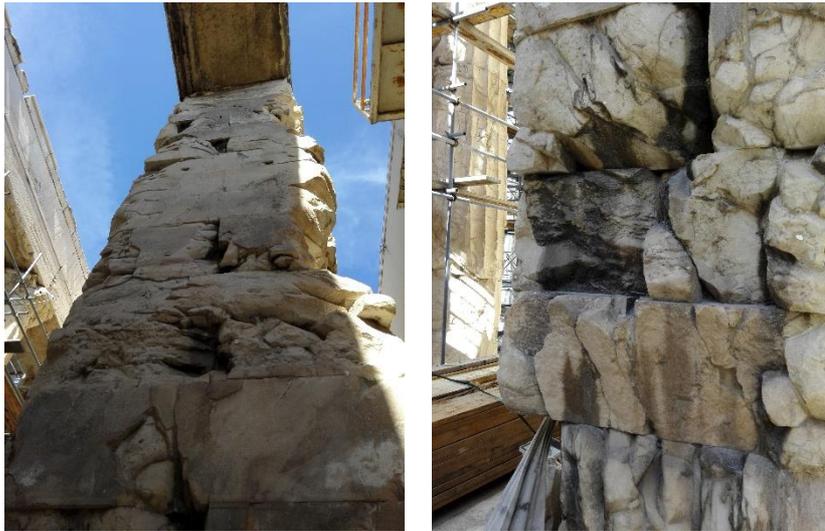
Fig.1-6: Wall damaged by historical fires on the west side

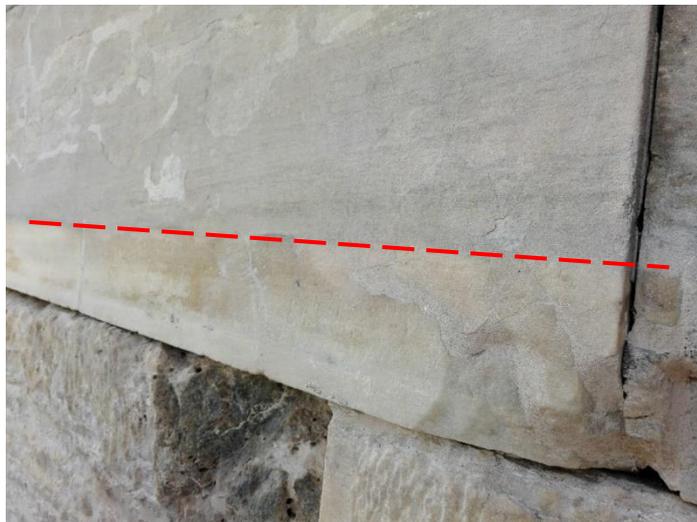
Fig.1-7: Marble pediment with discoloration on the top of the Parthenon

Moreover, the marble pediment on the top of the Parthenon had been badly foxed. (See Fig.1-7) Those discolorations of the surface of marble stone might be caused by high temperature. In addition, the border between discoloration area and un-discoloration area is straight and clear. Therefore, the upper from the un-discoloration area of the pediment is considered to be covered with wooden beams or something members in that time of fire. For this reason, those area have not been heated by direct fire. Thus, by comparing the columns with damages caused by fires on the west side and this un-discoloration marble, it is possible to envisage the damage scale caused by high temperature with considering the natural degradation. (e.g. ultraviolet rays or acid rain)

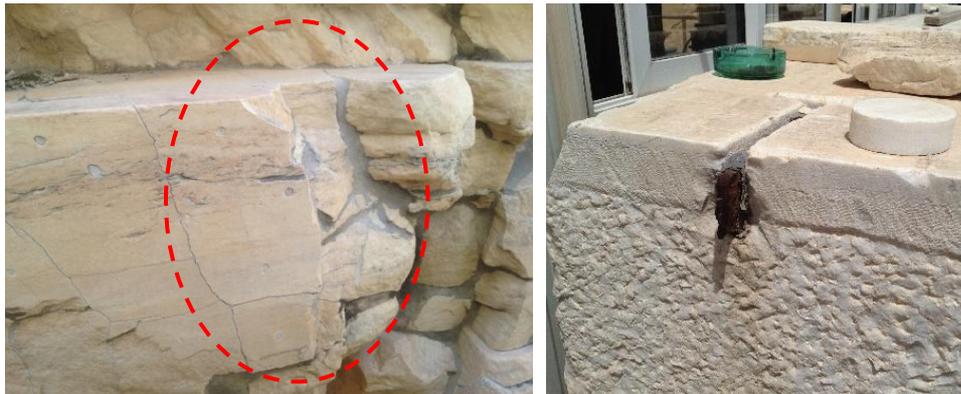
Fig.1-8: Former restoration using normal concrete and iron clamp

In regard to the way of the former restoration of the marble stone, since there were only a few studies have been performed on mechanical properties of marble, it was the sloppy method for the restoration. The normal concrete was injected into the cracks caused by high temperature on marble stone, and the iron clamps were used for the joining of the marble members. (See Fig.1-8) As the result, the adverse effects on marble stone were reported from the repairing using them, especially, the damage due to rust of iron clamps was very serious.⁽⁸⁾ The corrosion expansion of the iron caused the breakage of the marble members. However, at the present restoration, white cement is accepted for injection into cracks of marble instead of normal concrete and as adhesive marble members, moreover the almost iron clamps were replaced by the titanium clamps. (See Fig.1-9)

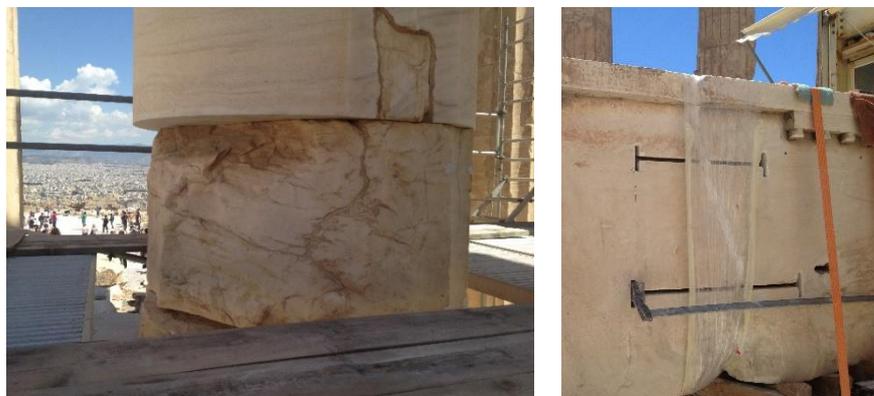
Fig.1-9: Present restoration using white cement and titanium clamp

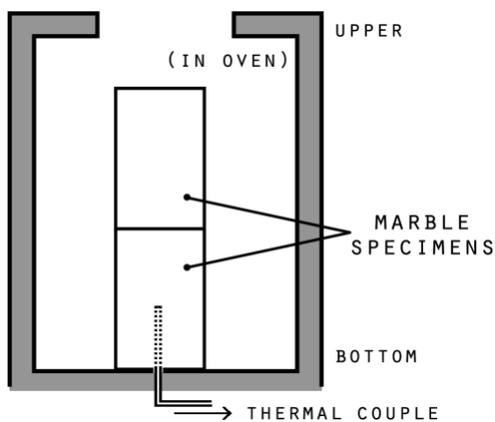
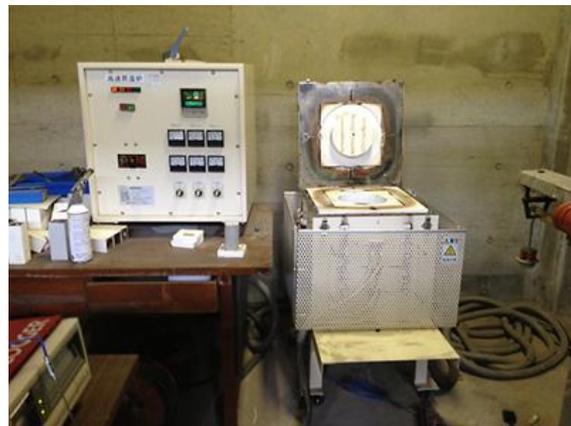
Fig.2-2-1: Test equipment and how to on Case-1

In Case-1, two marble specimens were set in piles of two in the oven, and then they were heated simultaneously at one time. (See Fig.2-2-1) Fig.2-2-2 shows time history at temperature as the experimental conditions. Because the high speed electric oven had little time-lag reaching to the target temperature in the chamber of the oven, the specimens were set in the oven before starting heating. Marble specimens were heated for 90 minutes until the internal temperature of the specimens reached to setting temperature (pre-heating), and then continued keeping the temperature for 30 minute, 1 hour, 2 hours or 4 hours at the temperature. Moreover a thermocouple (Type K: $\phi 3.2$ mm) was installed to one of two specimens to confirm that the internal temperature of the specimen continued keeping the temperature, and temperature in the chamber of the oven was also measured at the same time.

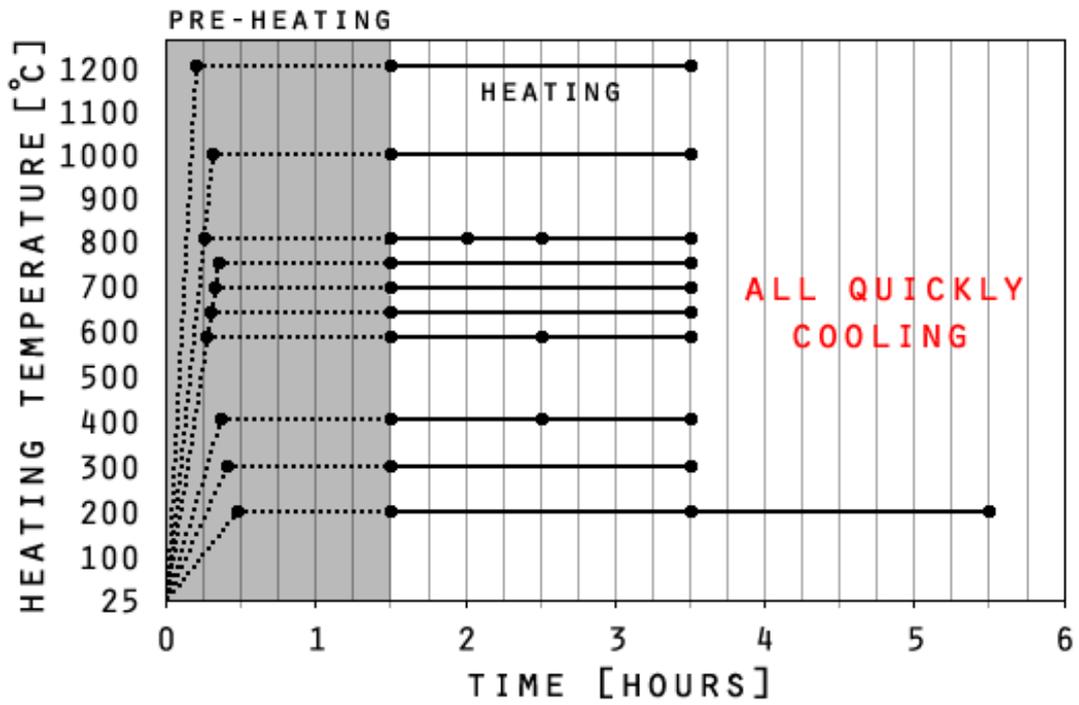
Fig.2-2-2: Experimental condition of Case-1

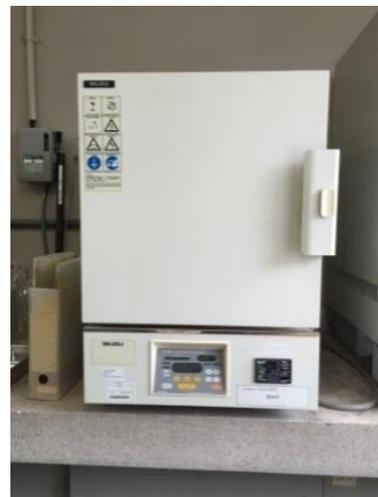
Fig.2-2-3: Test equipment on Case-2 and Case-3

oven had huge time-lag between starting heating and reaching setting temperature, the specimens were set in the oven after reaching to setting temperature (200 °C, 400 °C, 650 °C, 800 °C or 1,000 °C) in chamber of the oven, and heated for 210 minutes. As a side note, 90 minutes of them is for pre-heating time. (See Fig.2-2-4) After heating test, the specimens heated were left in the oven as it is whole one night. Moreover, they were moved to desiccators for controlling humidity after confirming the specimen's temperature.

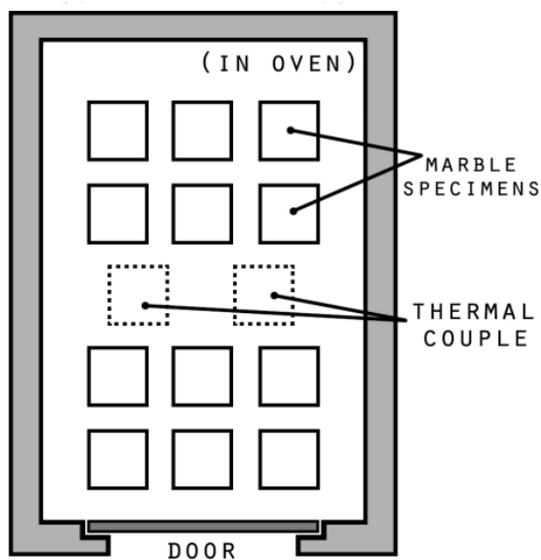
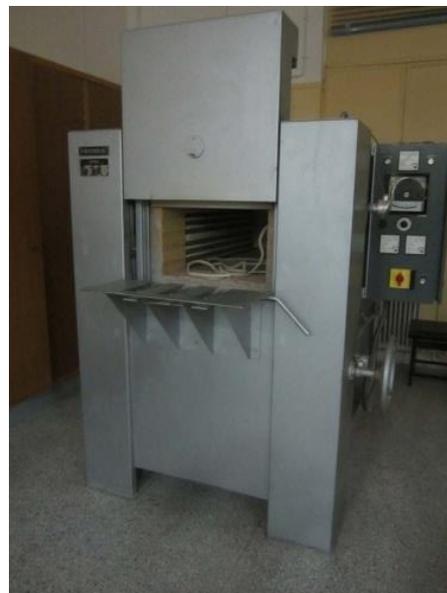
Fig.2-2-5: Test equipment on Case-4

In Case-4, 12 specimens were set and were heated as well as Case-2 and Case-3. (See Fig.2-2-5) The two marble specimens with thermocouples were set in the central position of the oven, and we managed the temperature of internal oven and specimens by the attached thermometer. In addition, these two specimens were used repeatedly by the all conditions of the heating test in Case-4.

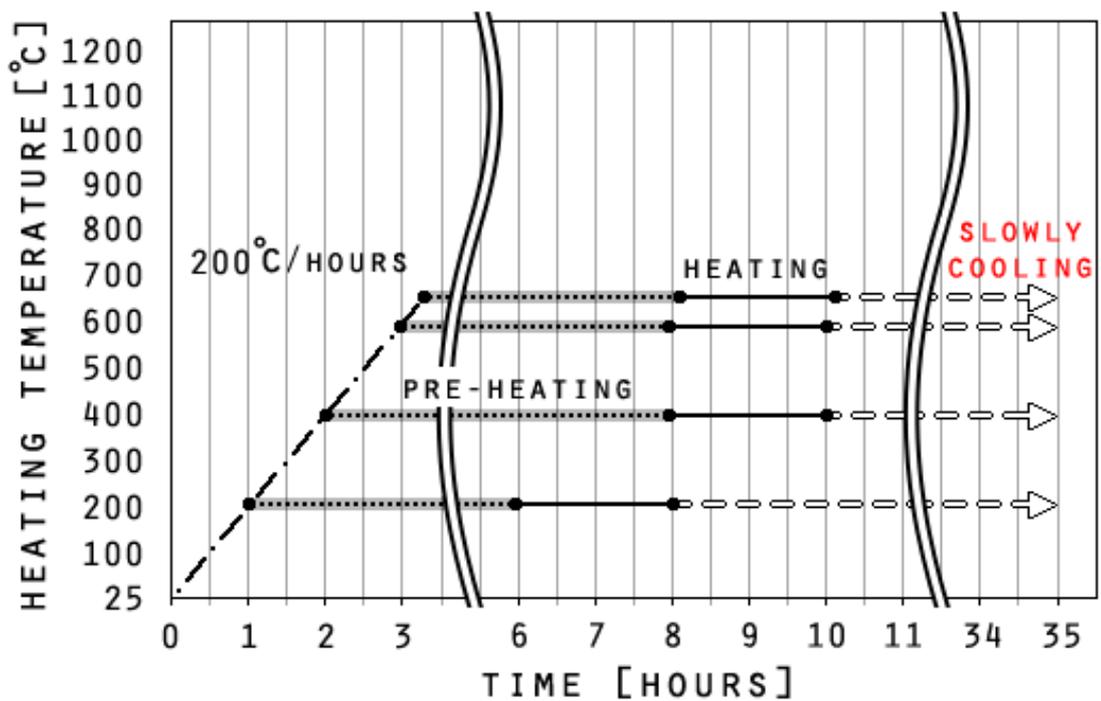
Fig.2-2-6: Experimental condition of Case-4

Fig.2-2-6 shows time history at temperature as the experimental conditions in Case-4. The temperature rising rate in this tests was set 200 °C/hour, and the specimens were heated until internal temperature of the specimens reached to the setting temperature for pre-heating. After heating tests, the specimens heated were left in the oven as it is whole one night as well as Case-2 and Case-3, and they were moved from the oven after confirming the oven temperature became less than 100 °C.

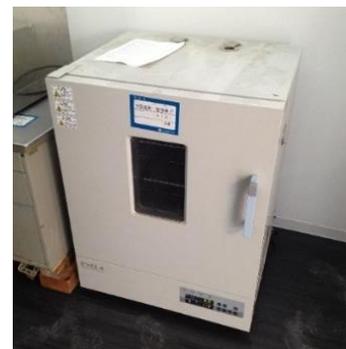
Fig.2-2-7: WFO-601SD

Fig2-2-8 shows prospective flow of the weight decrease. Therefore, we expected that water content is useful data for understanding weight decrease because of occurring chemical reaction. A total of 3 specimens of marble stones were examined by the Forced Air Flow Oven (See Fig.2-2-7) for understanding how many weight decreased by evaporating water content. Hence, the specimens were heated at 110 °C for 24 hours, and the weight was compared

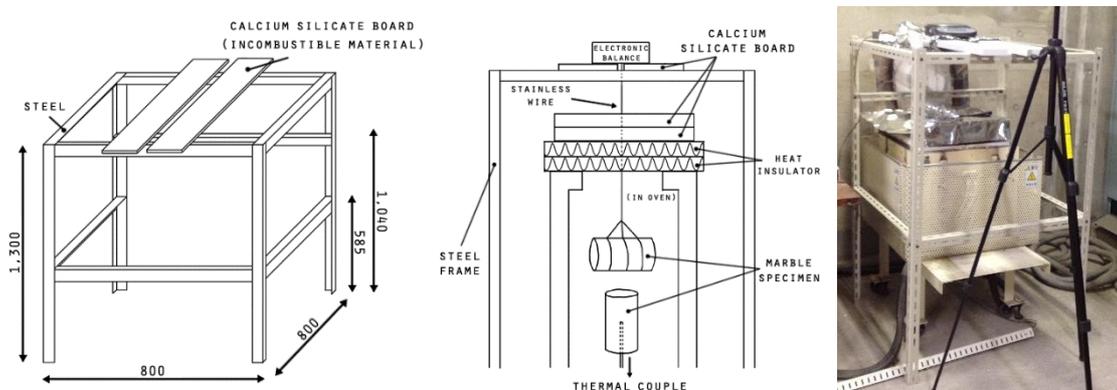
Fig.2-2-9: Experimental setup using for weight – measurement test –

After heating tests in all of tests, weight of the specimen was measured by an electronic balance. Hence, while specimens were cooled down naturally in the air, photographs were periodically taken to record the change of aspect of specimens in Case-1. Fig.2-2-9 shows a setup using this test. One specimen was set with a thermocouple and the other was hung on the electronic balance. The electronic balance covered with aluminum seats for protecting against electromagnetic wave from the electric oven. Fig.2-2-10 shows the experimental temperature condition of this measurement. In the electric oven, two specimens were heated at the same time at the temperature between room temperature and 1,200 °C.

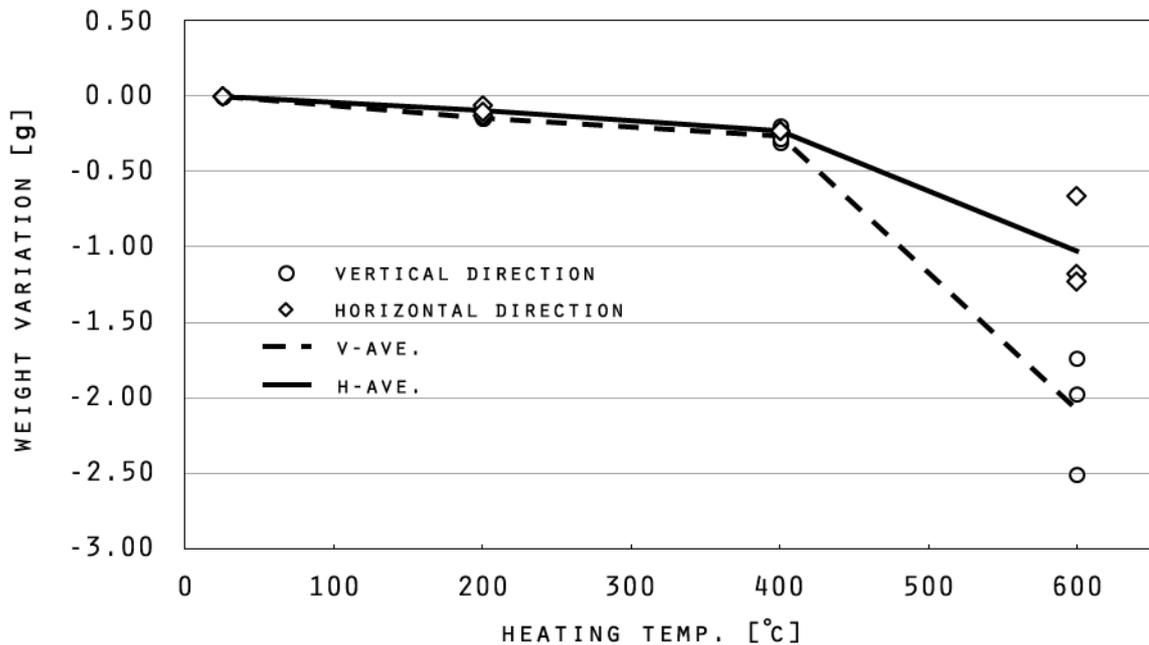
Figure 2-2-15: Relation between heating temperature and weight variation in Case-3

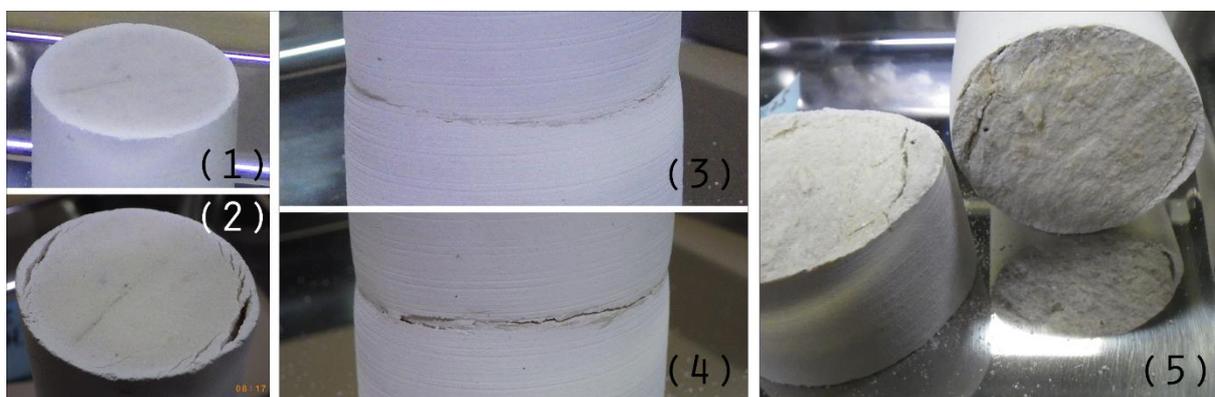
Fig.2-2-16: Deterioration process of heated marbles in Case-1

In Case-1, deterioration of the marble specimens heated at temperature higher than 800 °C were remarkably observed. Fig.2-2-16 and Fig.2-2-17 show the specimens heated at 800 °C. At first, the specimen has some cracks in the edge of the specimen along the curve of the specimen (1 and 2) and a crack in the side of the specimen's body (3). With the passage of time, this cracks were developed (4) and eventually, the surface layer of the specimen was separated into several parts of the specimen (5). In addition, the cracks also occurred in the internal specimen as well as cracks in the edge of the specimen. Moreover, the distortion was gradually caused at the inner part of the specimen and extended to whole body with the passage of time (I). During exposing to the air, the strength of the specimen was getting lower and the thin surface layer of the specimen which thickness was 1-2 mm are cast off. Eventually the specimen reached to collapse, while cracks were developed (II and III).

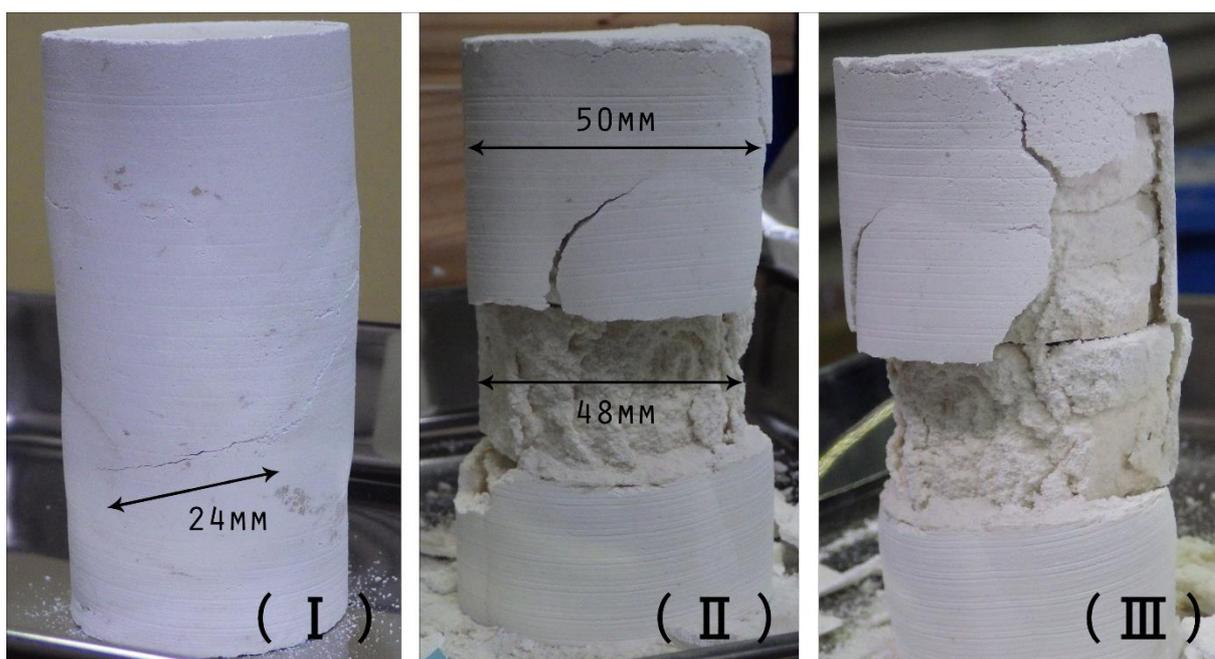
Fig.2-2-17: Deterioration process of heated marbles in Case-1

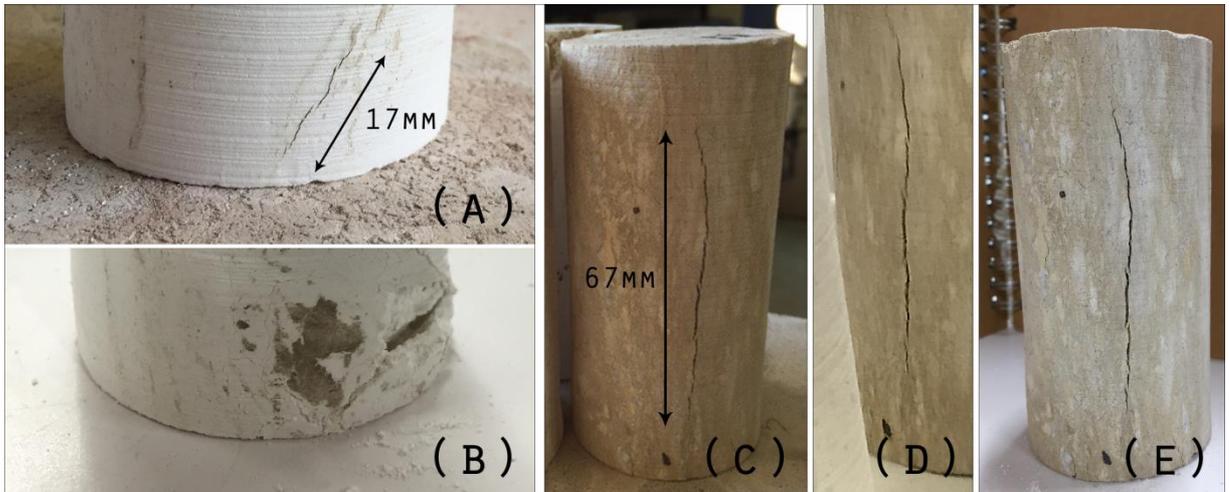
Fig.2-2-18: Deterioration process of heated marbles in Case-2

Fig.2-2-18 shows Deterioration process of marble specimens heated at 800 °C or 1,000 °C in Case-2. A marble specimen heated at 800 °C has an angled crack of which length was 17 mm just after heating (A). The angled crack of the specimen were developed after heating in the desiccator for 72 hours, then the surface of the marble specimen heated at 800 °C was exfoliated and collapsed near the developed crack (B). On the other hand, a marble specimen heated at 1,000 °C had a large crack on the side of the specimen, and it didn't develop (C), hence the surface of the marble specimen heated at 1,000 °C didn't have variation near the crack (D and E). In addition, comparing number of cracks between marble specimens heated at 800 °C and these heated at 1,000 °C, the number of cracks was almost the same. Furthermore, most of cracks occurred on the side of the

In addition, cooling speed after end of the heating also affected occurring cracks on marble. As shown in Fig.2-2-18, there were some differences between quickly cooling and slowly cooling. The rapid temperature change gave the specimens big shock, hence occurring cracks on marble depended on the thermal shock caused by quickly cooling than heating temperature.

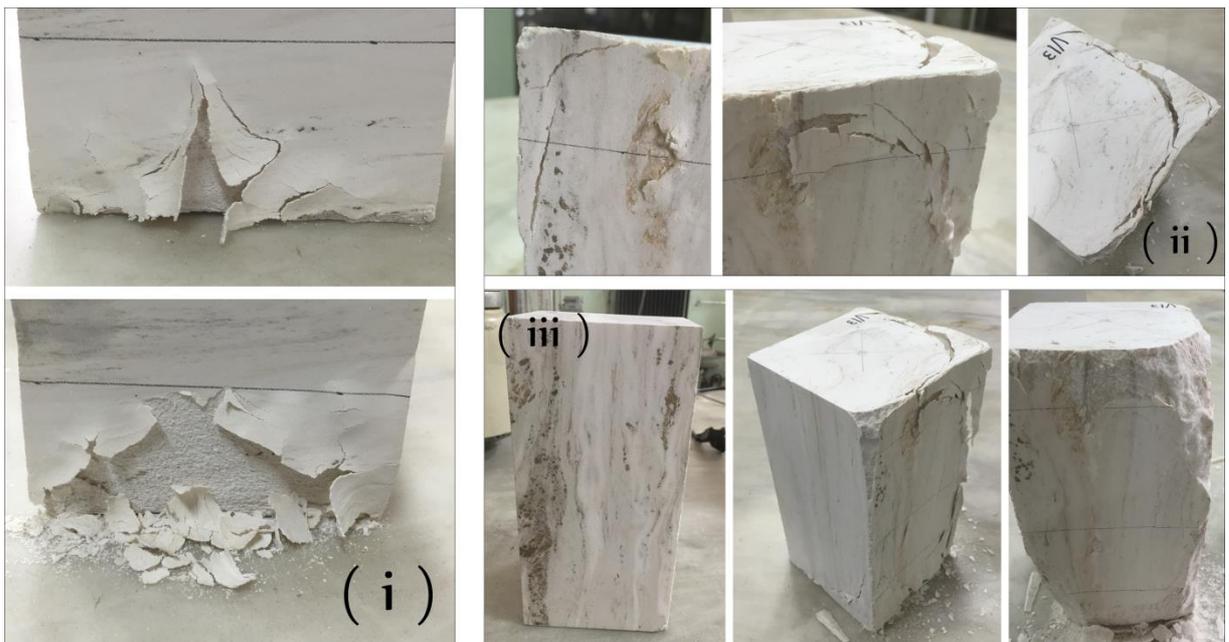
Fig.2-2-19: Deterioration process of heated marbles in Case-4

Fig.2-2-19 shows the deterioration process of marble specimens heated at 650 °C in Case-4. The size of the marble specimens using in Case-4 was bigger than them using in Case-1, Case-2 and Case-3, hence the pre-heating time needed about 3~4 times longer. Hence, the appearance deterioration of the specimen was observed more seriously, however the specimen was heated at just 650°C. After heating tests, the cracks of the tortoise shell form occurred in the bottom side of the specimen, moreover the cracks progressed with time, and then this process resulted in the delamination of surface of the specimen. (A) Besides, the marble specimens using in Case-4 were prism shapes, hence almost cracks on the specimens occurred partially around the edge of the specimen. In particular, there were serious damages around four corner parts of the specimen, and eventually the specimen collapsed with time. (B and C)

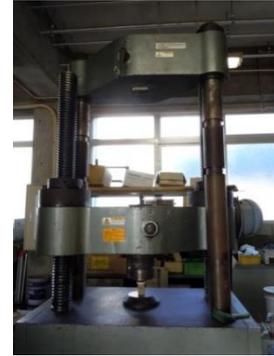
It is necessary to understand that how compressive strength is reduced by heating. Furthermore, there is degree of damage of marble stones by high temperature. Thus, we conducted compressive tests of a total of 52 specimens (16 specimens in Case-1 and 12 specimens in Case-2 and 24 specimens in Case-3) of marble after the heating tests by the compressive tests. Fig.3-3-1 shows the amsler testing machine using for these tests.

Fig.2-3-1: Using machine

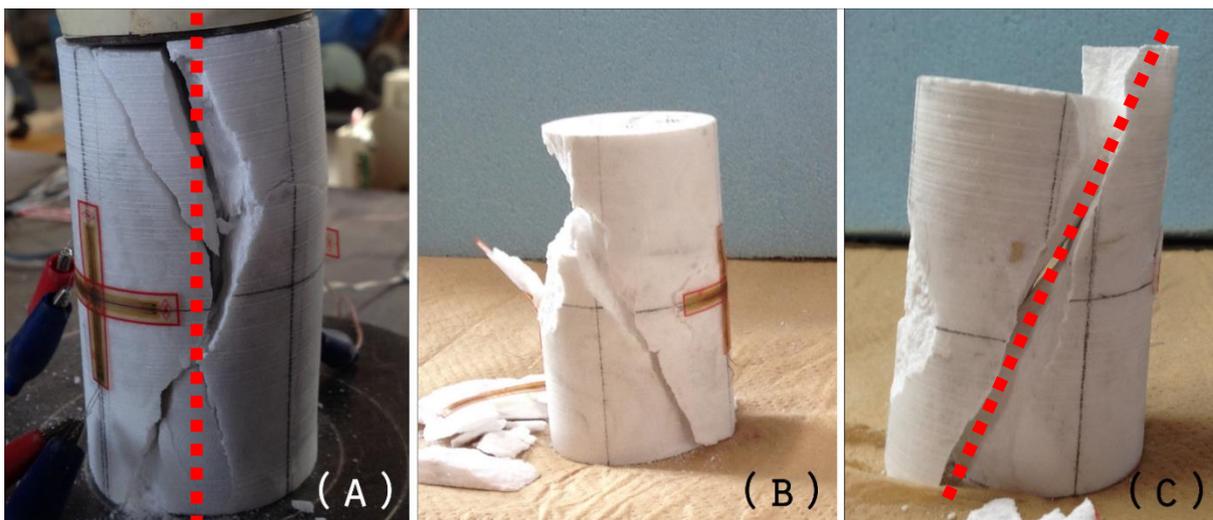
Fig.2-3-3: Failure mode of marble specimens in Case-1

Fig.2-3-3 shows the fracture mode of the specimens after the compressive tests of the un-heated specimen (A) and the specimens of heating at 400 °C (B) or 600 °C (C). Most of the heated specimens showed shear failure mode regardless of degree of temperature, shown in these photos. In addition, these marble specimen didn't be performed treatment of end.

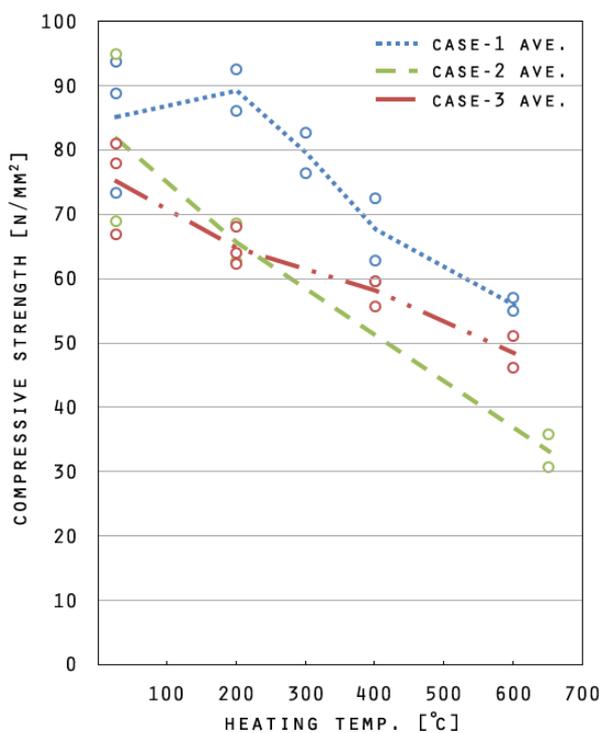
Fig.2-3-4: Compressive strength (N/mm²)

Fig.2-3-4 and Fig.2-3-5 show the relation between heating temperature and strength of the marble among Case-1, Case-2 and Case-3. In addition, all of the compressive strength in Fig.2-3-4 is them of the marble specimens have vertical crystal direction. Moreover, the data of same condition of heating time (90 minutes for pre-heating and 2 hours) among Case-1, Case-2 and Case-3 was shown in this figure.

In this figure, the strength began to decrease at the temperature of 300 °C. Additionally, the specimen heated at over 750 °C didn't be conformed compressive test because the specimen heated at over 750 °C collapsed naturally while cooling (See Fig.2-2-17). Thus, the compressive strength of the specimen heated at over 750 °C was treated as 0 (N/mm²).

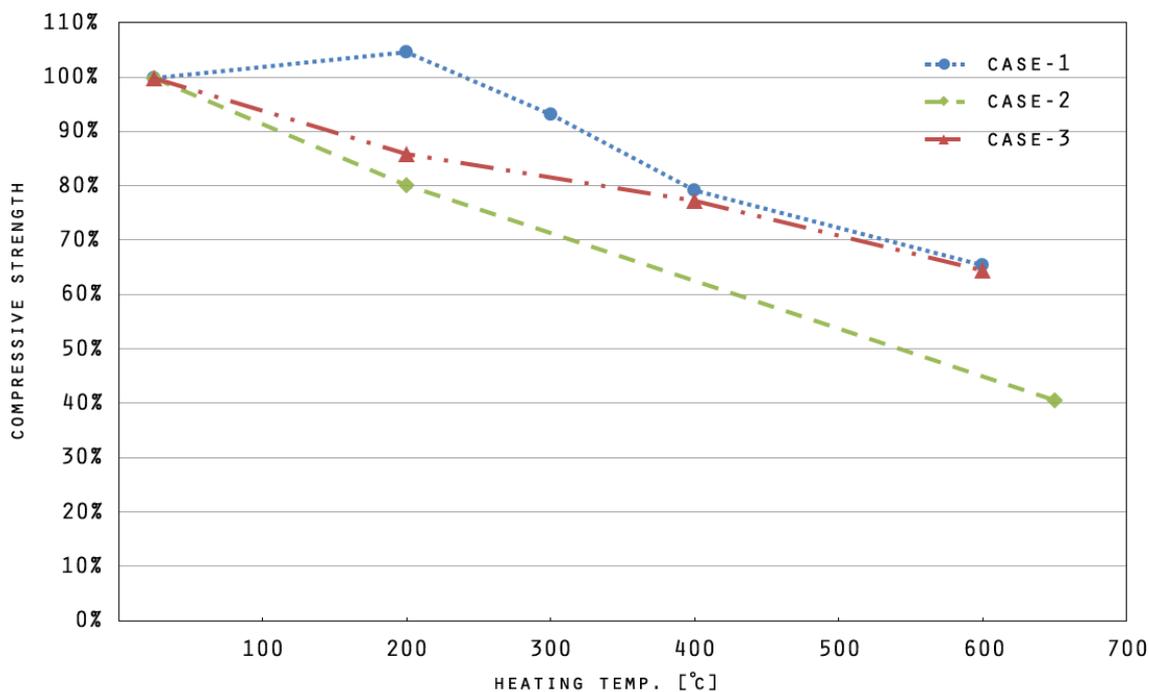
Fig.2-3-5: Compressive strength (%)

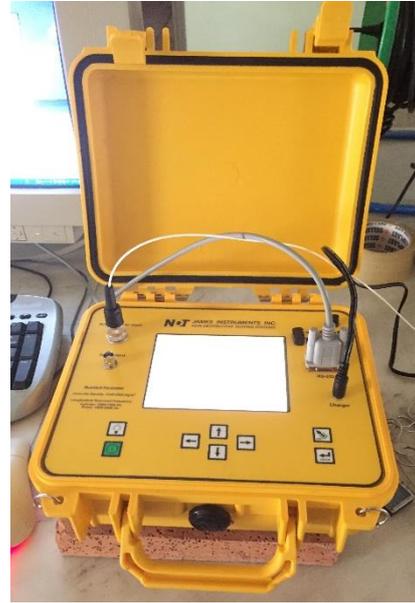
We verified whether this non-destructive method could be suitable for the field survey to the actual buildings with the non-destructive test using by the resonant frequency tester. (See Fig.2-4-1) This tester may determine the longitudinal, torsional and flexural or transverse resonant frequencies of the variation of materials. In the present study, prism marble specimens of $100^L \times 100^W \times 200^H$ mm were examined by the longitudinal mode and the torsional mode. (See Appendix 1) As a side note, the specification complies with ASTM C-215, ASTM C-666, BS 1991, and JISA 1127 standard for testing concrete specimens by the resonant frequency method. It is also meets standards to measure modulus of Elasticity of rocks and other materials.

Fig.2-4-1: Resonant frequency tester (E-Meter Mk II)

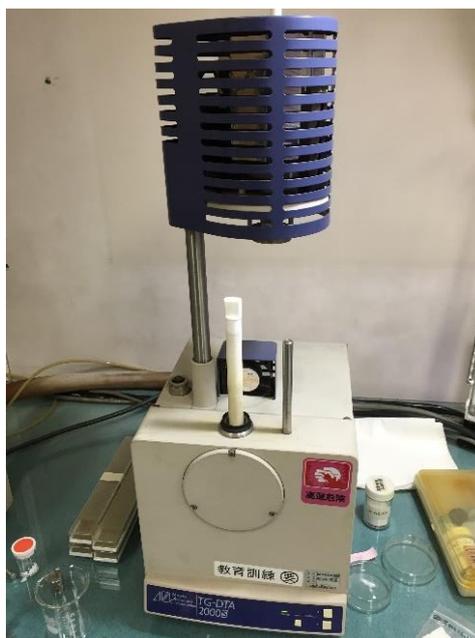
Fig.3-1-1: Experimental setup

Fig.3-1-1 shows the experimental setup using for TG-DTA. Both un-heated specimens and the specimens heated at 800 °C and 1,000 °C were analyzed by TG-DTA.

Thermal gravimetric is provided for thermal analysis. Changes of physical and chemical properties of materials can be measured as a function of increasing temperature with constant heating rate, or as a function of time with constant temperature and/or constant mass loss.

In this analysis, reference sample was alumina sample.

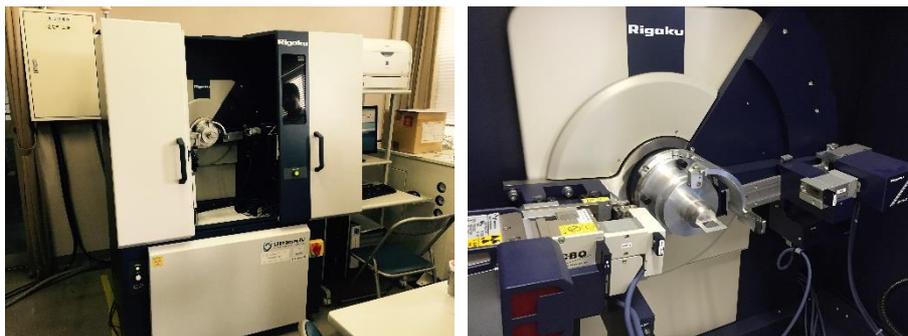
Fig.3-1-2: Experimental setup

Fig.3-1-2 shows the micro X-ray diffraction detector using this test. X-ray diffraction test is used for identifying the atomic and molecular structure of a crystal, in which the crystalline atoms cause a beam of incident X-rays to diffract into many specific directions. From this electron density, the mean positions of the atoms in the crystal can be determined, as well as their chemical bonds, their disorder and various other information.

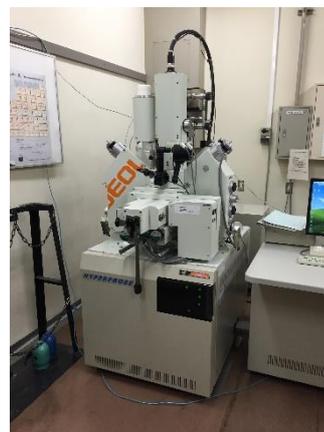
Fig.3-1-3: Experimental setup

Fig.3-1-3 shows the machine used for making color maps of calcium. Electron micro probe analyzer is used for non-destructively test of the chemical composition of small volumes of solid materials. It works similarly to a scanning electron microscope. This test enables us to determine the abundances of elements present within small sample volumes (typically 10-30 cubic micrometers or less).

In this analysis, marble specimens were treated with air purge by using a vacuum pump for 48 hours.

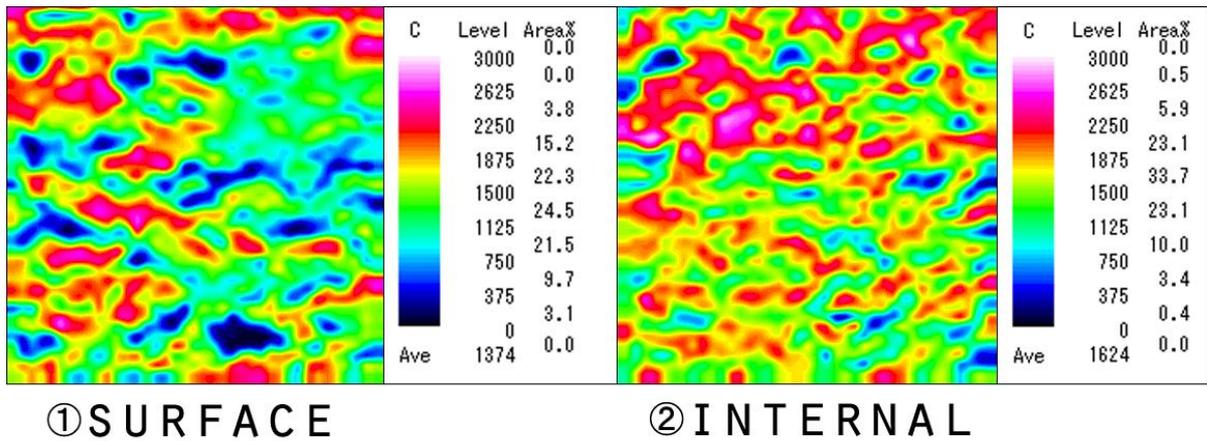
Fig.3-2-3: Carbon color map by EPMA

Moreover, the decarburization area (CaO) is very fragile. In the internal of specimen, more progressive thermal reaction might have occurred than on surface of specimen. In other words, there might be more strength difference between surface and internal of marble specimen. Hence, the compressive strength variation might cause the characteristic failure mode as shown in our previous study.⁽¹³⁾

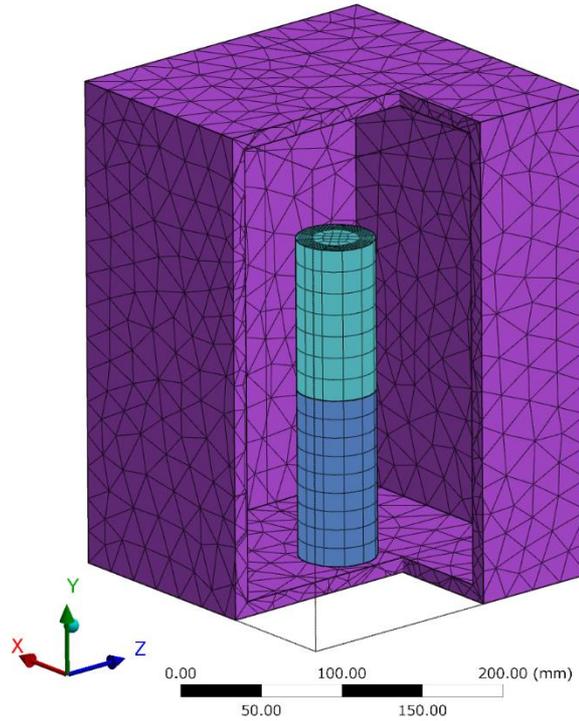
Fig.4-1-1: Model of oven and marble specimen

In the fitting analysis for the convection coefficient and emissivity rate of marble, we made a model as Fig.4-1-1. For the actual dimension data of the structure and the shape of the electric oven, see appendix 5. Moreover, to reproduce the actual experimental conditions on the previous heating tests, we performed the fitting analysis that focused on the temperature elevation curve of the central area in the marble specimen.

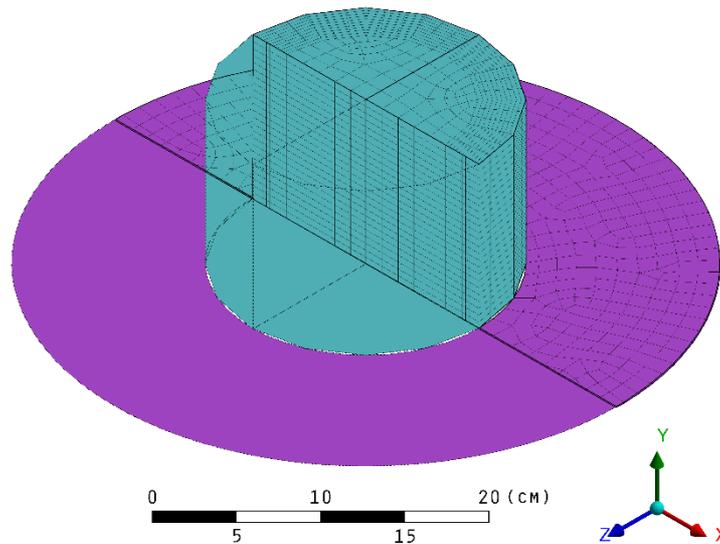
Fig.4-2-1: Model of a marble drum

As for the heat source on the model, we assumed that the heat source existed concentrically within 4 meters from the center of the drum. As a side note, the distance between columns of the portico in the Parthenon is about 4 meters.

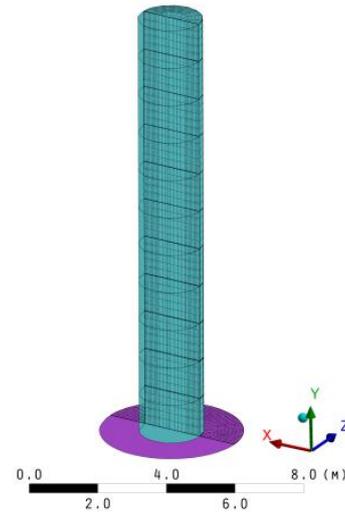
Fig.4-3-1: Multi-dram model

The model using for the thermal analysis to multi-dram column is designed that the height is 13.2 meters constituted by stacking 11 drams. As for the heat source on the model, we assumed that the heat source existed concentrically within 4 meters from the center of the model as well as the dram model, and the heat source model has 0.5 meters in height.

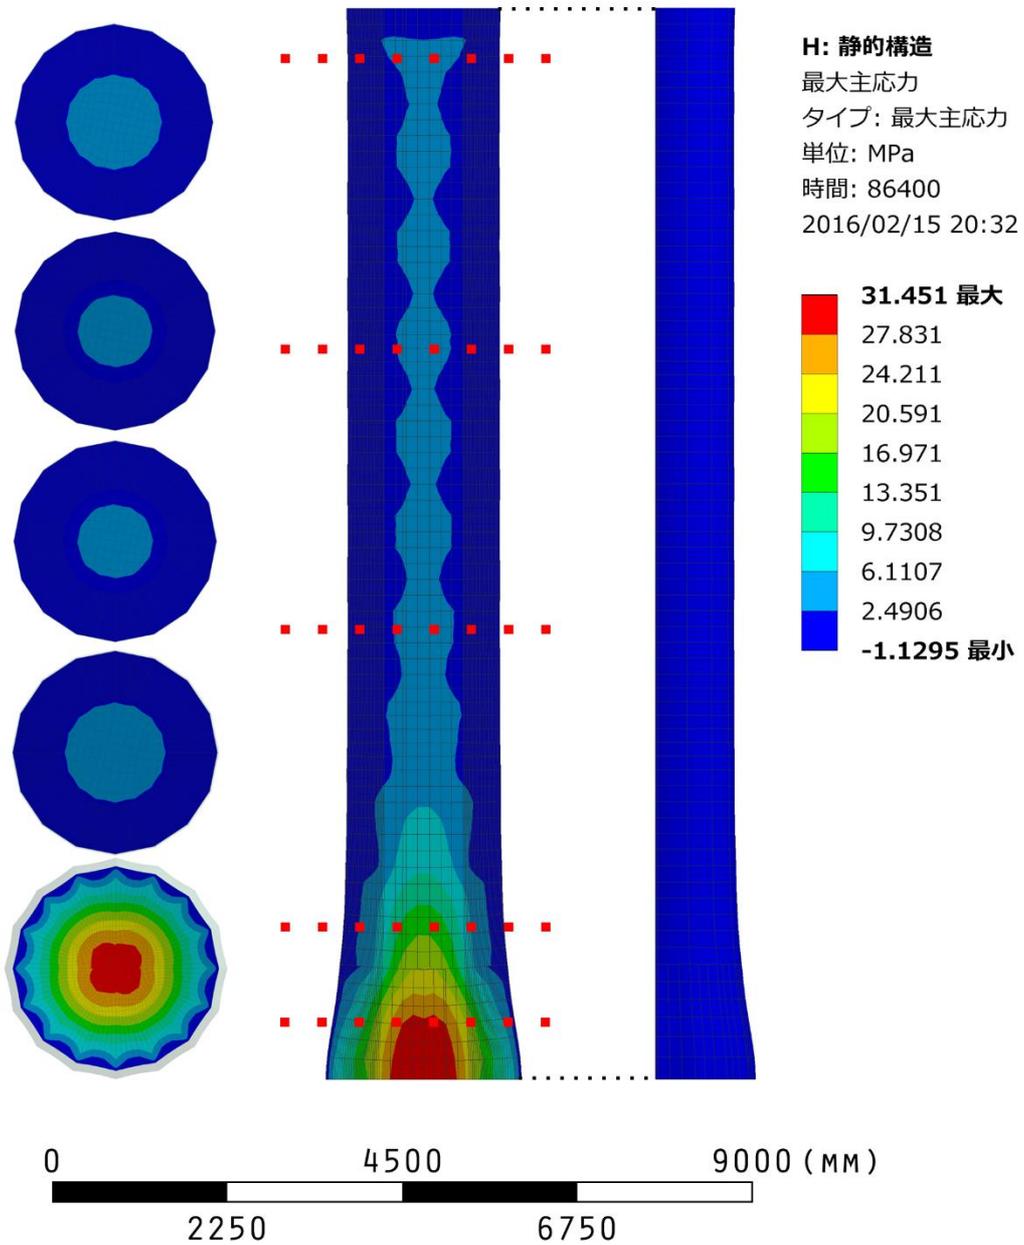
Fig.4-3-4: Maximum principal stress of model at 24 hours
