Damage Propagation of Ceramic Cutting Tools

Kiyoshi ISOGIMI, Jippei SUZUKI, Eitoku NAKANISHI and Mutsumi KUSUMOTO †
(Department of Mechanical Engineering)

Abstract

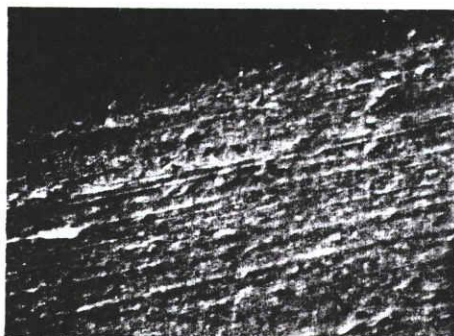
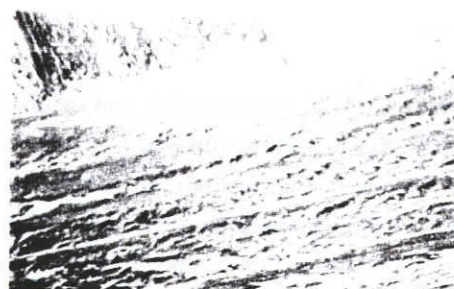
Fig. 1 Appearances of virgin ceramic tip edges chamfered.

(a) $\text{Al}_2\text{O}_3\text{+TiC}$ tip

(b) Si_3N_4 tip

As shown in Table 1, Alumina-type tip is superior in hardness and wear-resistance, but Silicon Nitride tip is superior in thermal shock resistance and toughness. The initial micro chipping width measured are shown in Table 2 as the values of roughness along those tip edges. The appearances of tip edges chamfered are shown in Fig.1 (a), (b). The surface of Silicon Nitride tip cutting edge looks somewhat smoother.

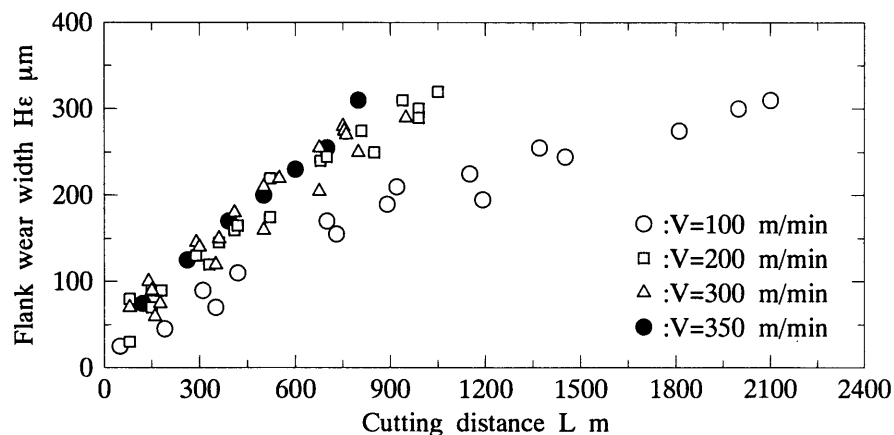
Fig.4 Relationship between flank wear and cutting distance for Al₂O₃-TiC tip.

Figures 4 shows the wear propagating curves of the Al₂O₃-TiC tip for the cutting speeds of 100, 200, 300 and 350 m/min. The flank wear seems to progress steadily for all the speeds without any sudden fracture. The wear band becomes wider in higher speed but the progressive rate seems to be very small especially in the lowest cutting speed of 100 m/min, so a very long tool life can be expected in lower

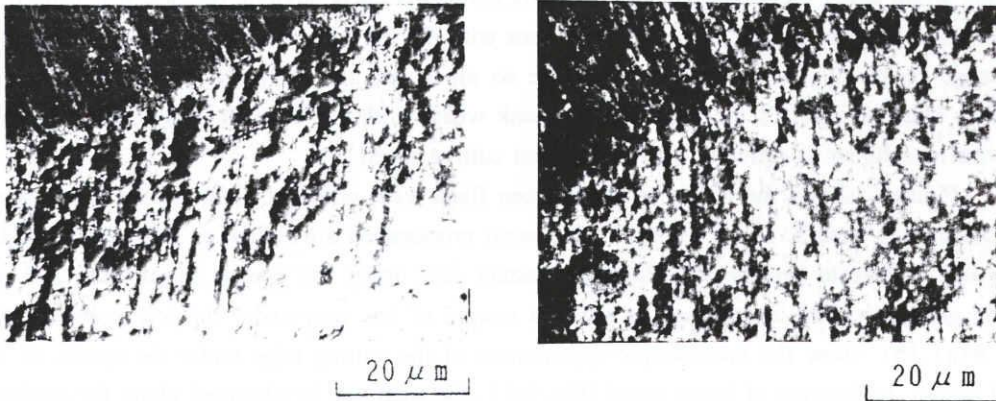
Fig.5 Appearances of cutting edge of $\text{Al}_2\text{O}_3\text{-TiC}$ tip in continuous cutting of FC25 under low speed of $V=100$ m/min.

(a) Cutting time: 1 min 51 sec

(b) Cutting time: 9 min 10 sec

cutting speed, it is opposite to the recommendation for the case of the higher cutting speed by the tool manufacturer for this ceramic material tip. By observation of the tip edge configurations shown in Fig.5 (a), (b) and Fig.6, we can explain the above mentioned phenomena. In the case of lower speed cutting (Fig.5), at the initial stage, the wear band is very narrow yet, but the certain frictional marks appears clearly on the both faces of flank and rake, therefore the surface has already become rough. On the other hand, at the middle stable stage, the friction marks become thin. This means that the wear occurs un-uniformly on the faces. In the case of higher speed (Fig.6), the flank surface has been already worn and seems to be smooth even after the short time cutting. The wear occurs all over

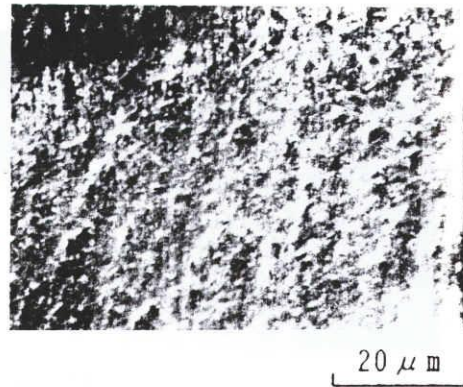
Fig.6 Appearance of cutting edge of $\text{Al}_2\text{O}_3\text{-TiC}$ tip under high speed of $V=300$ m/min.

Cutting time: 33 sec, $H\epsilon = 92 \mu\text{m}$

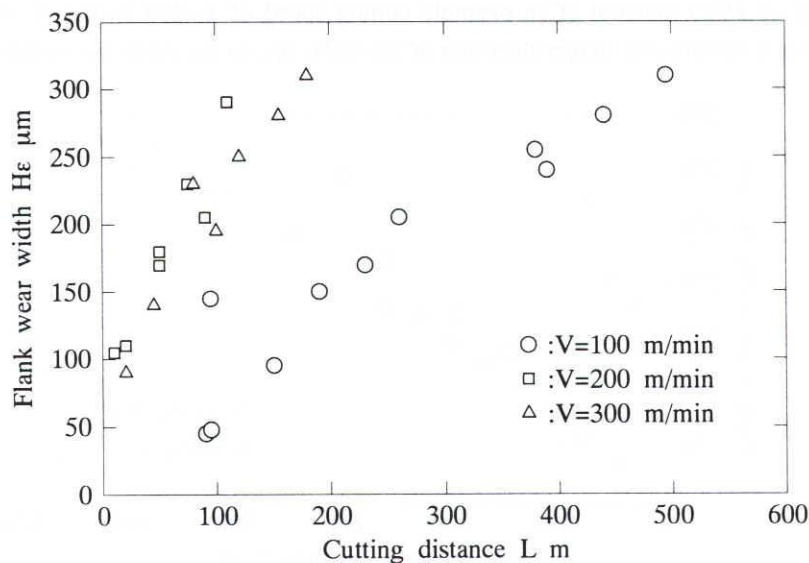
Fig.7 Relationship between flank wear and cutting distance for Si_3N_4 tip.

Figure 7 shows the relationships between flank wear width of Si_3N_4 tip and the cutting distance for various cutting speeds. The features of flank wear propagation are similar to those of the $\text{Al}_2\text{O}_3\text{-TiC}$ tip, that is, they propagate rapidly with almost constant rate under the speeds faster than 200 m/min and propagate gradually after initial wear of about a couple of ten μm under the low speed of 100 m/min. Figures 8(a), (b) show the microscopic appearances of the cutting edge under the speeds of 100 m/min and 200 m/min. In the case of lower speed (Fig. (a)), the wear can be observed along the cutting edge and the surface becomes somewhat smooth. But for the higher cutting speed (Fig. (b)), even after a very short cutting time of 10 sec, the cutting edge is worn out and the neighboring surface of the cutting edge becomes round and very smooth. This wear may occur under the mutual operation of mechanical and thermal effects.

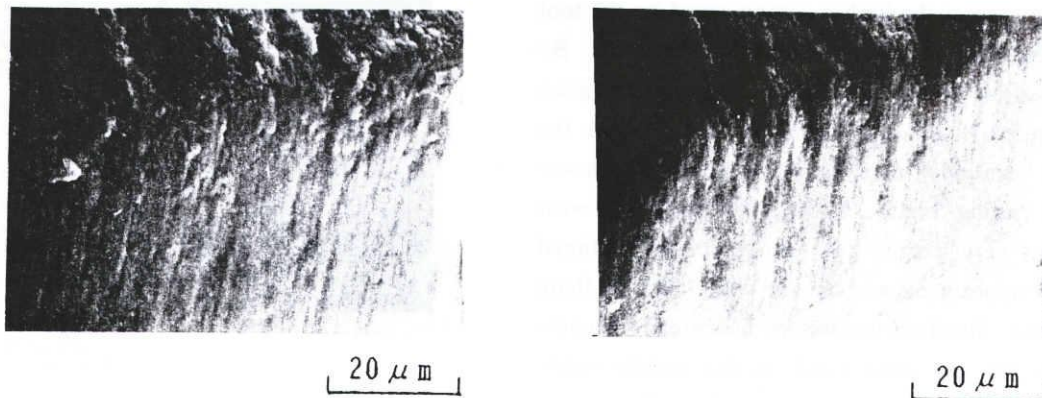
Fig.8 Appearance of cutting edge of Si_3N_4 tip for continuous cutting of FC25.

Time:10sec, $H\epsilon = 93 \mu\text{m}$,
(a) Edge wear under $V=100\text{m/min}$.

Time:141sec, $H\epsilon = 168 \mu\text{m}$,
(b) Edge wear under $V=200 \text{ m/min}$

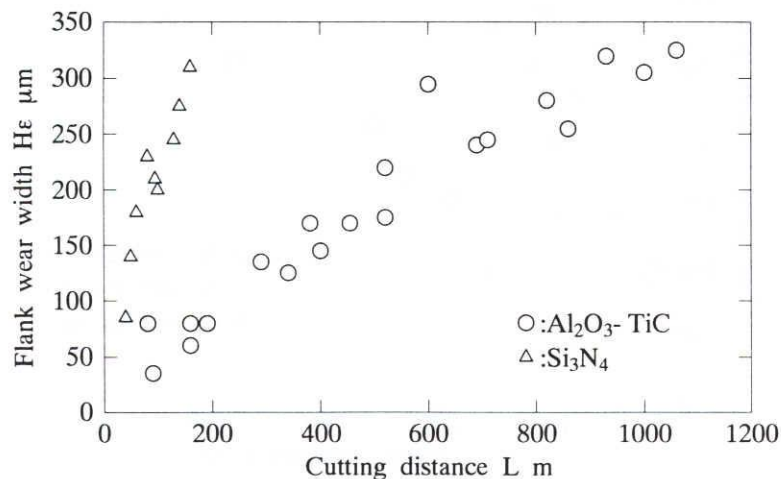
Fig.9 Comparison of wear propagations for $\text{Al}_2\text{O}_3\text{-TiC}$ and Si_3N_4 tips.

The flank wear propagations of both the Al_2O_3 and the Si_3N_4 tips are compared in Fig.9 for the continuous cutting of FC25 material at an example cutting speed of $V=200 \text{ m/min}$. It shows that the tool life of the Al_2O_3 tip is remarkably longer than that of the Si_3N_4 tip, so the Al_2O_3 tip is definitely superior for

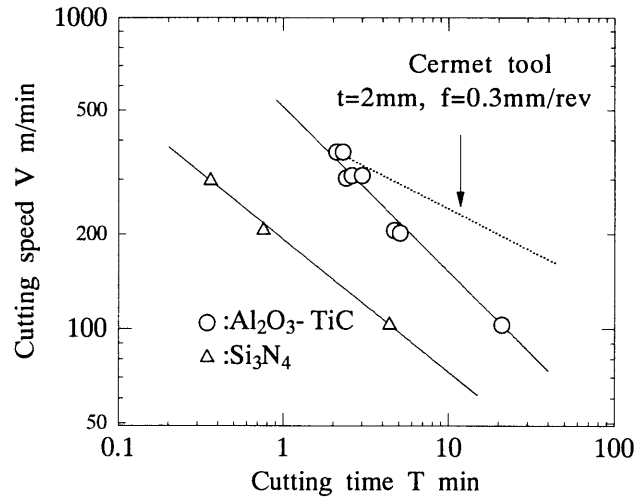
Fig.10 Tool life diagram (V-T diagram) for Al₂O₃-TiC and Si₃N₄ tips.

the continuous cutting of FC25 material under the operative conditions employed. Using these experimental results, we can draw the tool life diagram as shown in Fig.10 and can easily derive the tool life criteria as follows.

In this equation, variable V is cutting speed (m/min), T is tool life (min) and C is constant which depends upon the combination of tool and work material and the cutting condition. The smaller is value n obtained from this equation, the longer is the tool life under the same value of C. As shown in Fig.10, every experimental result can be fitted by one line, therefore, each relationship can be expressed by the following equations.

$$V T^{0.5} = 457 \quad : \text{Al}_2\text{O}_3\text{-TiC tip} \quad (2)$$

$$V T^{0.45} = 197 \quad : \text{Si}_3\text{N}_4 \text{ tip} \quad (3)$$

Both values of power n are comparable, but that of Al₂O₃-TiC tip is somewhat bigger, so it can be concluded that the drop of cutting performance depending on the increase of cutting speed is smaller. Moreover, though the value of power n in eq. (1) for the Si₃N₄ tip, that is, the gradient of the line for Si₃N₄ tip is smaller, it may be impossible to realize the longer tool life beyond that of the Al₂O₃-TiC tip under the generally used cutting speed, because the Si₃N₄ tip has extremely short life under the same condition. The dotted line for the cermet tip shown in Fig.10 which is suggested by the tool manufacturing company is shown by the following equation.

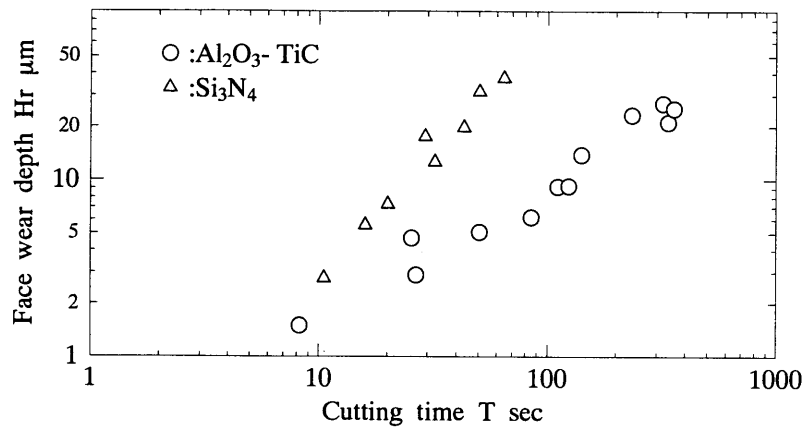
Fig.11 Comparison of crater wear depths of Al₂O₃-TiC and Si₃N₄ tips under V=200 m/min.

As a reference, an example of crater wear propagation is shown in Fig.11 under the cutting speed of 200 m/min. The depth and dimensions of the crater wear of the Al₂O₃-TiC tip is considerably smaller than that of the Si₃N₄ tip, as a result, Al₂O₃-TiC tip can be used for six times longer than the cutting distance of the Si₃N₄ tip. On observing the crater wear at any period in various cutting stages, the propagating process can be summarized as follows. First, the rake surface is rubbed by the chip ends and the shallow wear is created at the region of about 300 μm away from and parallel to the cutting edge. With the continuation of cutting, the wear becomes deeper and deeper, so irregular and very deep wear

appears at the boundaries of the rake wear region by the unexpected sudden external force. Under the higher cutting speed, the crater wear with typical feature can be appeared.

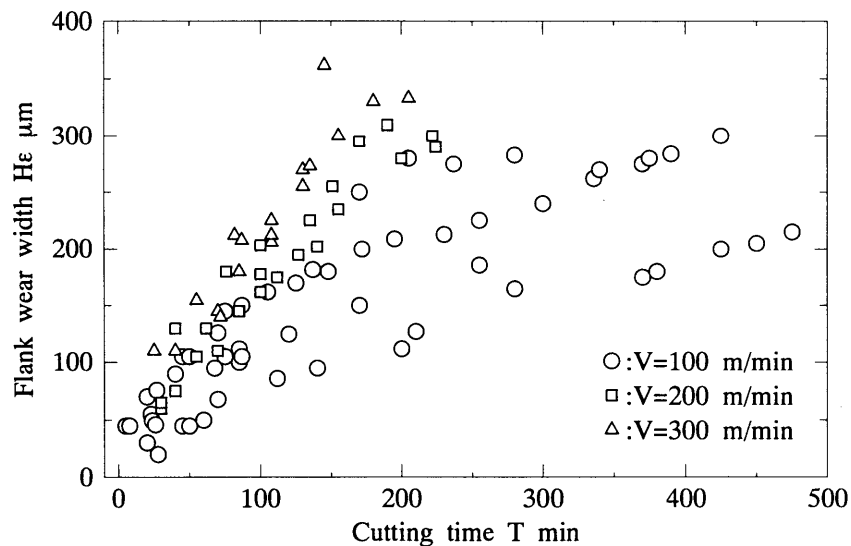
Fig.12 Flank wear propagation of Si₃N₄ tip for the discontinuous cutting of FC25.

Figure 12 shows the flank wear propagations of Si₃N₄ tips in discontinuous cutting of the FC25 work shown in Fig.3. The data for V=100 m/min has large scattering and this scattering is induced by the reason why every work used in each experiment has the different diameter, so the number of strike is also different in each work even under the same cutting speed. The higher the cutting speed is, the quicker the wear propagation is. As shown in continuous cutting, it propagates very slowly under the low speed V=100 m/min. The cutting edge is in very unstable condition, so that the tool wears not only by the gradual propagation but also by breakage, cracking and chipping those are created at the same time at the cutting edge. In this research the results for the suddenly encountered large scale breakages are not employed as the investigating objects, that is, only the gradually growing wears are investigated.

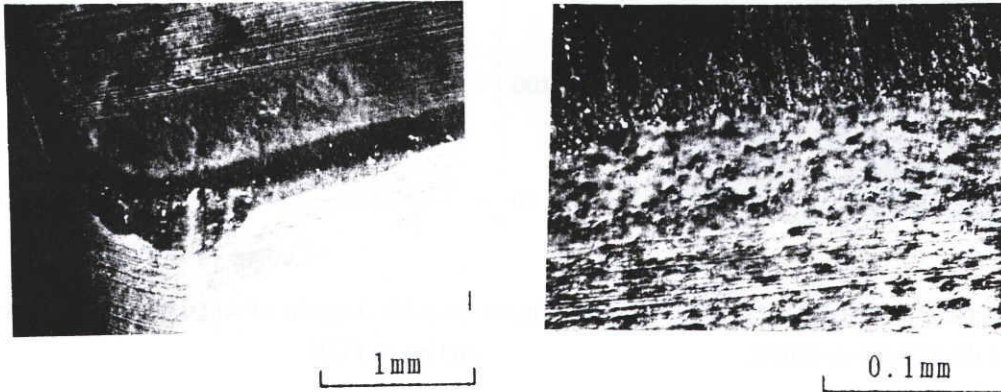
Fig.13 Appearances of flank wears of Si_3N_4 tip for discontinuous cutting of FC25 under $V=100$ m/min.

(a) Whole view of flank wear

(b) Worn region of flank

(Cutting time: $T=120$ sec, Flank wear width $H\epsilon = 155 \mu\text{m}$)

The appearances of the worn tool edge of the Si₃N₄ tip are shown in Fig.13 (a), (b) and Fig.14 (a), (b) at the different cutting stages in discontinuous cutting of FC25 under low and high cutting speed of V=100 and 300 m/min. From Fig.13, it can be recognized that a very wide flank wear at the zone of the tip nose and small scale chippings at many points along the cutting edge are occurred after about one or

two minutes of cutting under $V=100$ m/min. Moreover irregular brakedges suddenly occur at the neighboring region of cutting zone, but the periods when such brakedges may occur can not be defined clearly. In the case of higher speed of $V=300$ m/min (Fig.14), large and deep cracks can be propagated near the cutting zone. The width of flank wear, however, uniformly appears over the cutting region.

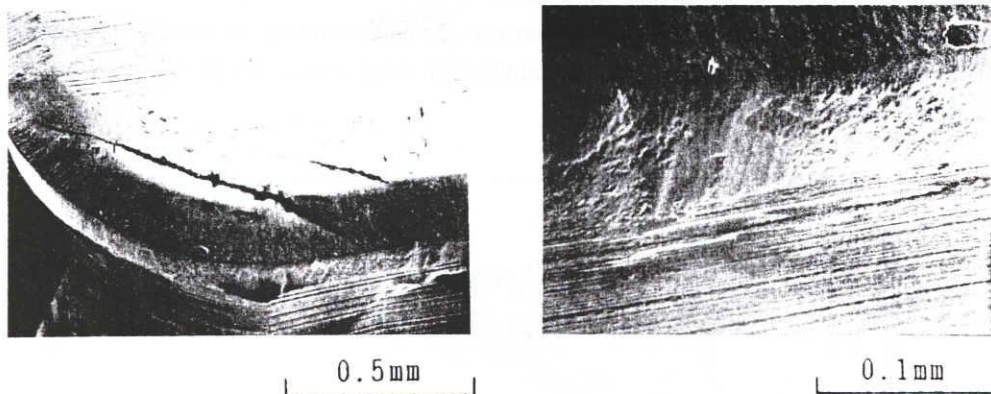
Fig.14 Appearances of flank wears of Si_3N_4 tip for discontinuous cutting of FC25 under $V=300$ m/min.

(a) Appearance of cracks induced on rake face

(b) Appearance of flank wear

(Cutting time: $T=10$ sec, Flank wear width $H\epsilon = 97 \mu\text{m}$)

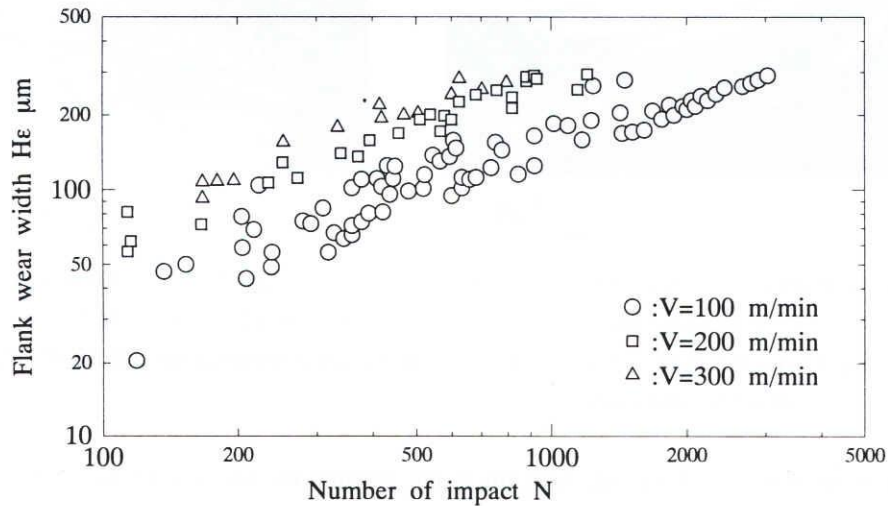
Fig.17 Relationship between flank wear width and the number of strikes for discontinuous cutting of FC25.

values. Figure 17 shows the re-arranged results of flank wear propagations by the number of strikes expected from the work, corresponding to cutting speed V . The tendency of increment of the wear width is similar in each case of cutting speed, but the rate of increment is stronger depending on the increment of the cutting speed. The flank wear is very unstable in the early stage of cutting, that is, in the period of the small number of strikes, so the width of induced flank wear is widely different for each experiment especially under low speed, but the dispersion converts gradually with the increase of the number of strikes. Then finally at the period of tool life, the number of total strikes which the tool accepts so far is approximately equal.

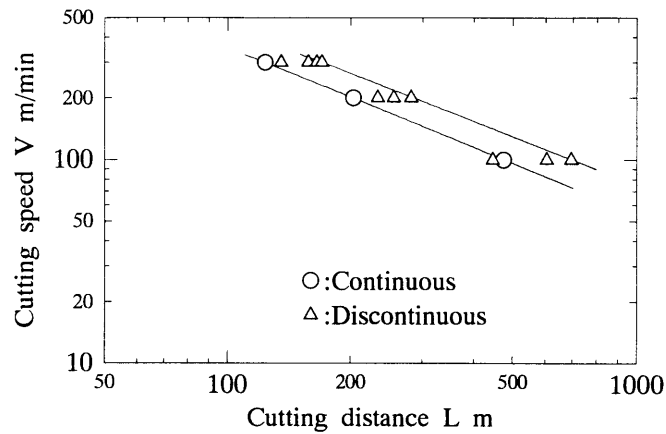
Fig.18 Tool life diagram concerning to cutting distance.

To summarize the experimental results for FC25, the tool life concerning to cutting distance L are compared for continuous cutting and discontinuous cutting in Fig.18 as the tool life diagram. In this figure the axis of abscissa is exceptionally noted by cutting distance L m opposite to the commonly employed values of cutting time T sec, because the cutting time can not indicate the accurate cutting distance in the discontinuous cutting. The equations for these lines are given as follows.

$$V T^{0.84} = 16900 : \text{Continuous cutting} \quad (5)$$

$$V T^{0.84} = 19700 : \text{Discontinuous cutting} \quad (6)$$

The tool lives for discontinuous cutting is always longer than those of continuous ones, but the difference is small under the high cutting speed. The main reason of such a strange result is that, as mentioned above, only the experimental values are employed, which are obtained in the case that the flank wear propagates gradually without expecting large scale brakedges in the period of early stage of short time cutting. However, these values contain the effects of dynamic periodical shocks by strikes of the contact between tool and work, so it can be stressed that the property of the Si_3N_4 tip material, that is, toughness has been developed very much.

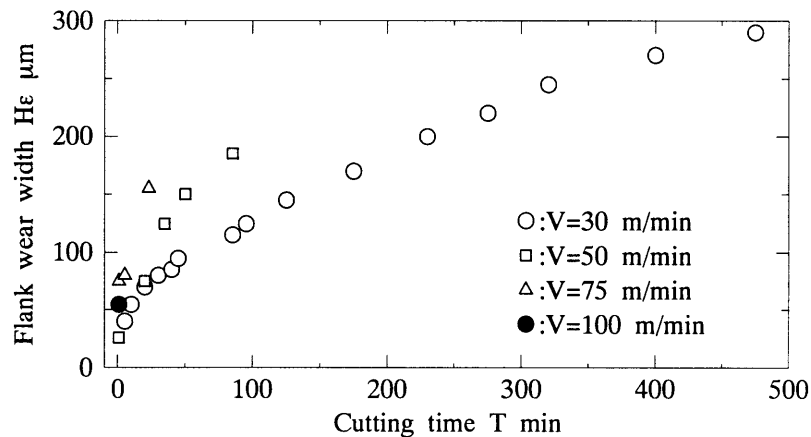
Fig.19 Propagation of flank wear against cutting time for cutting of SKS93 by $\text{Al}_2\text{O}_3\text{-TiC}$ tip.

Figure 19 shows the development of the flank wear width of $\text{Al}_2\text{O}_3\text{-TiC}$ tip concerning to cutting time T min for the hardened tool steel alloy of SKS93. In the practical cutting, catastrophic brakedge or

very wide flaking occasionally happens at the cutting edge and instantaneously becomes unable to cut under the condition of the cutting speed higher than $V=50$ m/min. Therefore, the datum for the wider propagating flank wears can not be obtained for $V \geq 50$ m/min and the cutting with the long tool life can be realized in the case of expecting typical wear propagation only at the very low cutting speed of $V=30$ m/min.

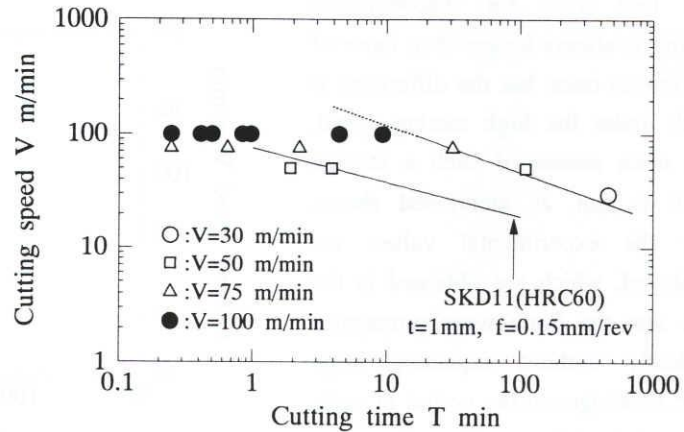
Fig.20 Tool life diagram for $\text{Al}_2\text{O}_3\text{-TiC}$ tip in cutting of SKS93.

Figure 20 shows the tool life diagram of the $\text{Al}_2\text{O}_3\text{-TiC}$ tip. This diagram contains all the values of tool life, whatever reasons lead the tips to their tool lives, that is, considering the gradually propagating wear and also the brakedge. As a reference, the datum for the cutting of SKD11 (HRC60) by using the same material tool tip suggested by the tool manufacturing company are shown in this figure. As it is impossible to define the period when the big scaled fatal brakedge or flaking occurs beyond the cutting speed of $V=50$ m/min, the dispersion width of the experimental results obtained depends on the period. From these experiment it may be predicted that such a fatal brakedge will occur by the period of the cutting time of 550 sec or so under the cutting speed of $V=100$ m/min and also by the period of the longer cutting time of about 30 or 95 min under the lower speed of $V=50$ or 75 m/min. Many examples with fatal

brakedges can be observed in this experiment under the somewhat higher cutting speed of $V=50$ m/min. The obtained results can be concluded to be reasonable, because even if the upper limit time is considered to be the tool life, those values are beyond the datum specified by the tool manufacturing company. The equations of tool lives can be derived as follows.

$$V T^{0.35} = 86 \quad : \text{Suggested datum by tool manufacturing company} \quad (7)$$

$$V T^{0.4} = 258 \quad : \text{Experimental results} \quad (8)$$

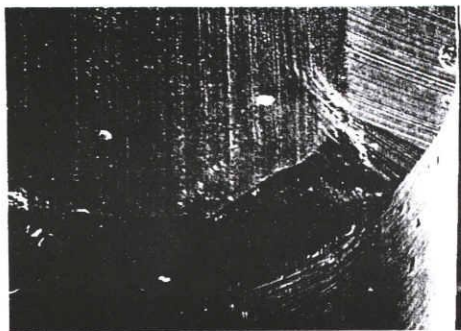
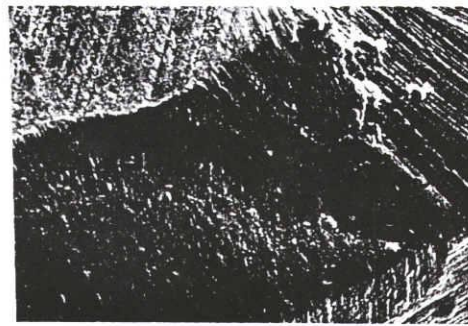
Fig.21 Edge wear under $V=50$ m/min (Cutting time: 265 sec, $H\epsilon = 38 \mu\text{m}$).

(a) Whole appearance of wear

(b) Boundary of worn region

Figures 21 and 22 show the appearances of the tool wears and brakedges induced at the cutting edges. The former is under $V=50$ m/min, and the later is under $V=75$ m/min. From Fig.21, we can clearly observe that, at the initial period of cutting the wear is induced all over the cutting region without

any brakedge at both the flank and rake face. The boundary looks very distinct and the surface of the worn out area looks rough, which may be created mainly by mechanical aggressive friction with tearing grains of the tip structure. On the other hand, the brakedge which occurs at comparatively earlier stage under $V=75$ m/min, has spreaded very wide region over both the flank and rake face as shown in the photo of Fig.22. The feature on the flank face is quite complicated and uncertain, but on the rake face it seems to be a wide flaking damage with uniformly distributing thickness. Moreover the surface appearance of the damaged region clearly reveals that it is created by the brakedge which is caused by brittle crack. This means the tool of Al_2O_3 material is more inferior in toughness.

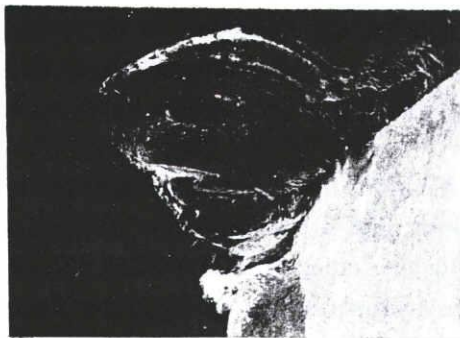
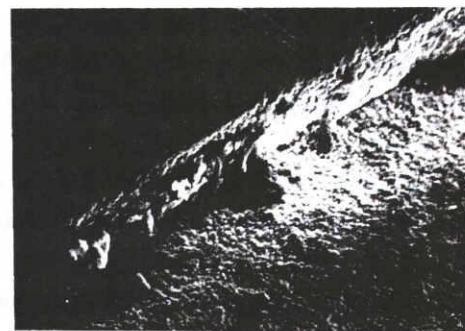
Fig.22 Appearances of brakedge and flaking (Cutting time: 15 sec).

(a) Whole appearance of damaged region

(b) Boundary of flaking region

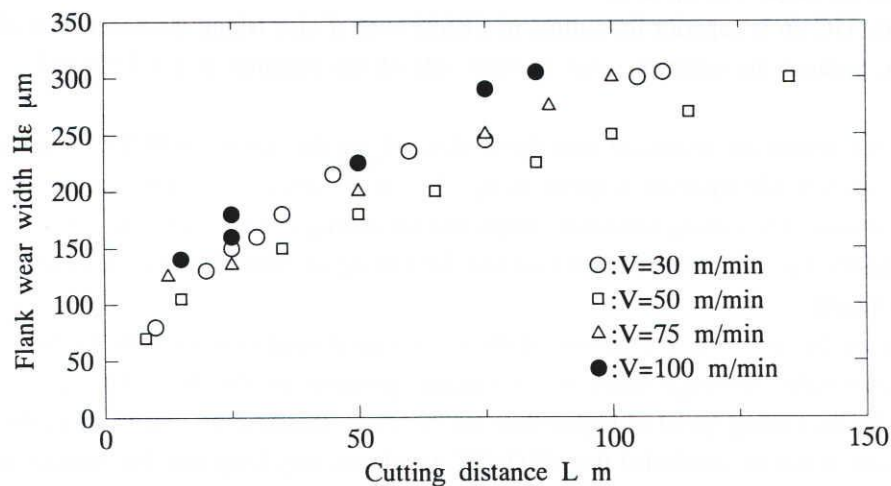
Fig.23 Relationship between flank face wear and cutting distance of Si_3N_4 tip for SKS93.

The relationship between the flank wear propagation of the Si_3N_4 tip in cutting of hardened SKS93 and cutting distance L m is shown in Fig.23 for various cutting speed $V=30,50,75,100$ m/min. After inducing the initial stage wear of about $50 \sim 120 \mu m$, wear propagates steadily depending on the increase of the cutting distance. Moreover when the speed is higher, the propagating rate of the flank wear is larger and the tool tip reaches its tool life earlier with an exception of $V=30$ m/min. Observing the appearance of cutting edge of this material tip, we can hardly find big and fatal brakedge, crack and flaking. The wear surface is very smooth and both the flank and rake wear are continuous and have reasonable shape. Figure 24(a),(b) show some examples of the local and fine scale chipping and brakedge induced at the cutting edge. Any way, the wear for the Si_3N_4 tip is induced mainly by mechanical aggressive and rubbing mechanism at the somewhat soften region of the tool material under high temperature.

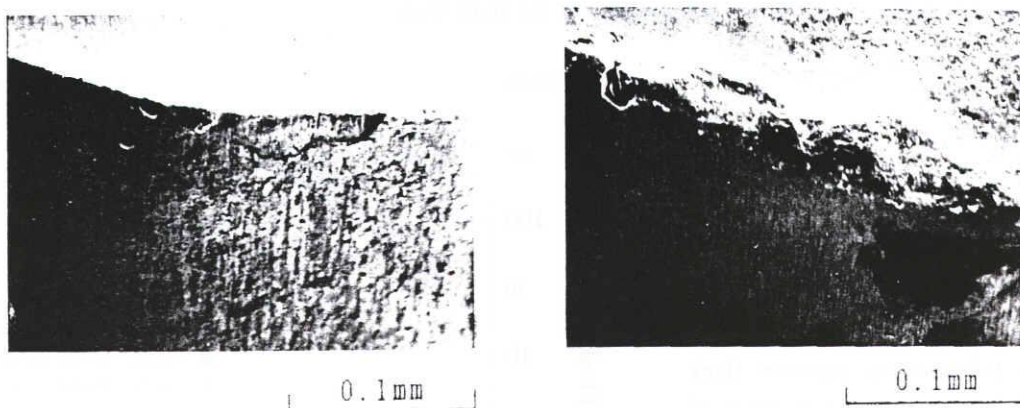
Fig.24 Appearances of cutting edge (Cutting time: $T=213$ sec, $H\epsilon=300 \mu m$).

(a) Chipping and crack at cutting edge

(b) Small brakedge at cutting edge

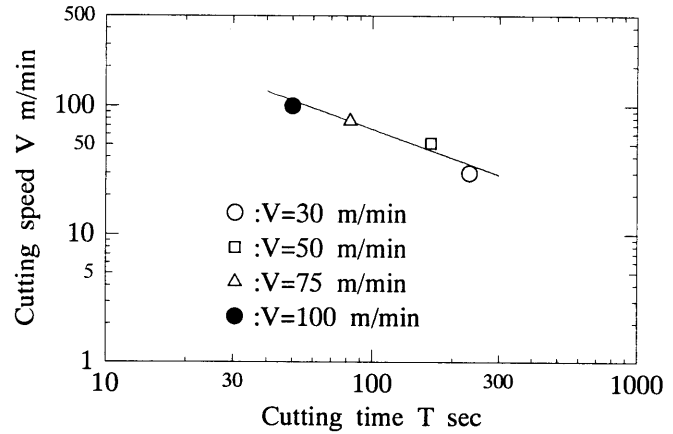
Fig.25 Tool life diagram of Si_3N_4 tip in cutting of water-hardened SKS93.

Similarly to the case of other work materials, the tool life diagram can be drawn as shown in Fig.25 and the equation can be derived as follows.

$$V T^{0.8} = 94 \quad (9)$$

All the results obtained are close enough to one linear line. Comparing with the results obtained for $\text{Al}_2\text{O}_3\text{-TiC}$ tip, the Si_3N_4 material tool is easily expected the brakedge under the speed higher than $V=50$ m/min and the performance of the Si_3N_4 material tip has low reliability. However, the power value in equation (8) is given as 0.4, therefore the value is just half compared with that of the Si_3N_4 tip. This means that the former tip, that is, $\text{Al}_2\text{O}_3\text{-TiC}$ tip has a smaller change of tool life than that of the Si_3N_4 tip for the corresponding cutting speed. Therefore the slower the speed is, the superior the $\text{Al}_2\text{O}_3\text{-TiC}$ tip is. In addition, $\text{Al}_2\text{O}_3\text{-TiC}$ tip is superior for cutting of SKS93 even if also taking the occurrence of brakedge into consideration, because the constant value of right side of the equation is 2.7 (258/94) times to that of Si_3N_4 tip.

If the results are compared with those obtained for the cutting of FC25 by using the same tool of Si_3N_4 tip (its tool life equation is given as eq.(3)), it is easily recognized that the tool life becomes considerably shorter. The cutting conditions employed for cutting of FC25 are very different from those for cutting of SKS93, but the extreme short tool life for cutting of SKS93 is too intolerable in the case of practical machining.

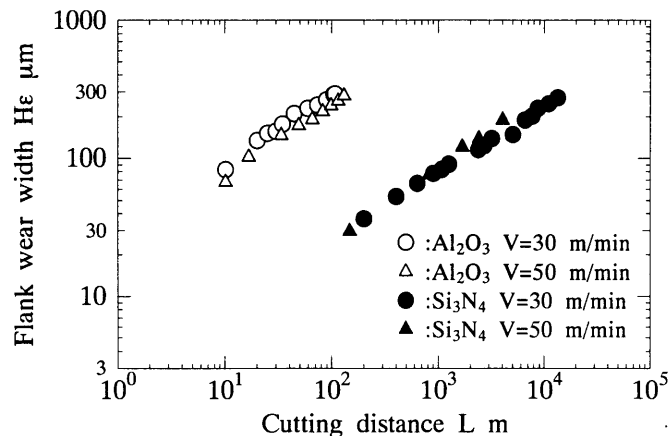
Fig.26 Relationship between flank wear width and cutting distance of $\text{Al}_2\text{O}_3\text{-TiC}$ tip compared with Si_3N_4 tip for cutting of SKS93 material.

Figure 26 shows the comparison of the flank wear propagation for both the Si_3N_4 and $\text{Al}_2\text{O}_3\text{-TiC}$ tip. If the catastrophic brakedge happens, the cutting operation for the $\text{Al}_2\text{O}_3\text{-TiC}$ tip no longer can be continued under the cutting speed of higher than $V=75$ m/min, therefore no results are plotted in the figure. From this figure it can be concluded that $\text{Al}_2\text{O}_3\text{-TiC}$ tip shows very long tool life without inviting big and fatal brakedge under the lower cutting speed, but it easily invites such damages, as to become very short tool life under higher cutting speed. On the other hand, Si_3N_4 tips does not reach to the tool life by fatal brakedge and so on, but the tool life is extremely shorter than that of $\text{Al}_2\text{O}_3\text{-TiC}$ tip because of the substantial high speed rate of the propagation of the flank wear.
