修 士 論 文

Fundamental Study on Dynamic Behaviors of the Parthenon Athens

三重大学大学院工学研究科
建築学専攻

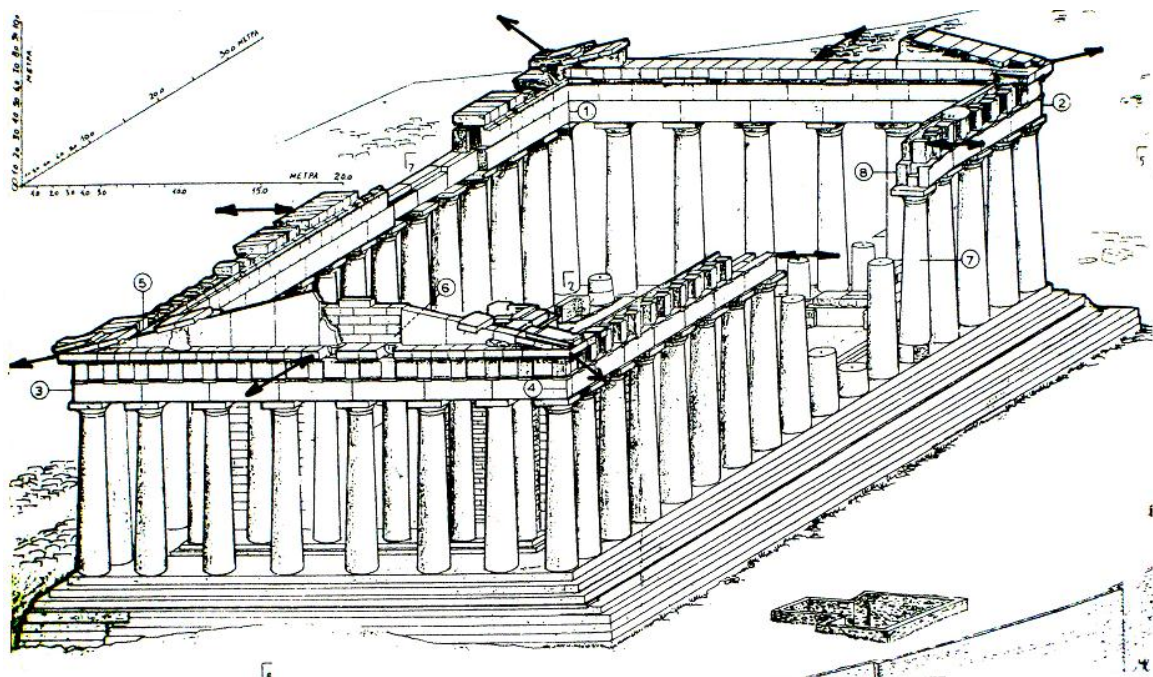
Fig. 1-1 Axonometric projection of the Parthenon [12]

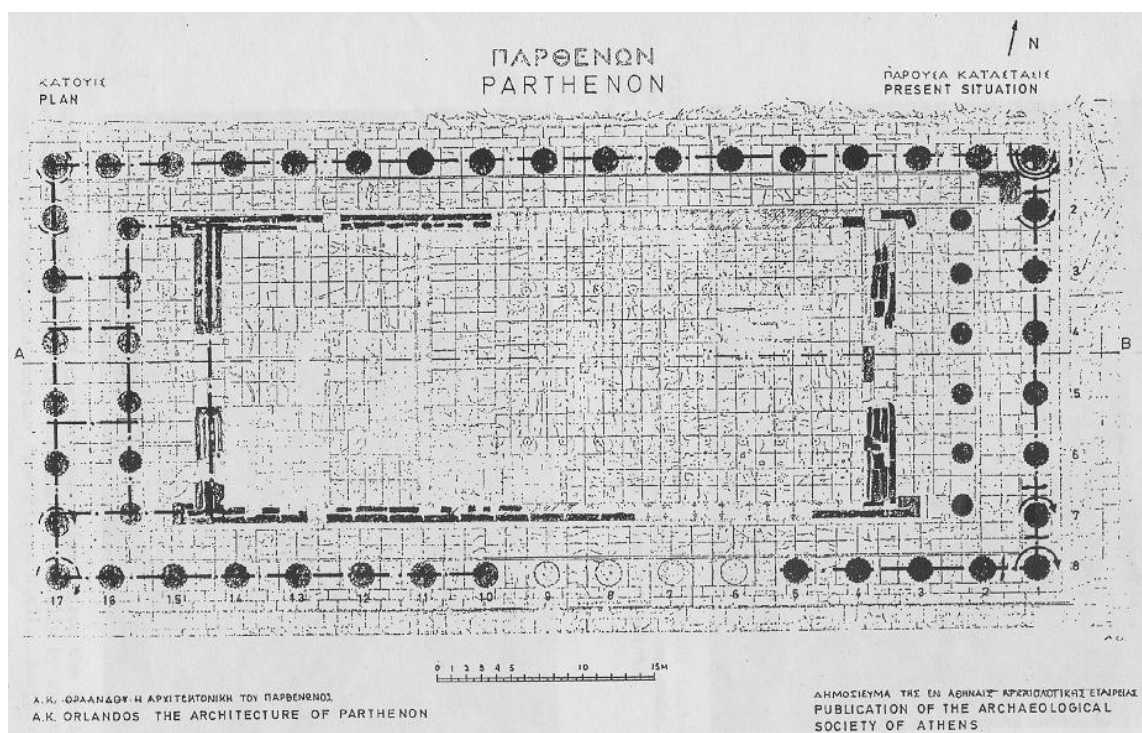
Fig. 1-2 The Parthenon after the earthquakes of 1981 [11]

“The arcs with arrows indicate rotations of the top in relation to the bottom. The lines indicate cracks of the head beams after the recent earthquakes. The dotted and dashed lines indicate horizontal beams at the top.”

The deformation of the monument caused by the Athens earthquake of 1999 and the Corinth earthquake of 1981 is mentioned here. According to reference [11 and 12], after the earthquake of 1999, *“the width of the crack in the exterior south architrave block of the SW corner, caused by the earthquake of February 24, 1981 was increased.”* And after the earthquake of 1981, *“The entablatures of the four corners were expanded outside (Fig. 1-1). The cracks in the marble and the gaps in the marble blocks were extended. Extension of the gap in the NE marble blocks which was unstable before; maximum length of 2.5cm (1 in Fig. 1-1). The NE corner column revolved horizontally and inclined. The SE corner column (2 in Fig. 1-1) revolved vertically. The entablature of the NW corner (3 in Fig. 1-1) and the SW corner (4 in Fig. 1-1) had gaps. Two bronze elements for joints, inserted at the 1973 restoration work, were cracked. The horizontally expansion on the upper part of the beams (6 in Fig. 1-1) were maximum length of 36mm. The 5th column from the SE (7 in Fig. 1-1) inclined outside. The gap on the vertical joint of the member of the architrave. Many slippages and marks of revolution on the drums of the colonnade, it was found extended cracks which were before on some of them.”*

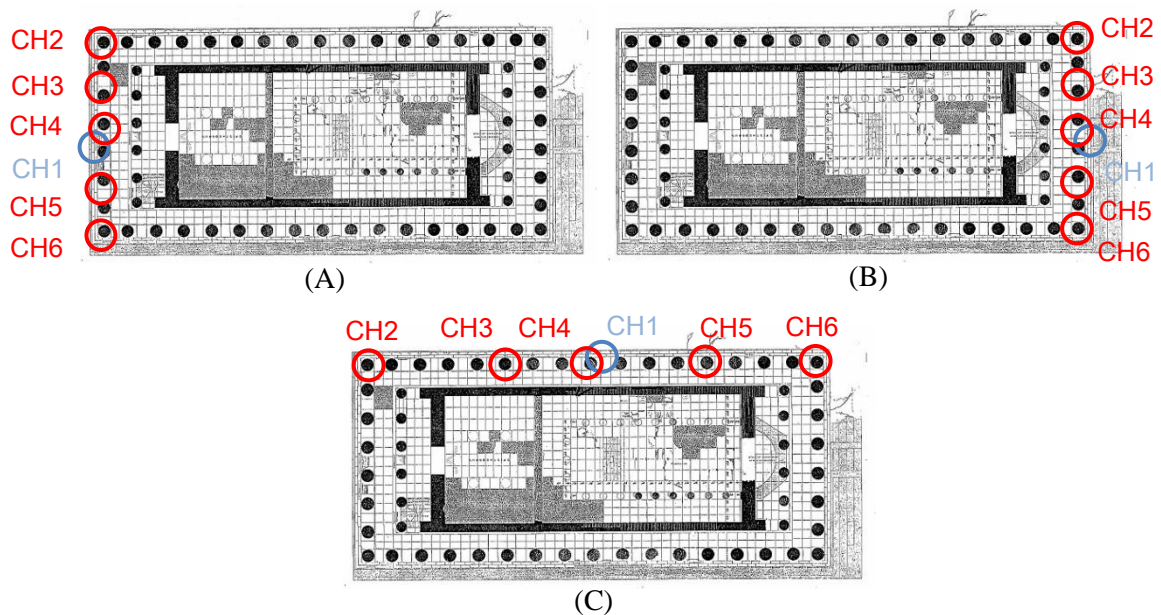
Fig. 2-2 Arrangement of the microtremor sensors at A) the west colonnade, B) the east colonnade, and C) the north colonnade

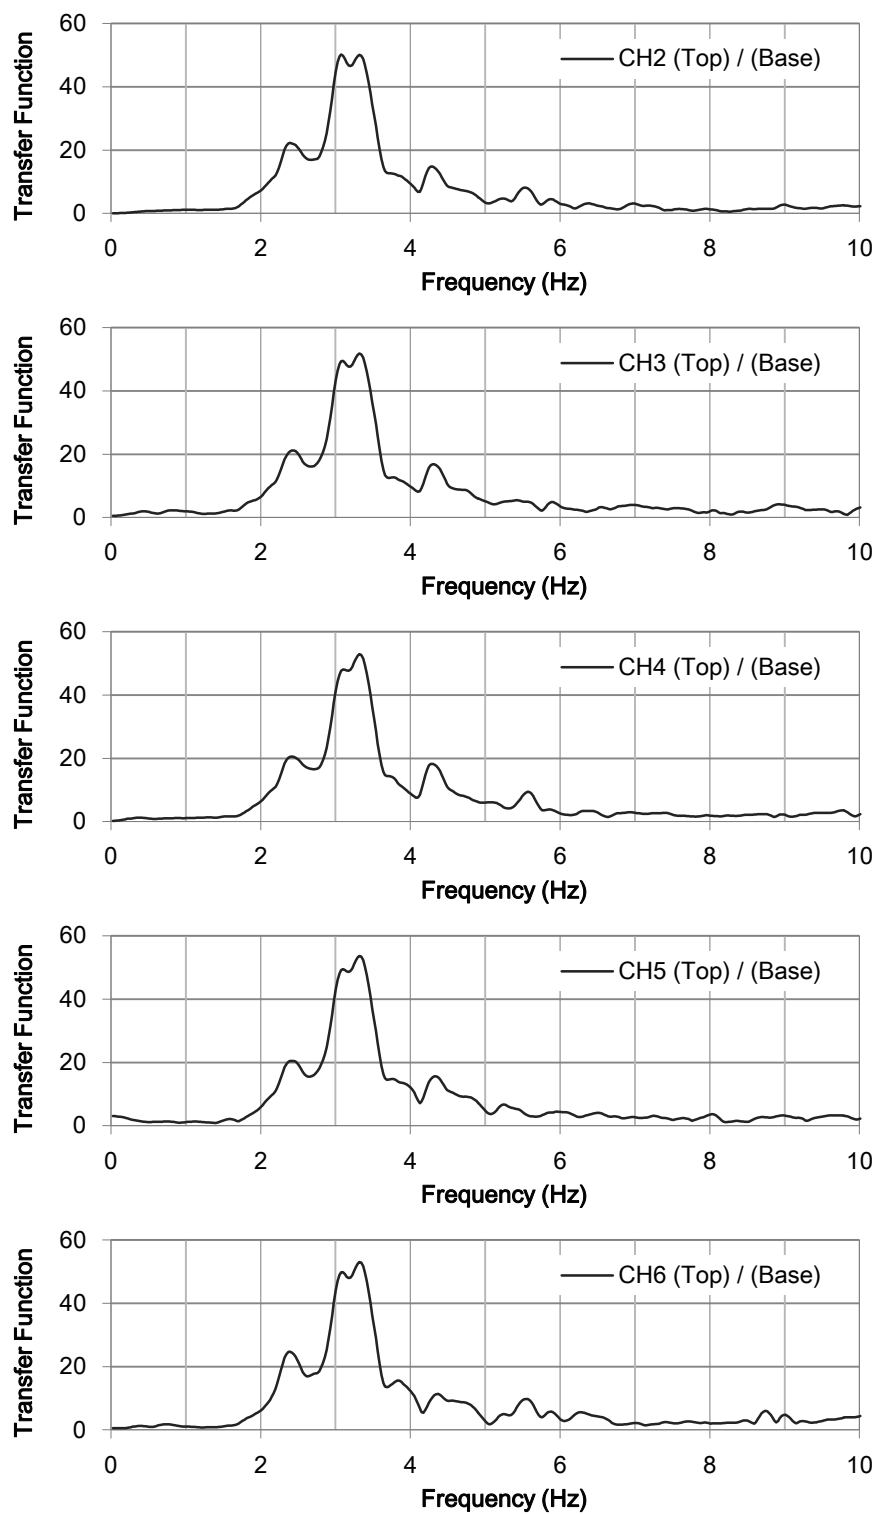
Fig. 2-3 Transfer function of the west colonnade in in-plane direction

Figs.2-3 shows the transfer function at the west colonnade in its in-plane direction. It can be recognized that the natural frequency of the west colonnade is about 3.3 Hz in this direction. On the other hand, spectral peaks, shown in Figs.2-4, were affected by the sensor's location in out-of-plane direction. In these figures, there found a predominant peak at 2.4 Hz in the spectra observed at the measuring points in the middle (CH3, 4 and 5) of the west colonnade.

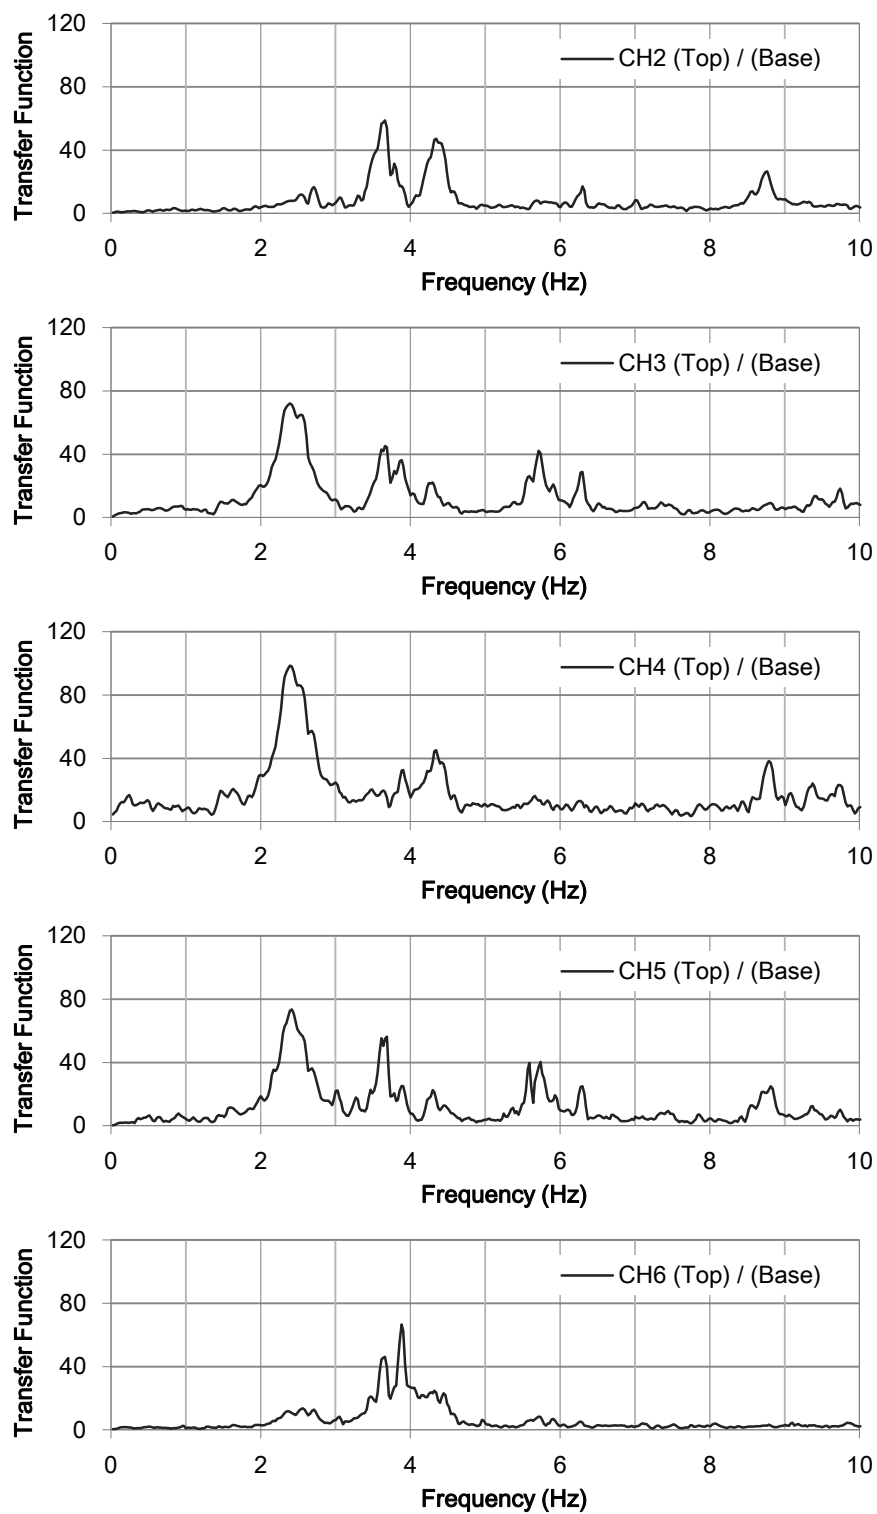
Fig. 2-4 Transfer function of the west colonnade in out-of-plane direction

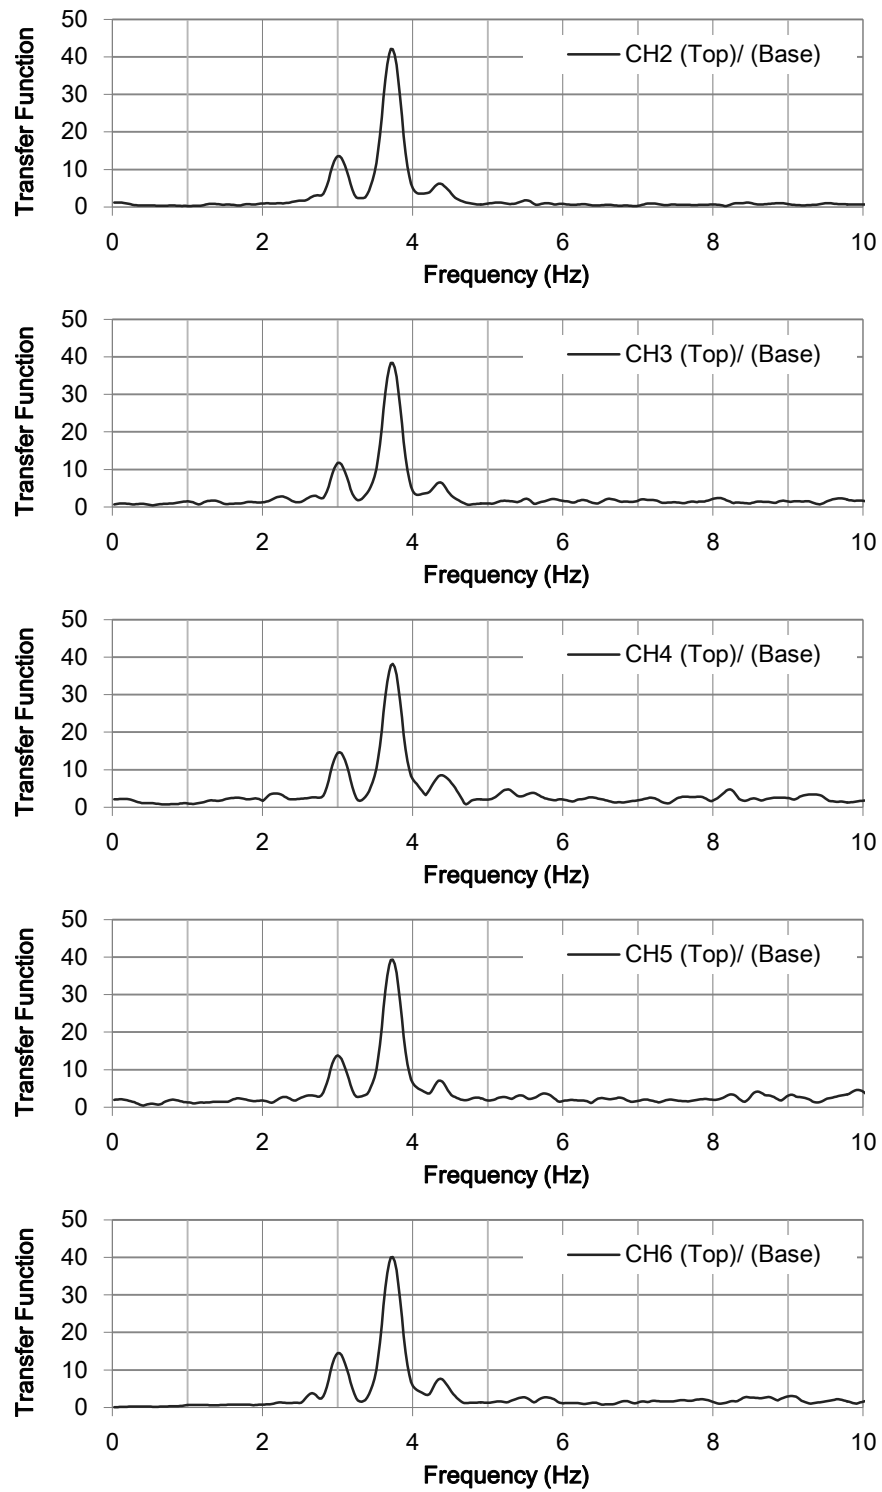
Fig. 2-5 Transfer function of the east colonnade in in-plane direction

It can be found in Figs.2-5 that the natural frequency of the east colonnade was 3.7 Hz in in-plane direction. The natural frequency of this colonnade in out-of-plane direction was also found to be 2.7 Hz shown in Figs.2-6.

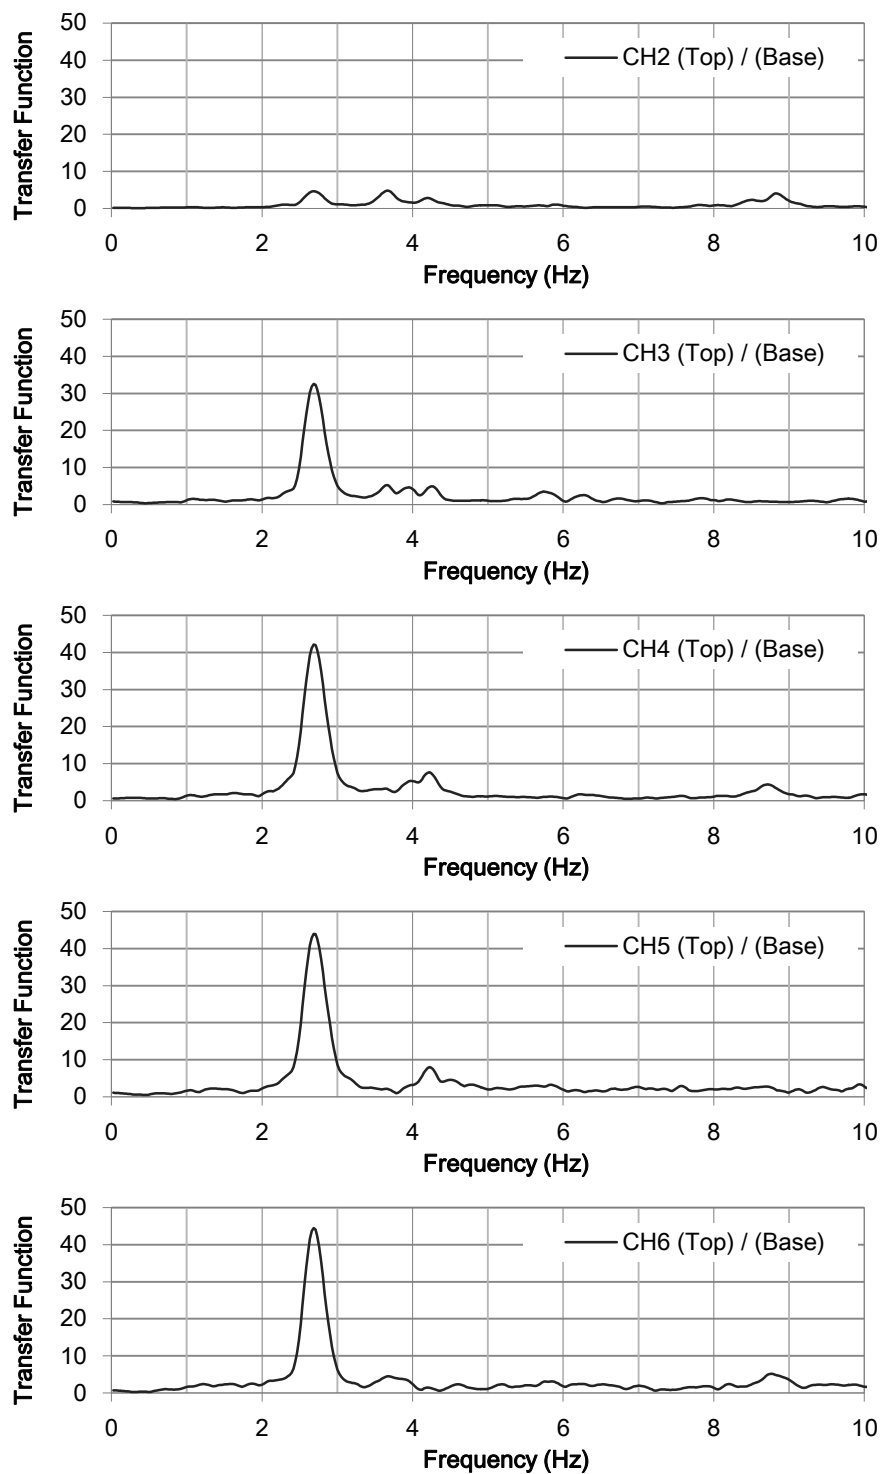
Fig. 2-6 Transfer function of the east column in out-of-plane direction

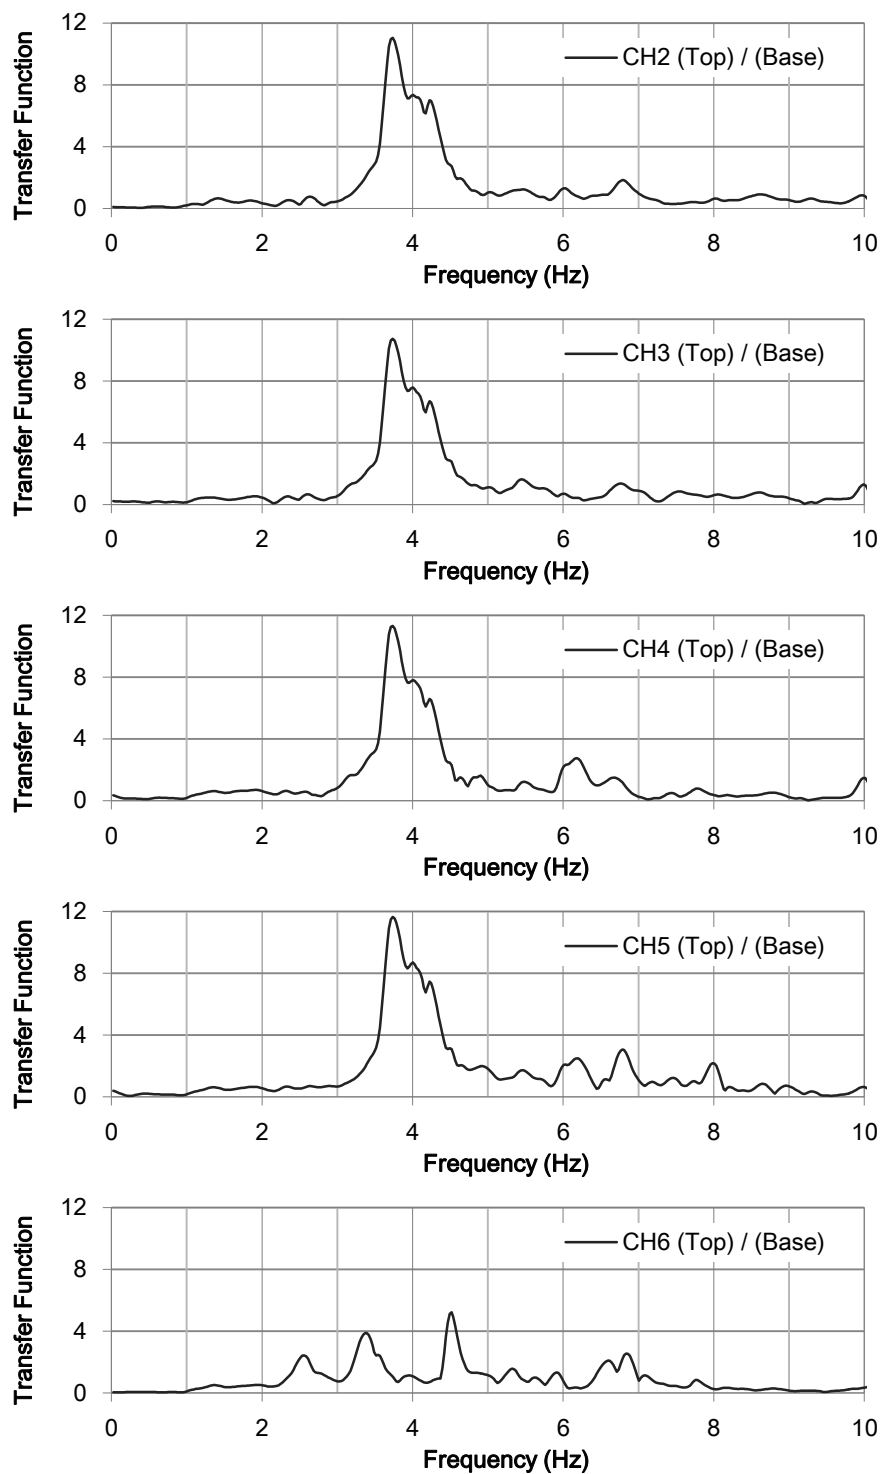
Fig. 2-7 Transfer function of the north colonnade in in-plane direction

Transfer function of the micro tremor records at the north colonnade showed that the natural frequency was 3.7 Hz for the in-plane behavior, shown in Figs.2-7. On the other hand, the natural frequency for the out of-plane behavior was not observed clearly, shown in Figs.2-8.

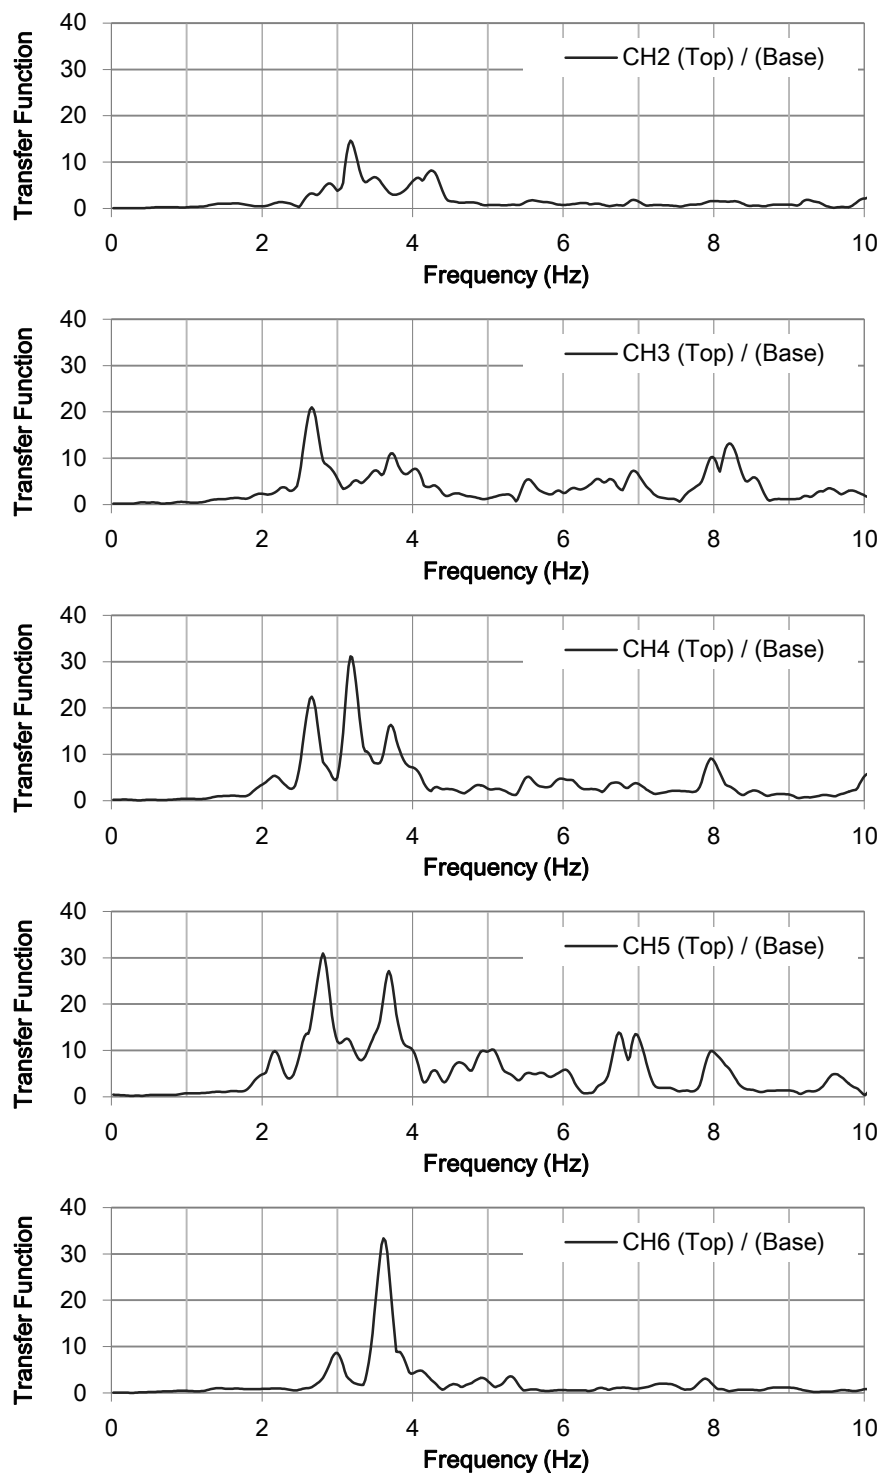
Fig. 2-8 Transfer function of the north colonnade in out-of-plane direction

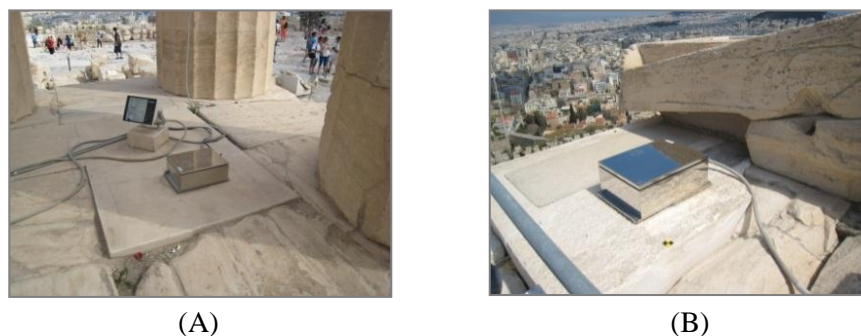
Fig. 2-9 Servo accelerographs. (A) Master sensor, and (B) Slave sensor

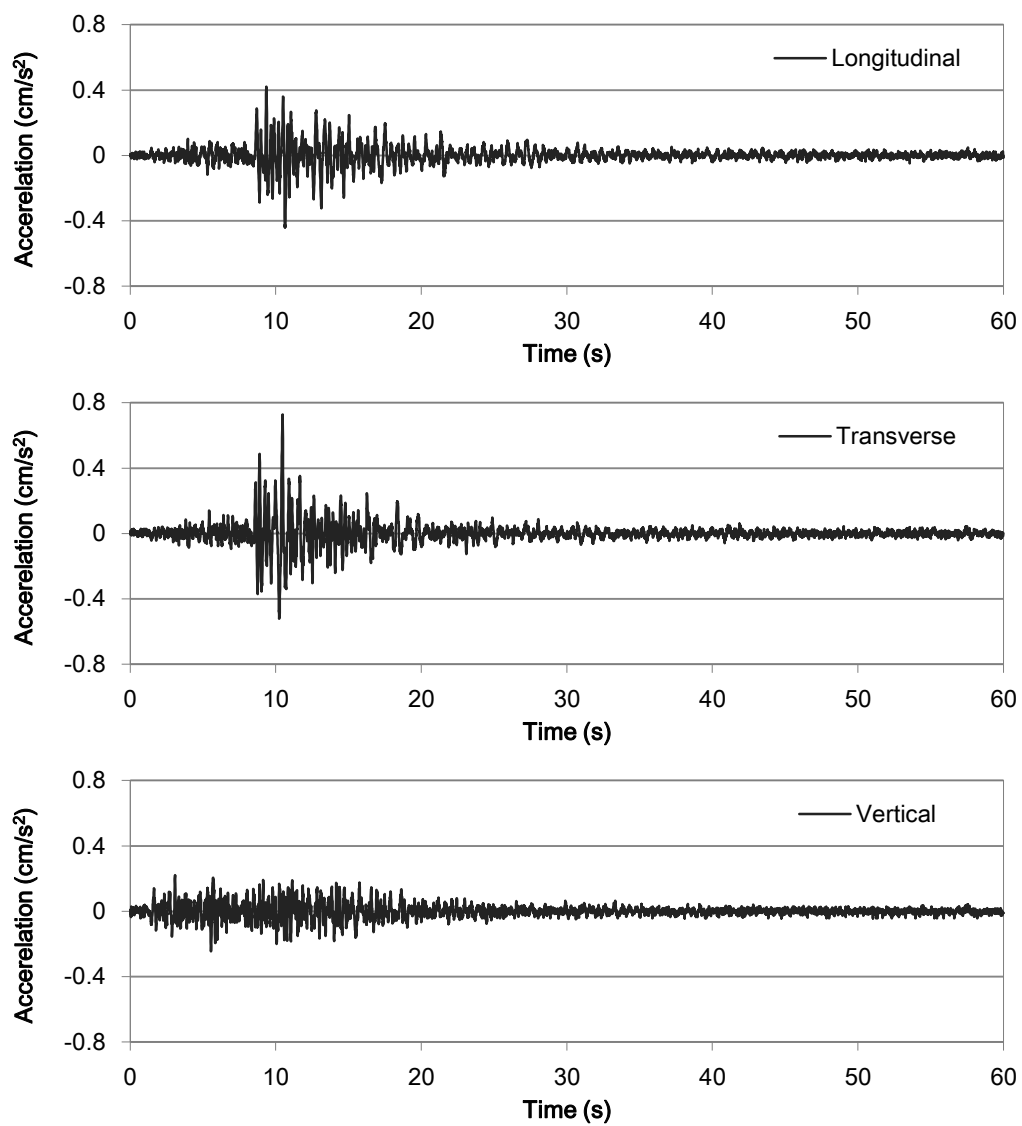
Fig. 2-10 Time histories of ground motions at the base

On 2nd of September, 2010, a small earthquake was recorded at the base (see Fig. 2-10). The amplitude of that earthquake record was as small as 0.0007G. The predominant period was found in the response spectra at 0.5s. However, the topographical effect of Acropolis hill on the ground motions still remains as a subject to be studied.

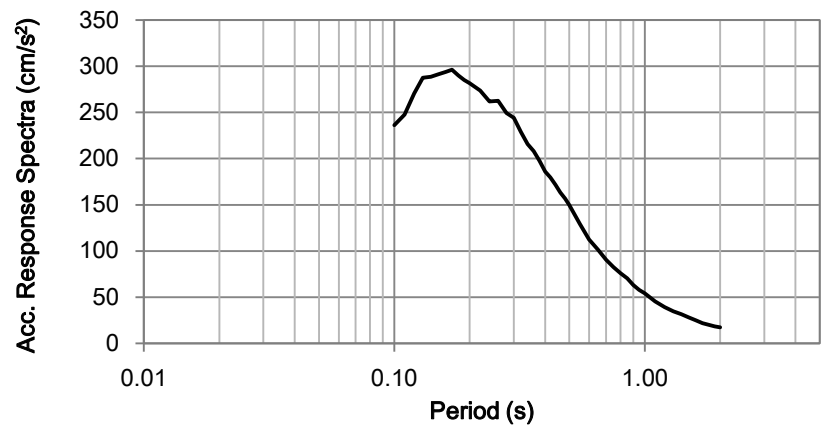
Fig. 3-2 Target acc. response spectra for the foot of the Acropolis hill for the Athens earthquake

The fig.3-2 and 3-3 represent target response acceleration spectra for simulation of the ground acceleration for the Athens earthquake and Corinth earthquake respectively.

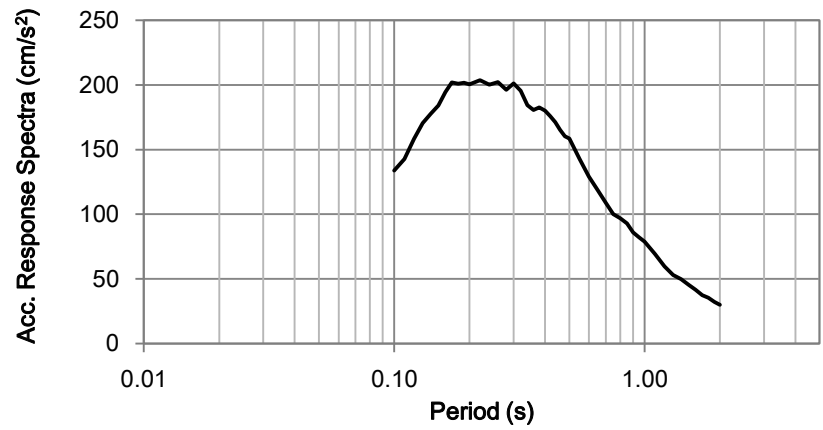
Fig. 3-3 Target acc. response spectra for the foot of the Acropolis hill for the Corinth earthquake

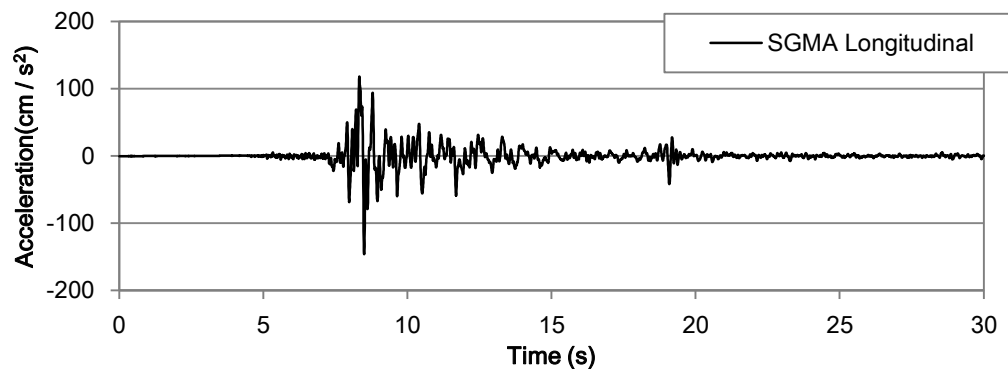
Fig. 3-4 Recorded time history of the acceleration of the Athens earthquake

Following figures 3-4 and 3-5 describe the actual acceleration records obtained at Athens earthquake and Corinth earthquake, respectively. Simulated ground motions were generated by referring the phases of these records. While seismic records were obtained from 15 instruments at the Athens earthquake, the record of SYNTAGMA A was used for simulation because the distance to the Acropolis hill was short (about 1 km) and its good quality. For the case of the Corinth earthquake, only one record was caught. Therefore, that record was used for simulation.

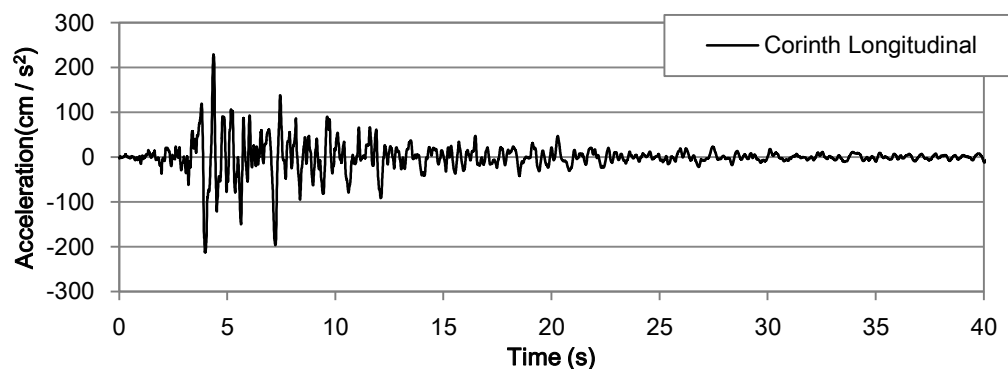
Fig. 3-5 Recorded time history of the acceleration of the Corinth earthquake

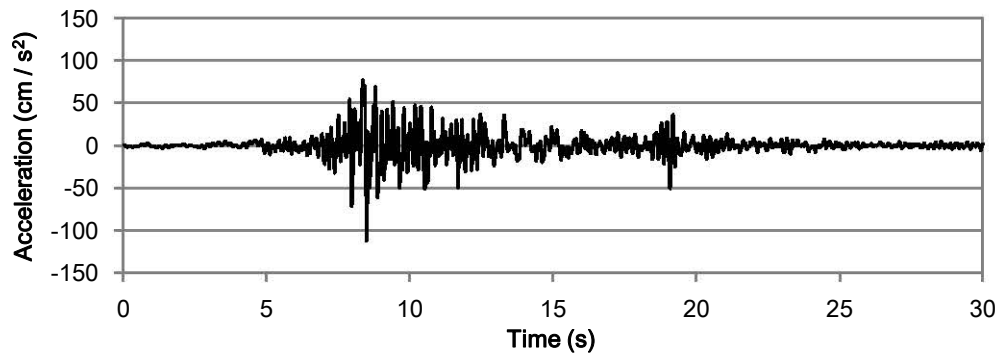
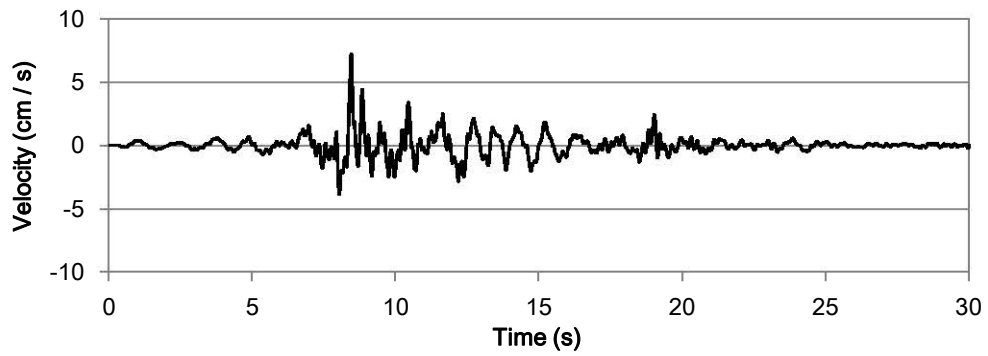
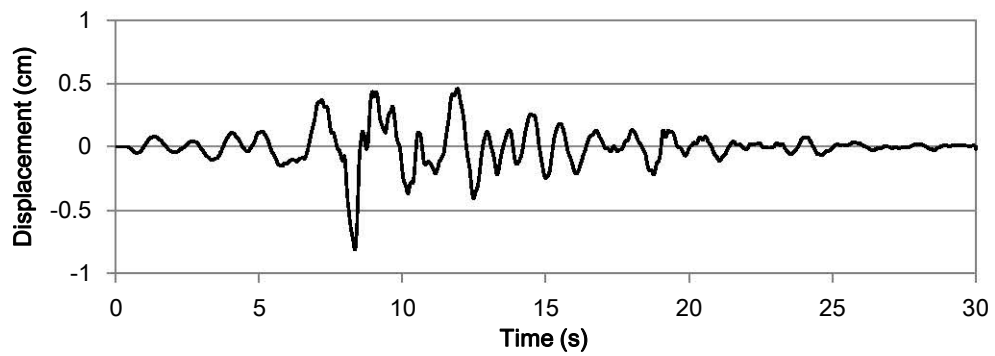
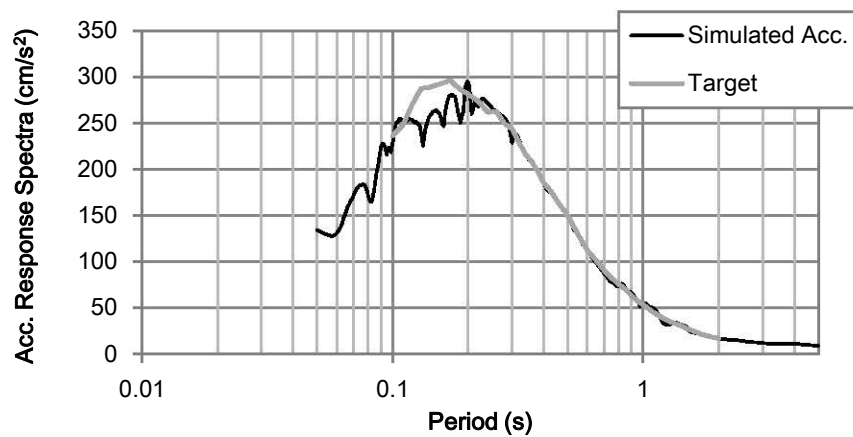
Fig. 3-6 Simulated time history of A) acceleration, B) velocity and C) displacement and D) the response spectra of the simulated acc. at the Athens earthquake

Figs.3-5 and 3-6 show the simulated motions of the ground acceleration, velocity and displacement at the Athens earthquake and the Corinth earthquake, respectively. Their acceleration response spectra with target spectra are also shown in figs. 3-5 and 3-6 in order to demonstrate the fitting condition. The peak accelerations of these simulated motions are shown in table 3-4. The calculated peak accelerations, which were estimated our previous study [13], are also shown in table 3-4.

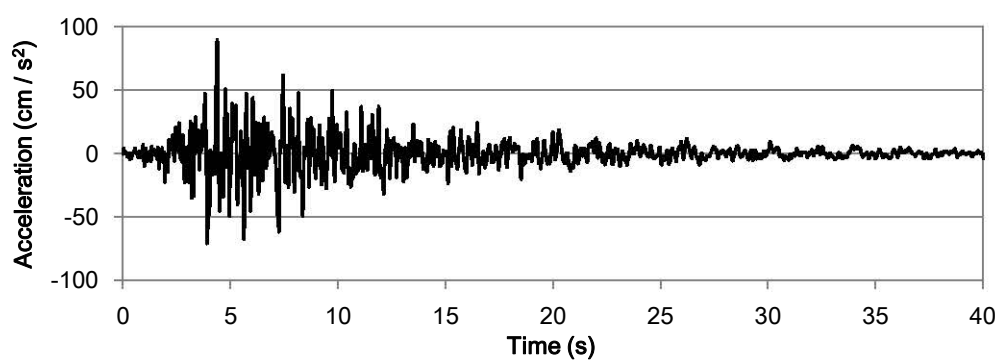
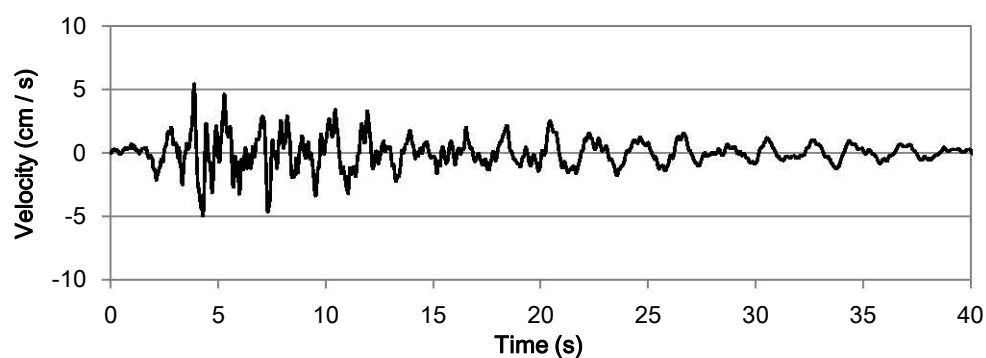
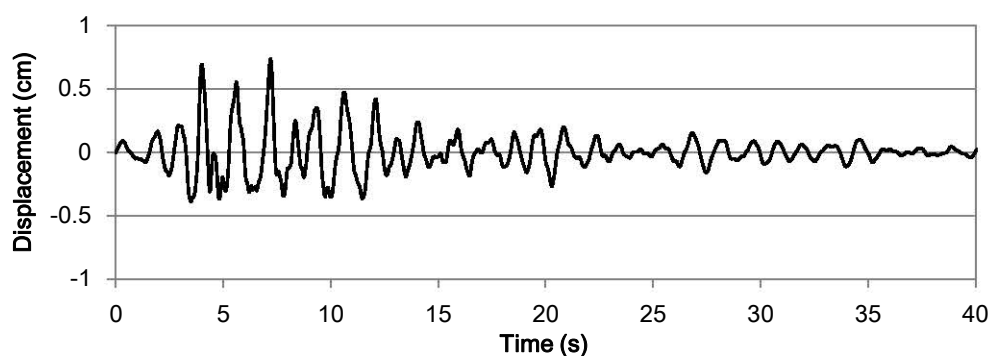
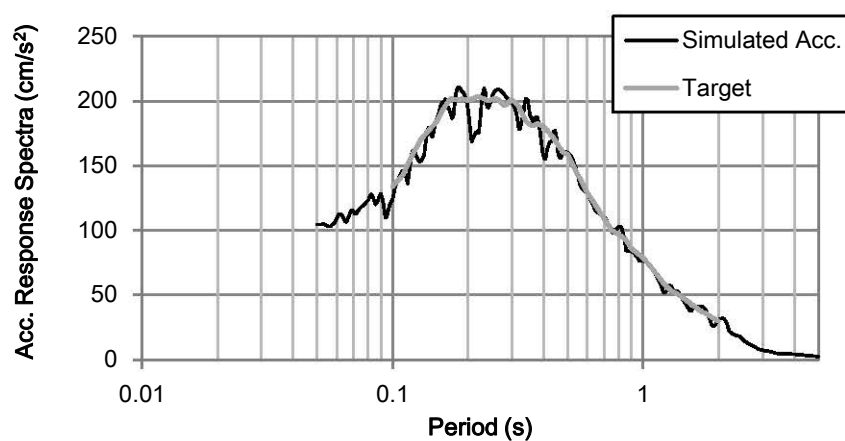
Fig. 3-7 Simulated time history of A) acceleration, B) velocity and C) displacement and D) the response spectra of the simulated acc. at the Corinth earthquake

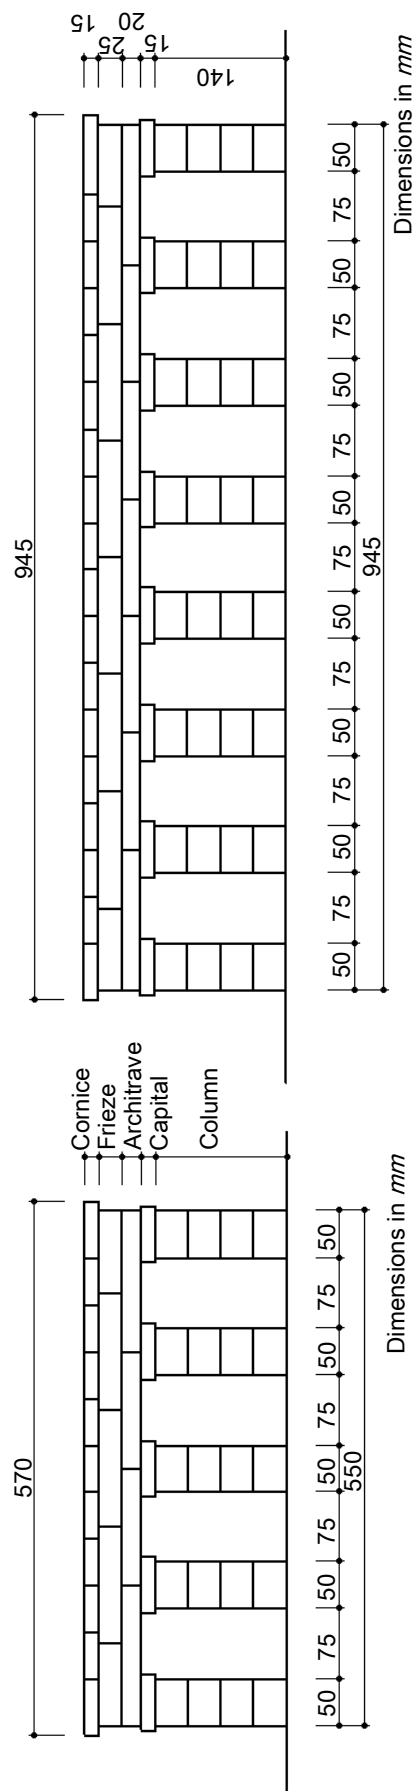
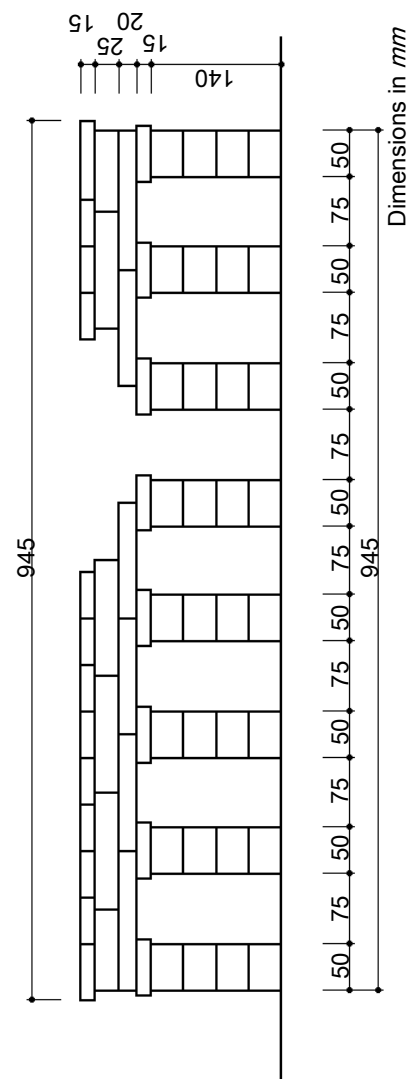
Fig. 4-1 Elevation of the north colonnade

The specimen was about 1/60 scaled model of the Parthenon Athens shown in figs. 4-1 through 4-4. The model drums and beams were made of cement. The number of members, entasis of the columns, the proportions etc. were simplified. It was rested on the cement base fixed on the shaking table. The model column was composed of 4 drums and a capital. The entablature: architraves, friezes and cornices were on the capitals. The diameter of drums was 50 mm. A special form was given to the contact surface between neighboring drums shown in fig. 4-5 in order to ease to fit drums, but not all drums had such contact surface. Wooden (balsa) dowels were between the drums of the columns and between the cement base and drum (see fig. 4-5). In addition, horizontal clamps made of brass were between beams (see fig.4-6). The beams were not connected vertically.

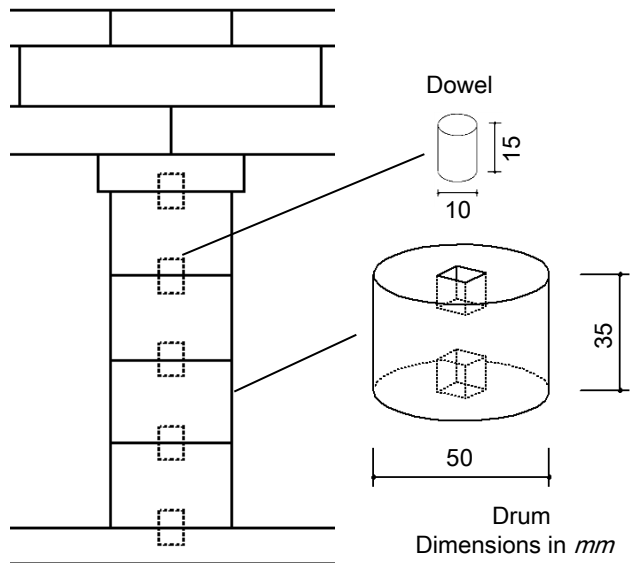
Fig. 4-5 Drums of the columns and wooden dowels

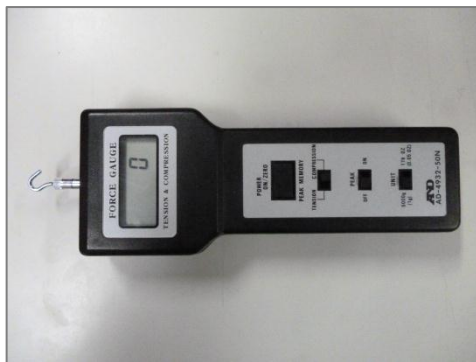
Fig. 4-8 Force gauge

The friction coefficients of members were measured to be around 0.5. This value was average of the 2 kinds of measurement; between the capital and the architrave and between the frieze and the cornice. The measurements were conducted with the force gauge AD-4932-50N (A&D Company Limited) (fig. 4-8). Fig. 4-9 shows the measurement between the frieze and the cornice. In the figure, there is no weight on the member, but the multiple measurements were carried out with several weights. In past study, the friction coefficients of marble drums were measured and the values were in the range of 0.36 to 0.80 [6].

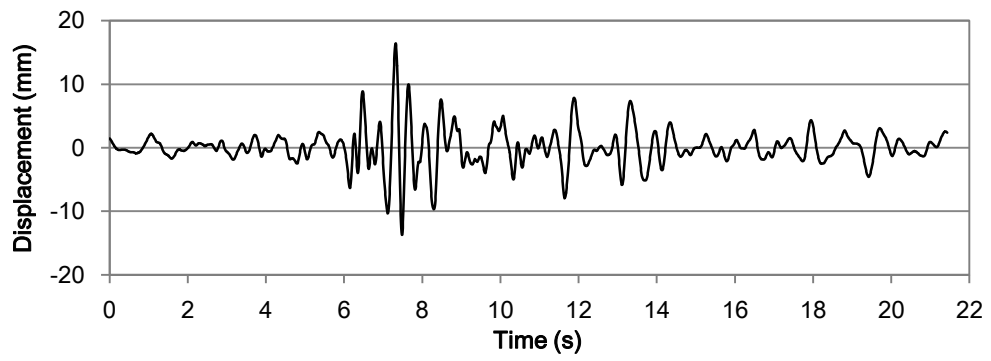
Fig. 4-10 Input base motion of 2th Sep. 2010 phase

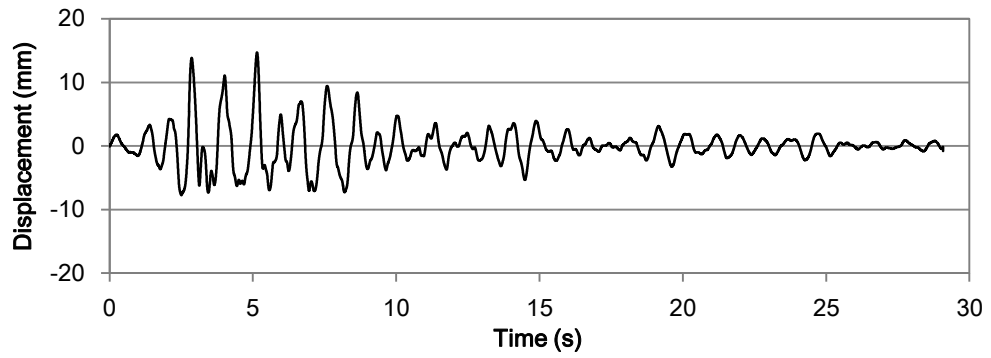
Fig. 4-11 Input base motion of Corinth earthquake phase

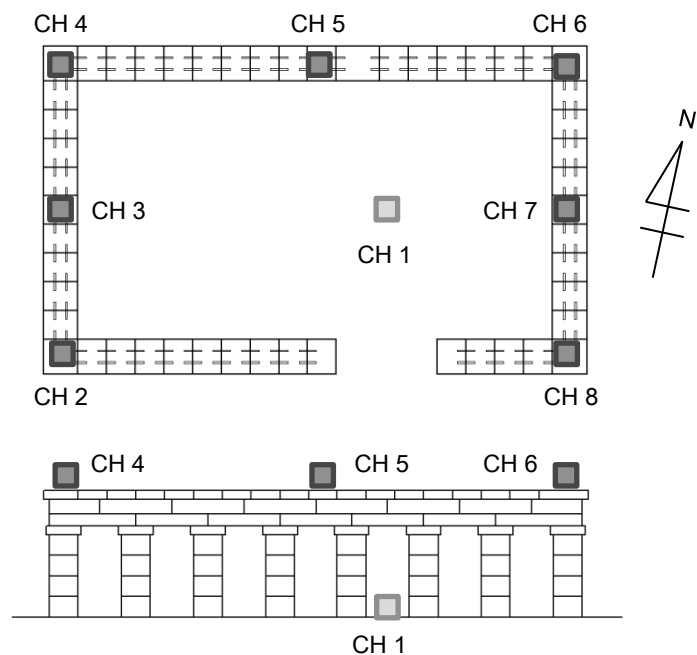
Fig. 4-12 Arrangement of the accelerometers

The accelerations of the specimen were measured by 7 accelerometers ARF-100A (Tokyo Sokki Kenkyujo Co., Ltd.) The experiments were conducted with 0° , 90° or 45° input base motion angle and the differences of model responses were compared. Moreover, the residual deformations of the model were observed after each test except the case in which the displacement was extremely tiny. All the experiments were video recorded by two cameras. Set up of the model and instruments were shown in fig. 4-12.

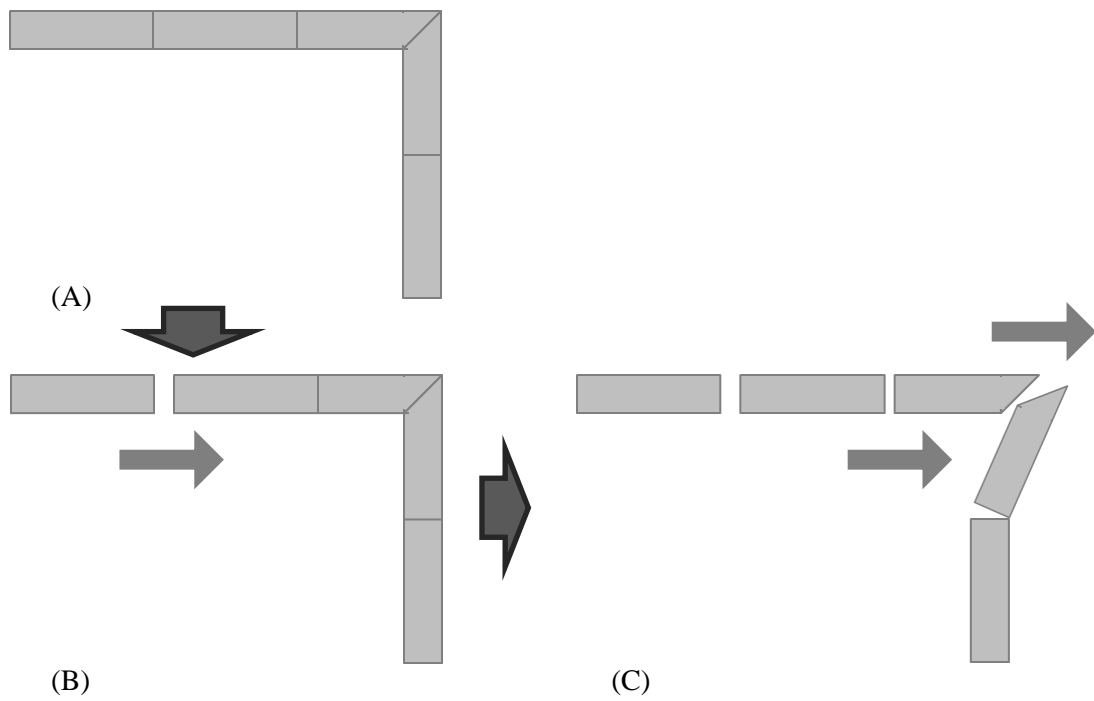
Fig. 4-23 Mechanism of the deformation of the entablature

As results of observation during and after excitation, it was supposed that the deformations of the entablature were produced by accumulation of the displacement of the beams. That is, one beam was moved during excitation (fig 4-23 (B)) then, it moved another beam. Finally, at the corner, the entablatures were expanded outside (fig 4-23 (C)). It could be said that such behavior was high non-linear response of the dry masonry.

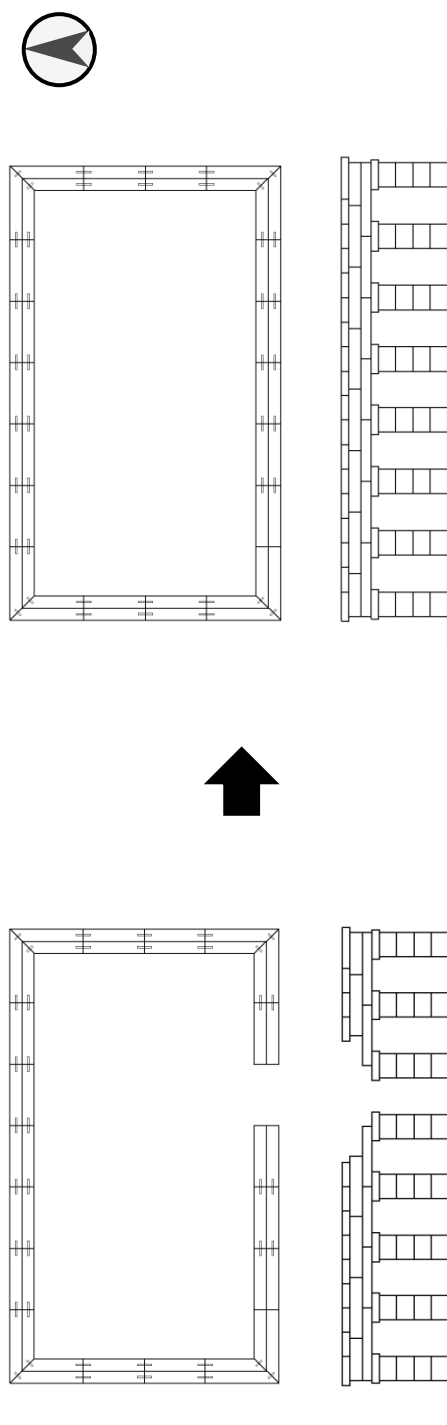
Fig. 4-24 Reinforcement method 1

Method 1: Additional beam members were installed in the south colonnade to solve the structural problem that a part of the south colonnade has been missing by the explosion in 17th century, which might indicate imperfect structure against earthquakes.
