修 士 論 文

Fundamental Study on Dynamic Behaviors of the Parthenon Athens

三重大学大学院工学研究科
建築学専攻

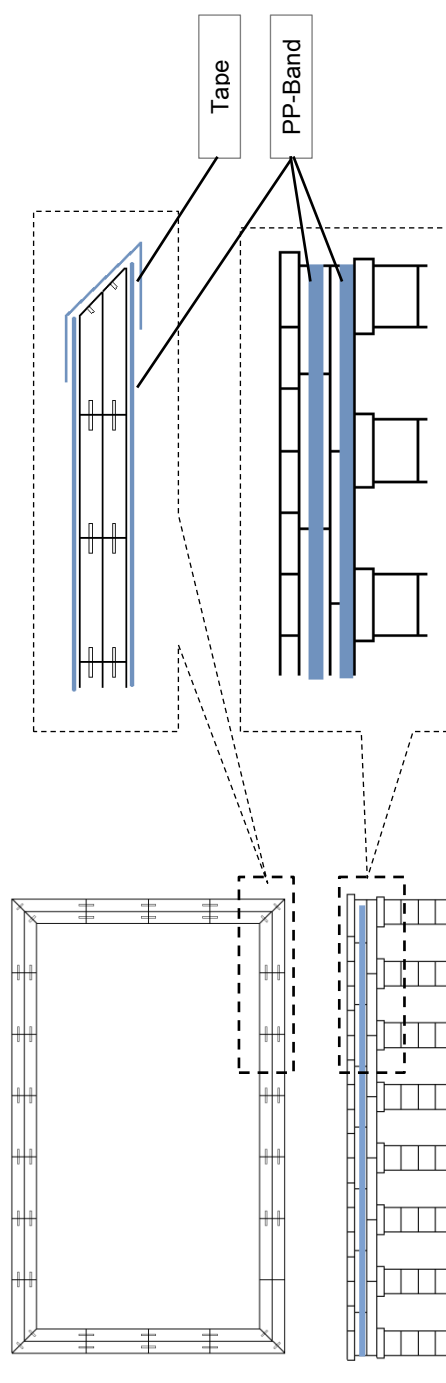
Fig. 4-25 Reinforcement method 2

Method 2: Connection between stone beams members was ensured by use of metal tie-bands or tie-rods for reinforcement, which must be effective in improvement of seismic performance. Residual displacement caused by the past earthquake would be prevented during future earthquake by employing such technique.

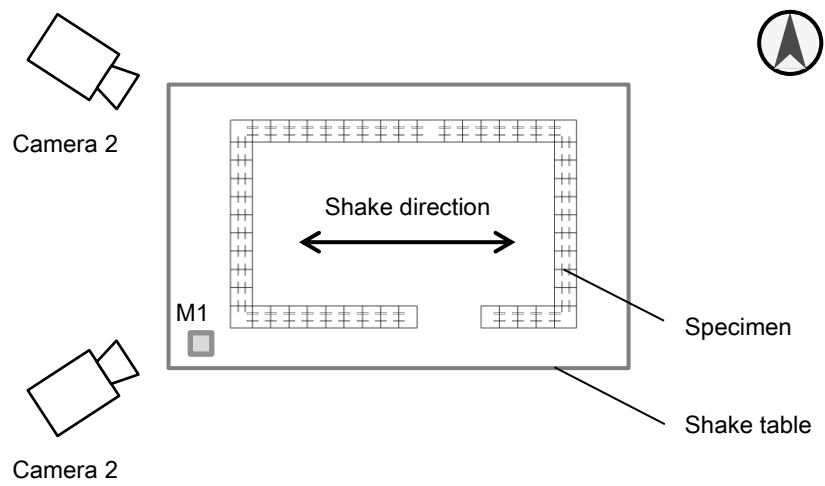
Fig. 4-26 Arrangement of the cameras for 3D measurements

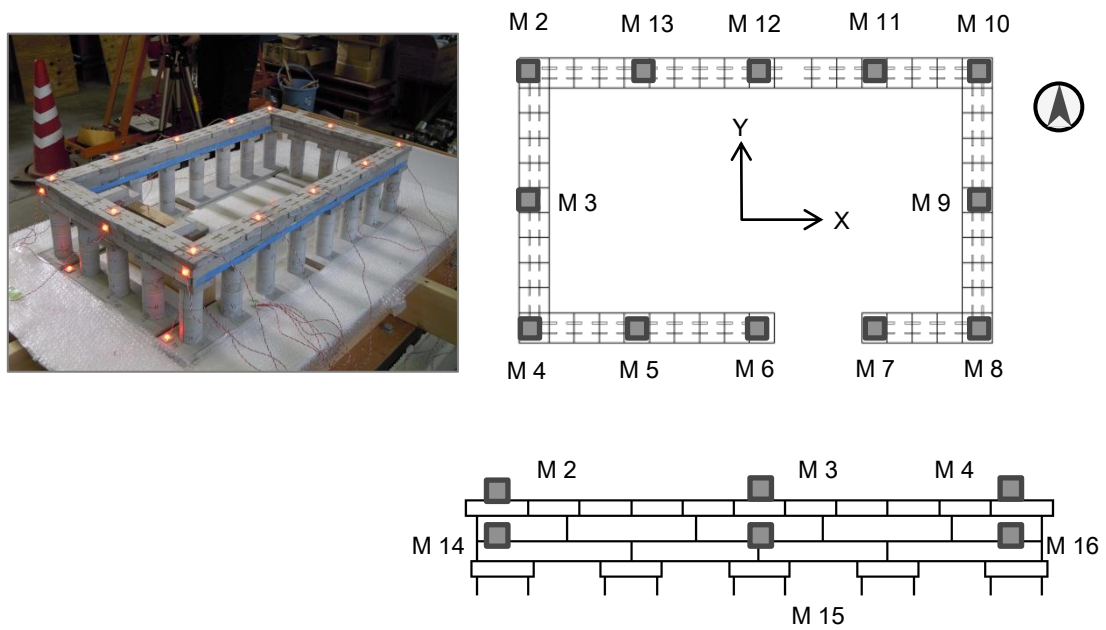
Fig. 4-27 Arrangement of the markers

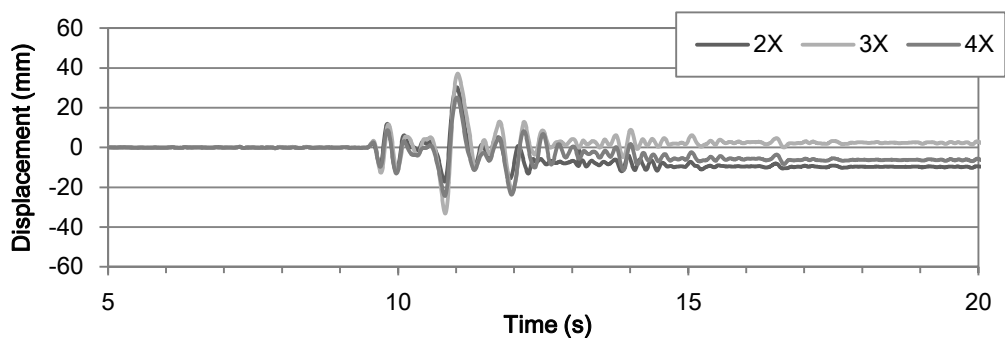
Fig. 4-33 Displacement of markers on the west colonnade on Case58 (With beam)

Compared time histories of case 55 with case 56 and case 58 with case 57, the time histories showed significant difference. On the other hand, compared case 55 with case 58, the time histories of displacement seem to have same characteristics. These difference or similarity might be caused by the “inner beam.” It could be said that the inner beams were effective to control the displacement of the west colonnade in out-of-plane direction. In particular, the inner beams reduced the deformation of the colonnade toward outside of the structure.

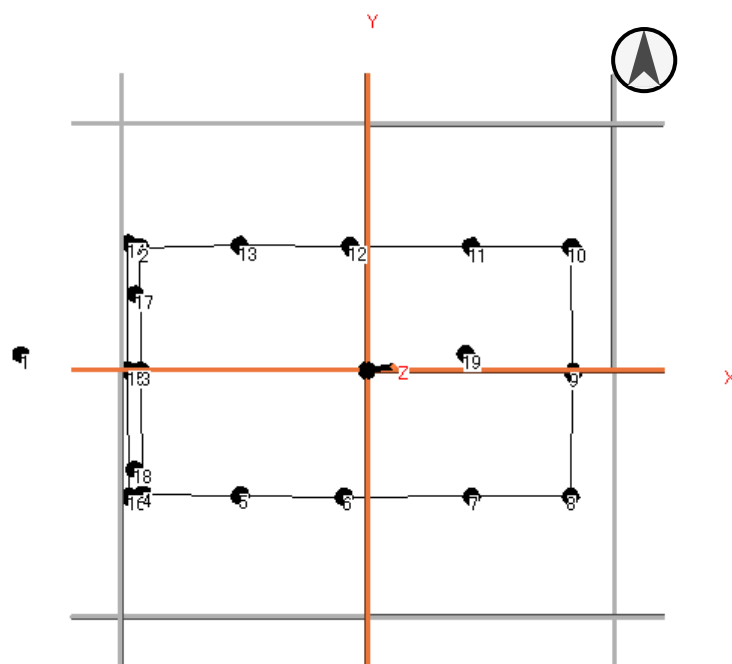
Fig. 4-34 Initial Position of the markers on the model

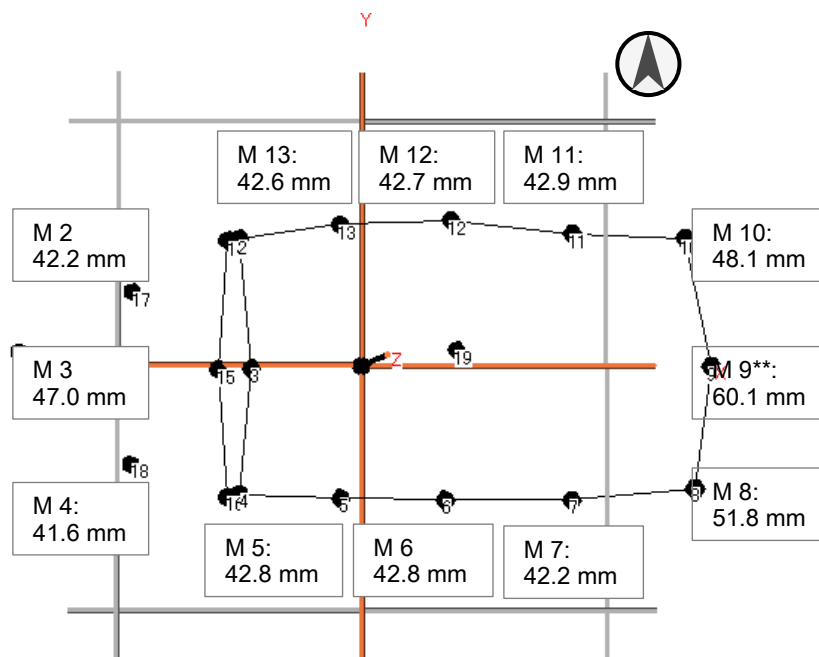
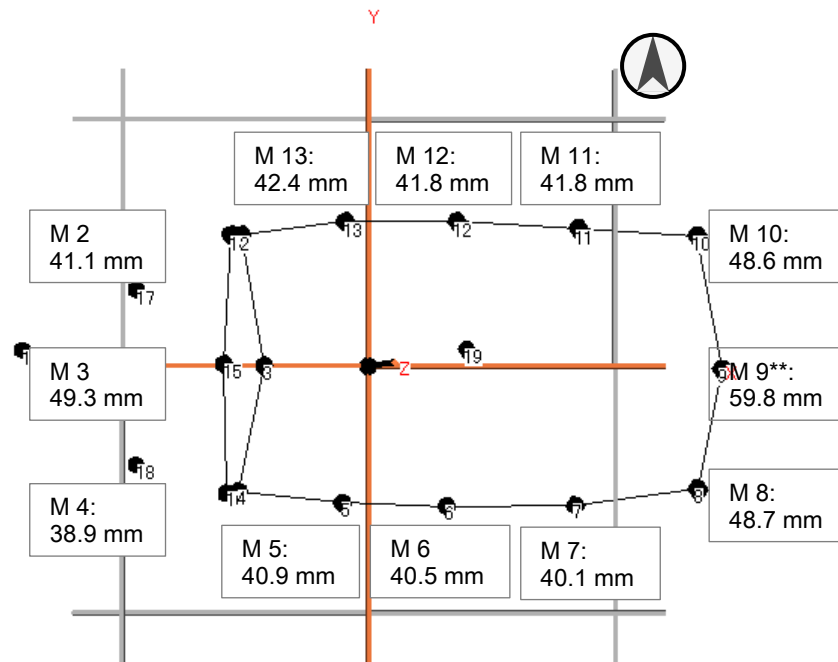
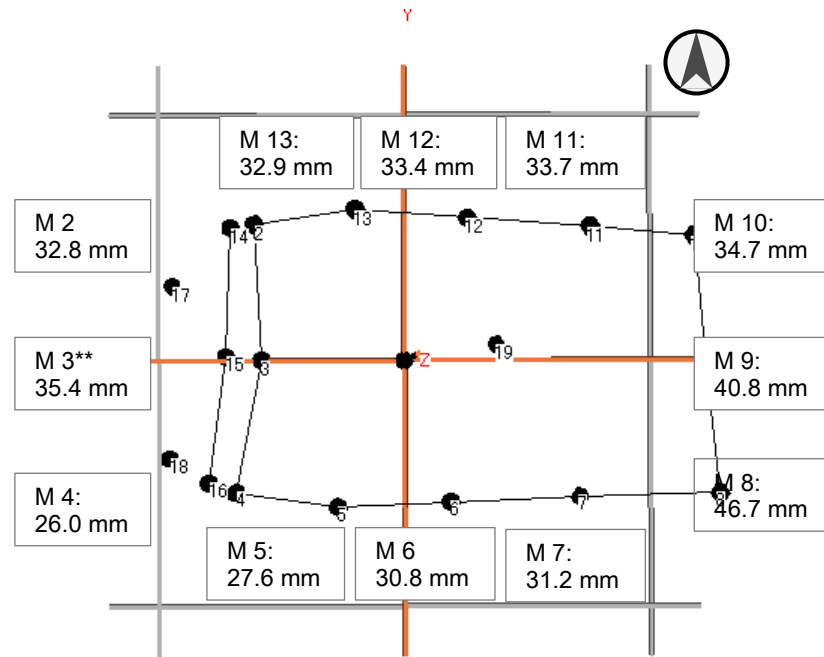
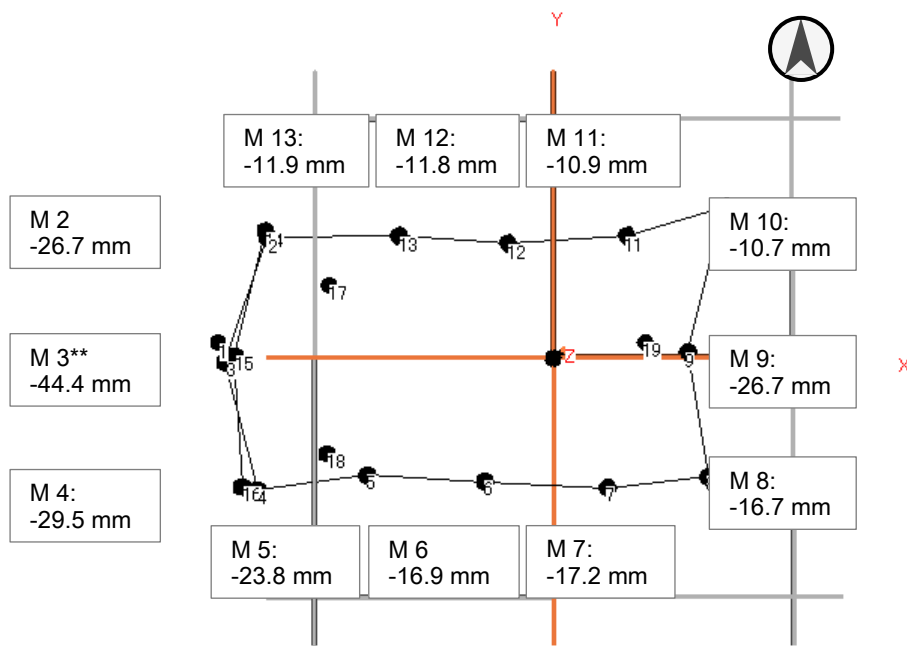
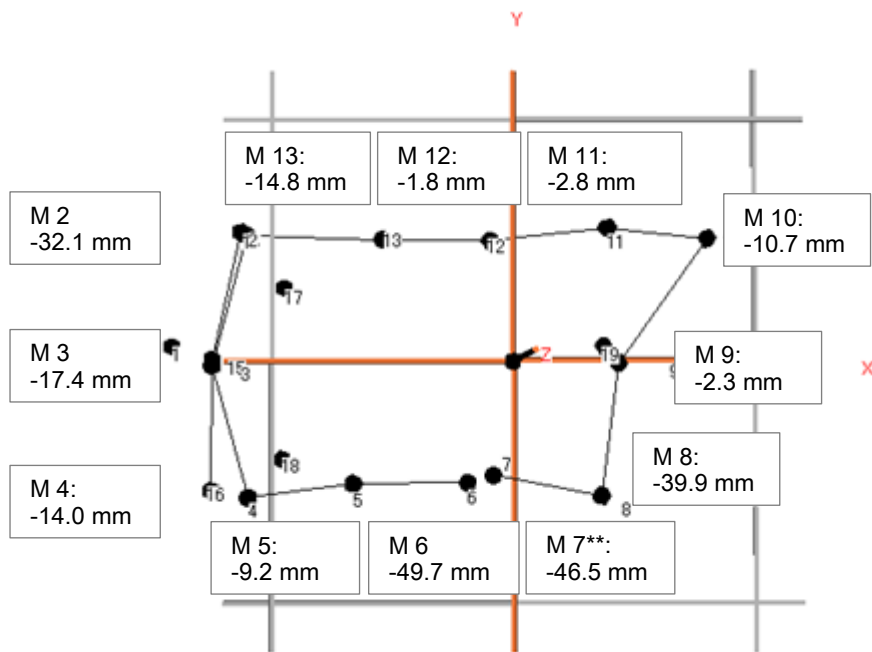
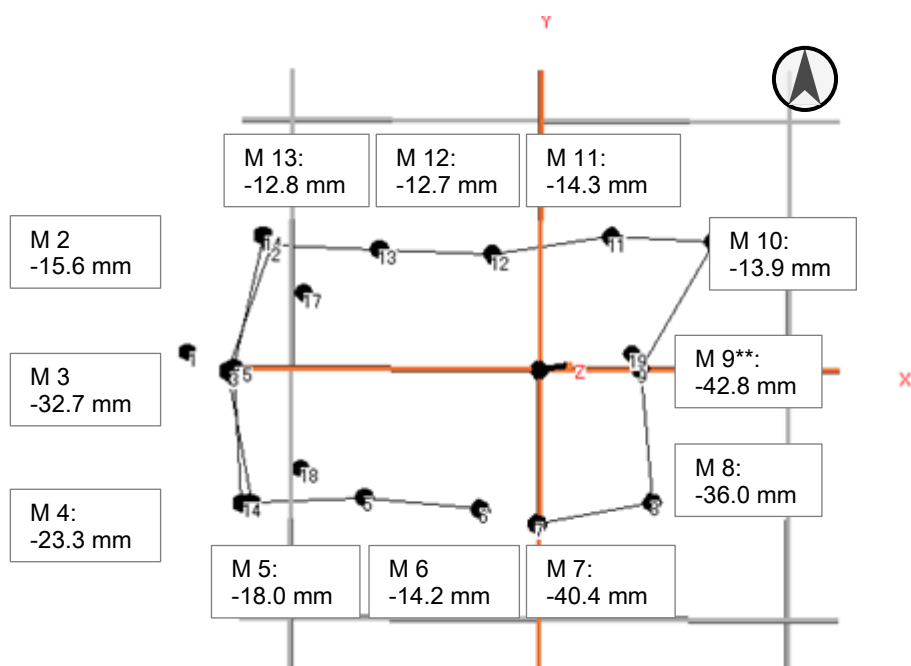
Fig. 4-35 Deformation when M 9 reached its maximum displacement at case 53

Fig. 4-37 Deformation when M 9 reached its maximum displacement at case 54

Fig. 4-39 Deformation when M 3 reached its maximum displacement at case 55

Fig. 4-41 Deformation when M 3 reached its maximum displacement at case 56

Fig. 4-43 Deformation when M 7 reached its maximum displacement at case 57

Fig. 4-45 Deformation when M 9 reached its maximum displacement at case 58

The response deformation in the horizontal in-plane at the roof level is drawn in Figs. 4-35, 4-37, 4-39, 4-41, 4-43 and 4-45. These figures show the simultaneous displacements at the time when the measuring points reached the peak displacement which was the largest of all the points during the excitation. Figs 4-36, 4-38, 4-40, 4-42, 4-44 and 4-46 show the residual displacement after each test.

In all measurement points of the top of the model, marker3 or marker 9 located at the middle of the colonnade tended to show the largest response through case 53 to case 58. This might be affected by shaking direction. The residual displacements of them, however, were not always the largest. The phenomenon that the maximum dynamic response did not always coincide with the maximum residual displacement was exceptionally-interesting from an engineering point of view.

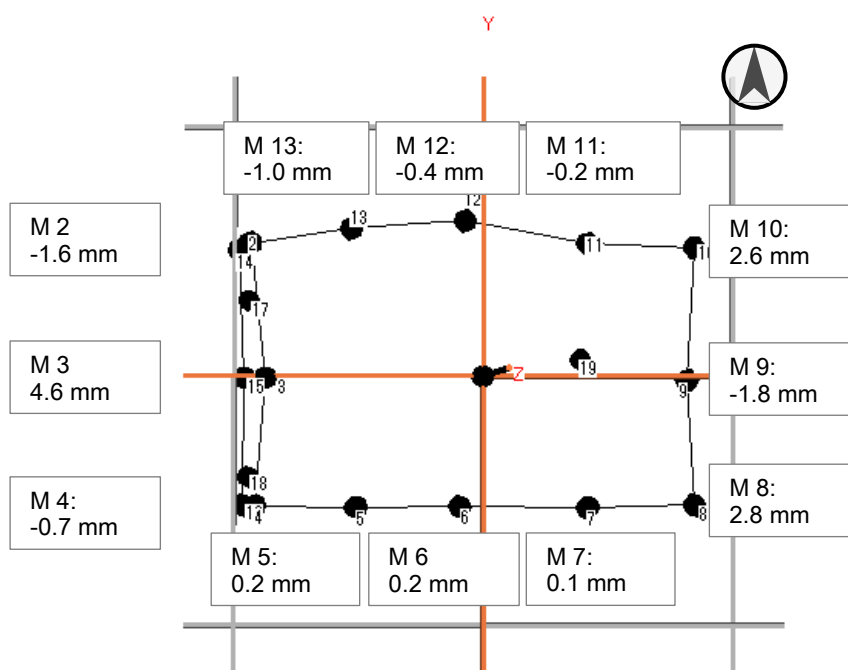
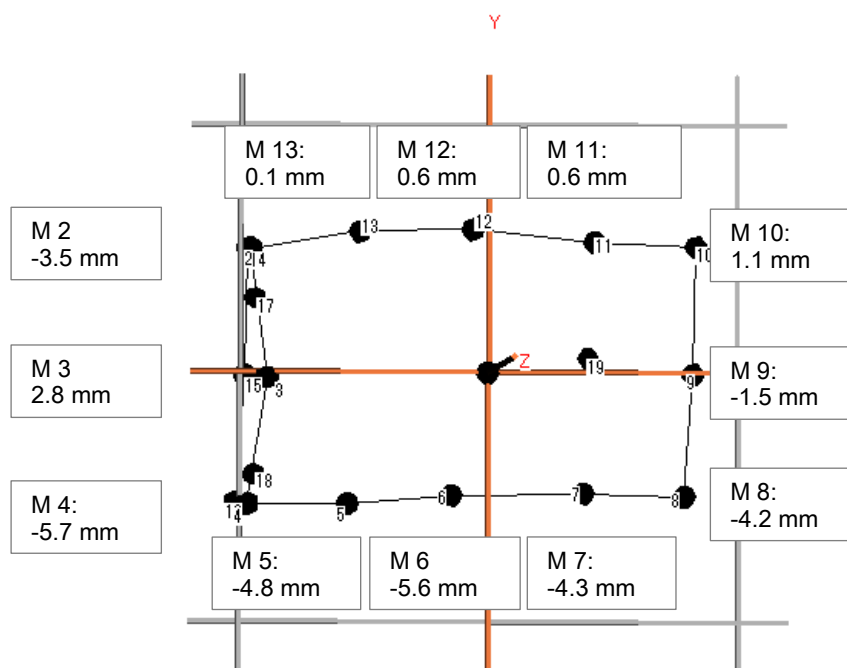
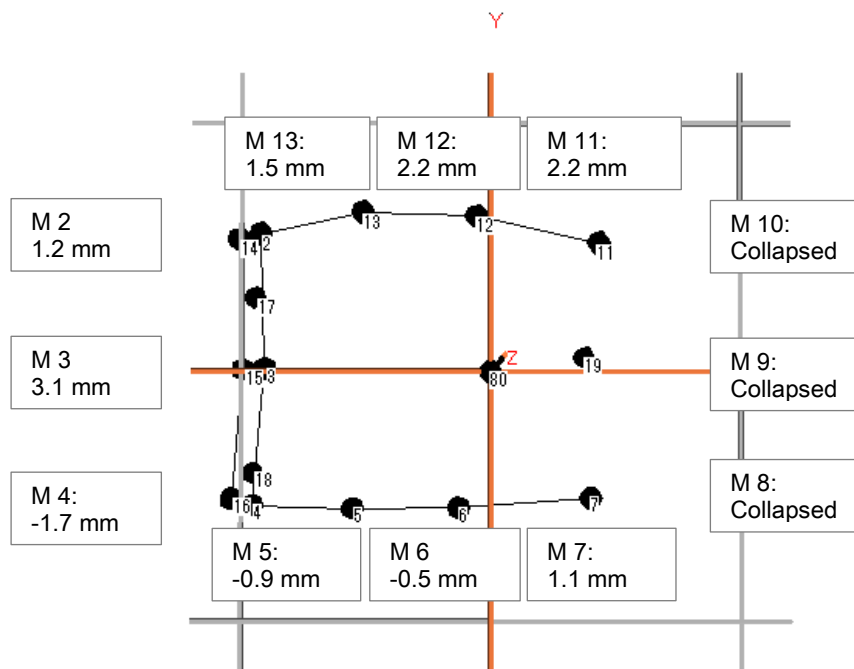
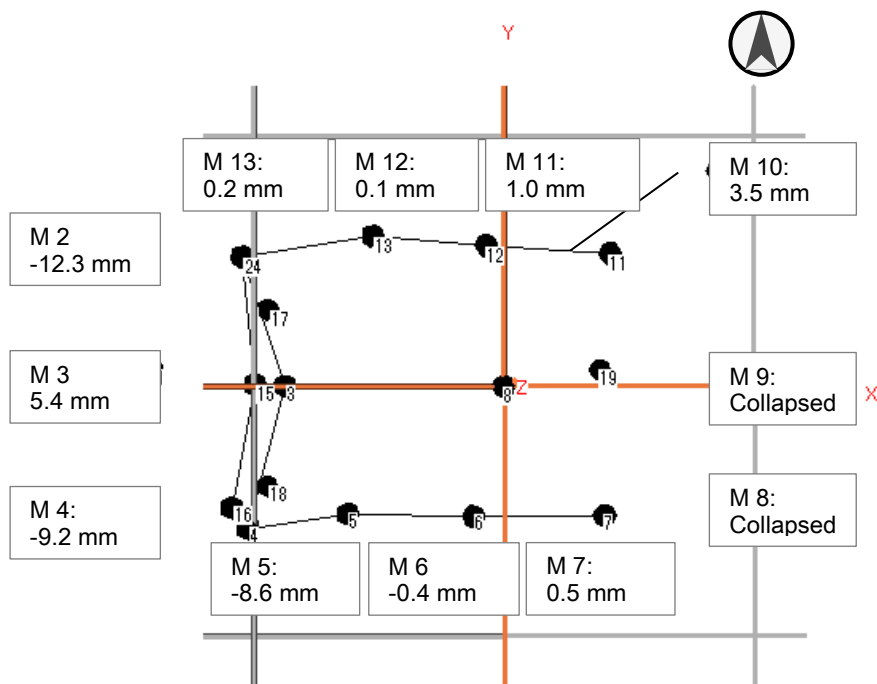
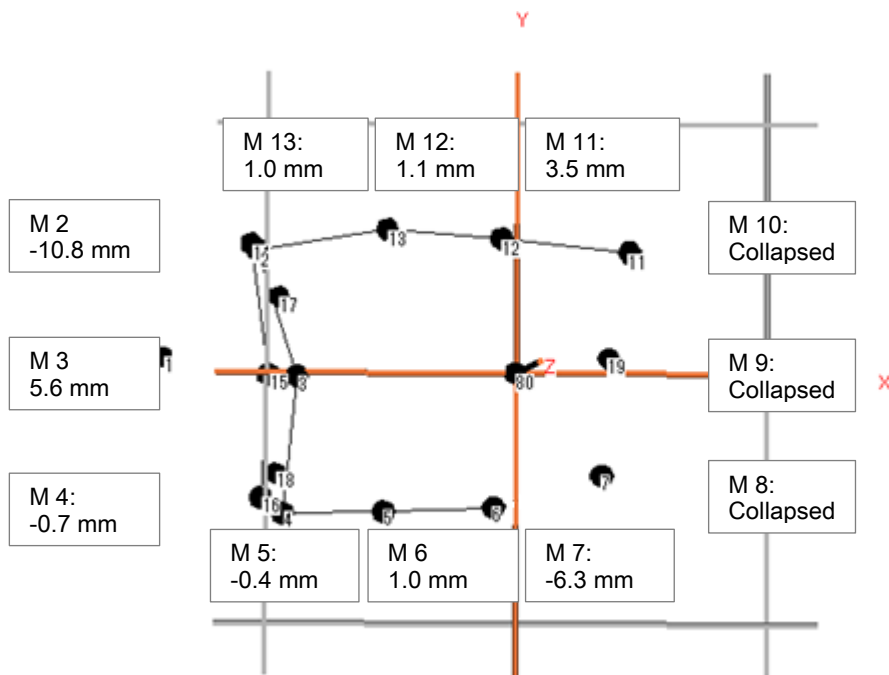
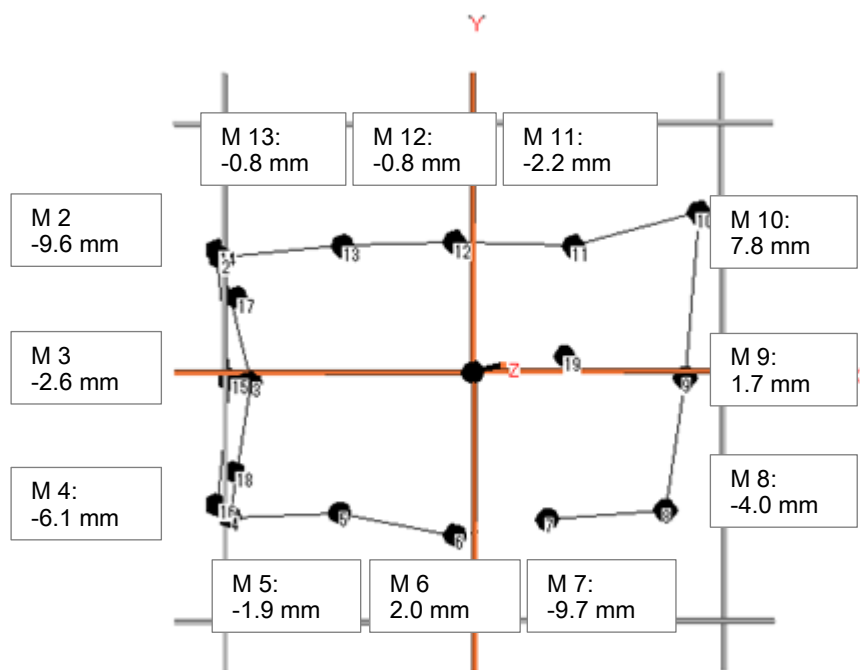
Fig. 4-36 Deformation after case 53

Fig. 4-38 Deformation after case 54

Fig. 4-40 Deformation after case 55

Fig. 4-42 Deformation after case 56

Fig. 4-44 Deformation after case 57

Fig. 4-46 Deformation after case 58

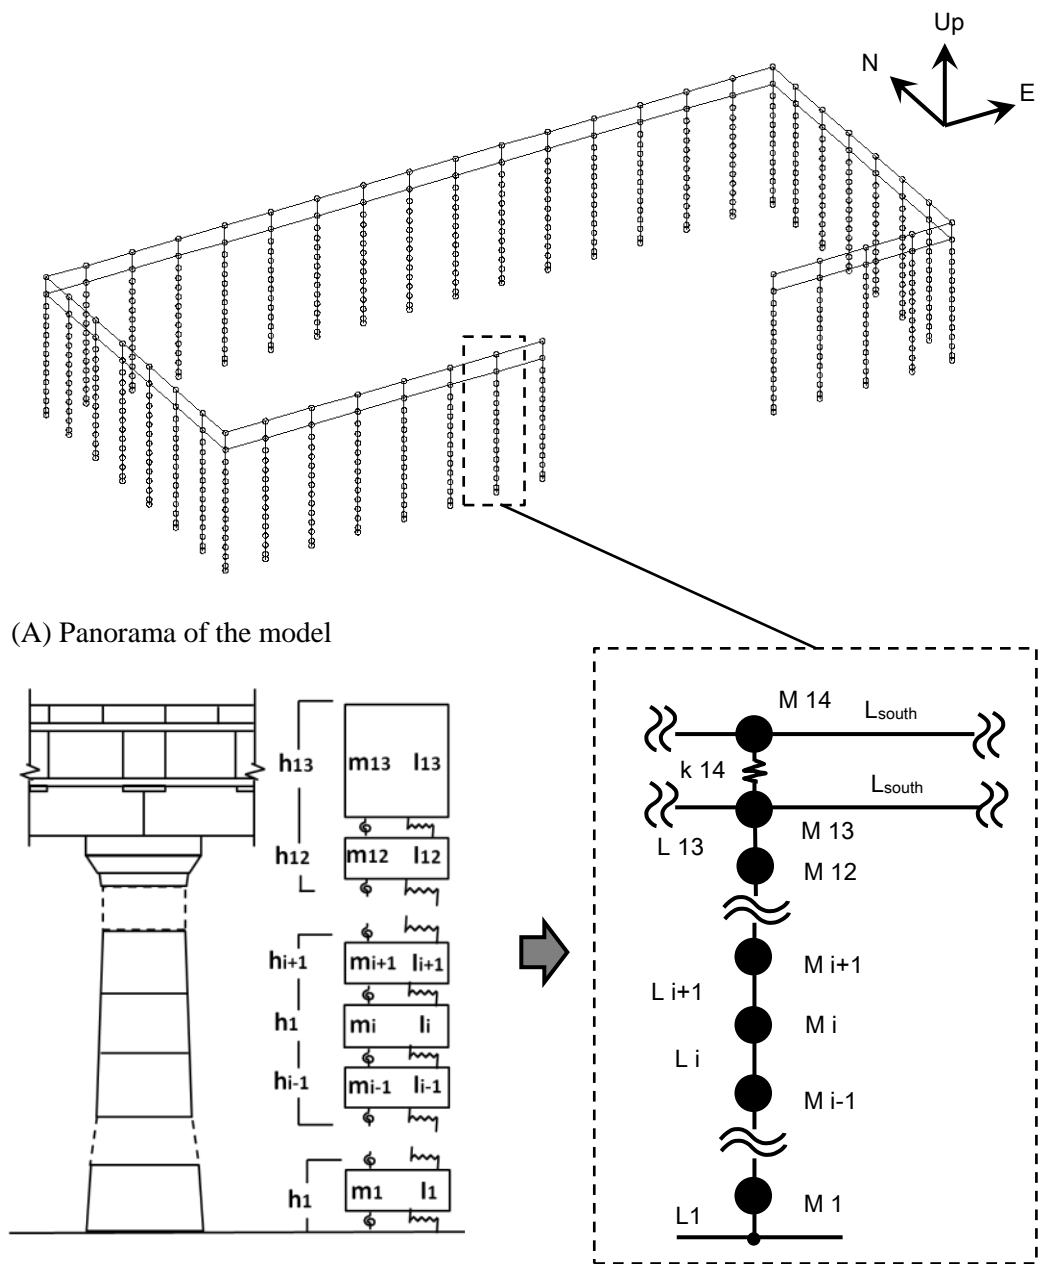
Fig. 5-1 Analysis model 1

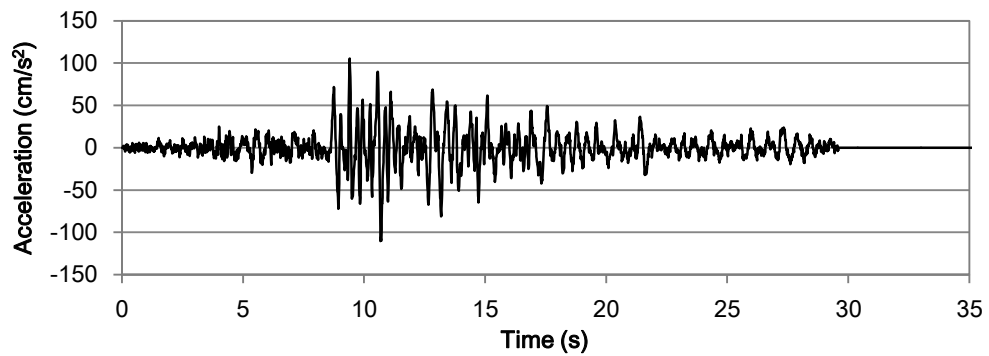
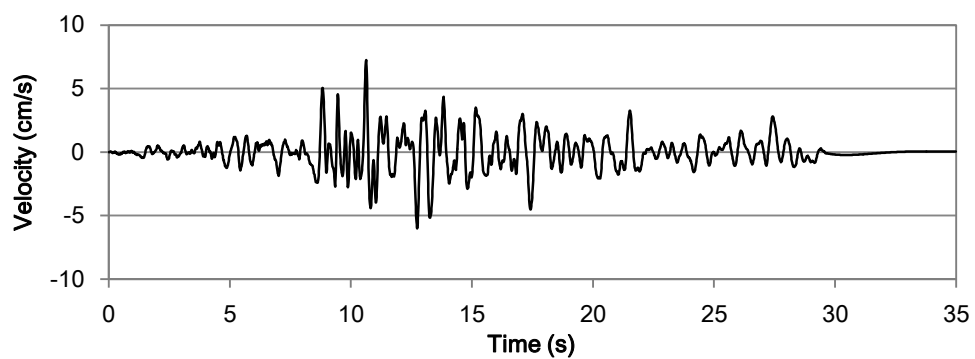
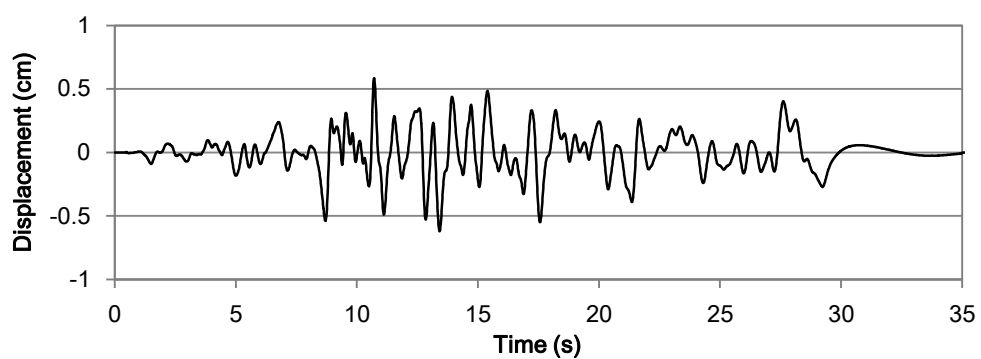
Fig. 5-3 Time histories of A) acceleration, B) velocity and C) displacement of Sep. 2010 motion in N-S direction

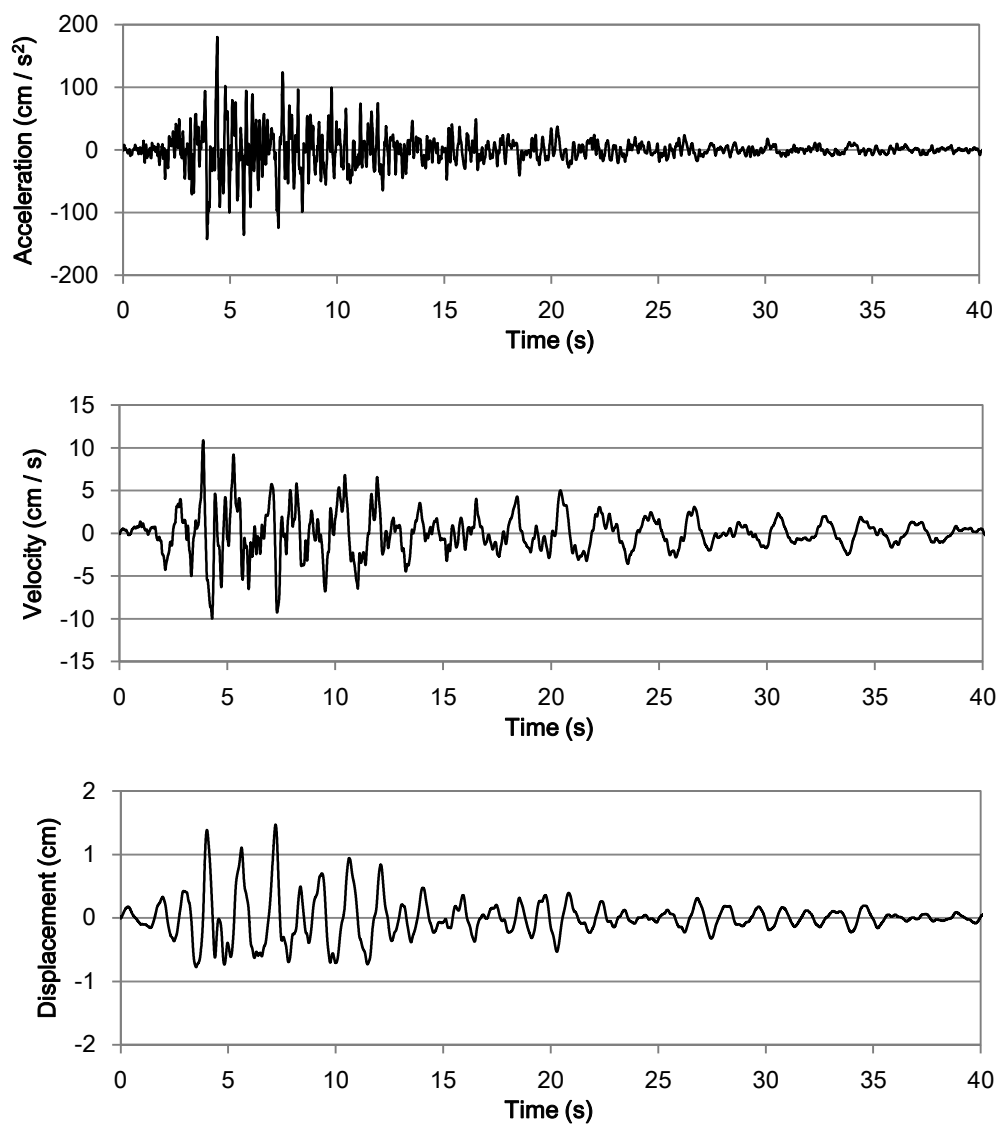
Fig. 5-5 Time histories of A) acceleration, B) velocity and C) displacement of Corinth motion in N-S direction

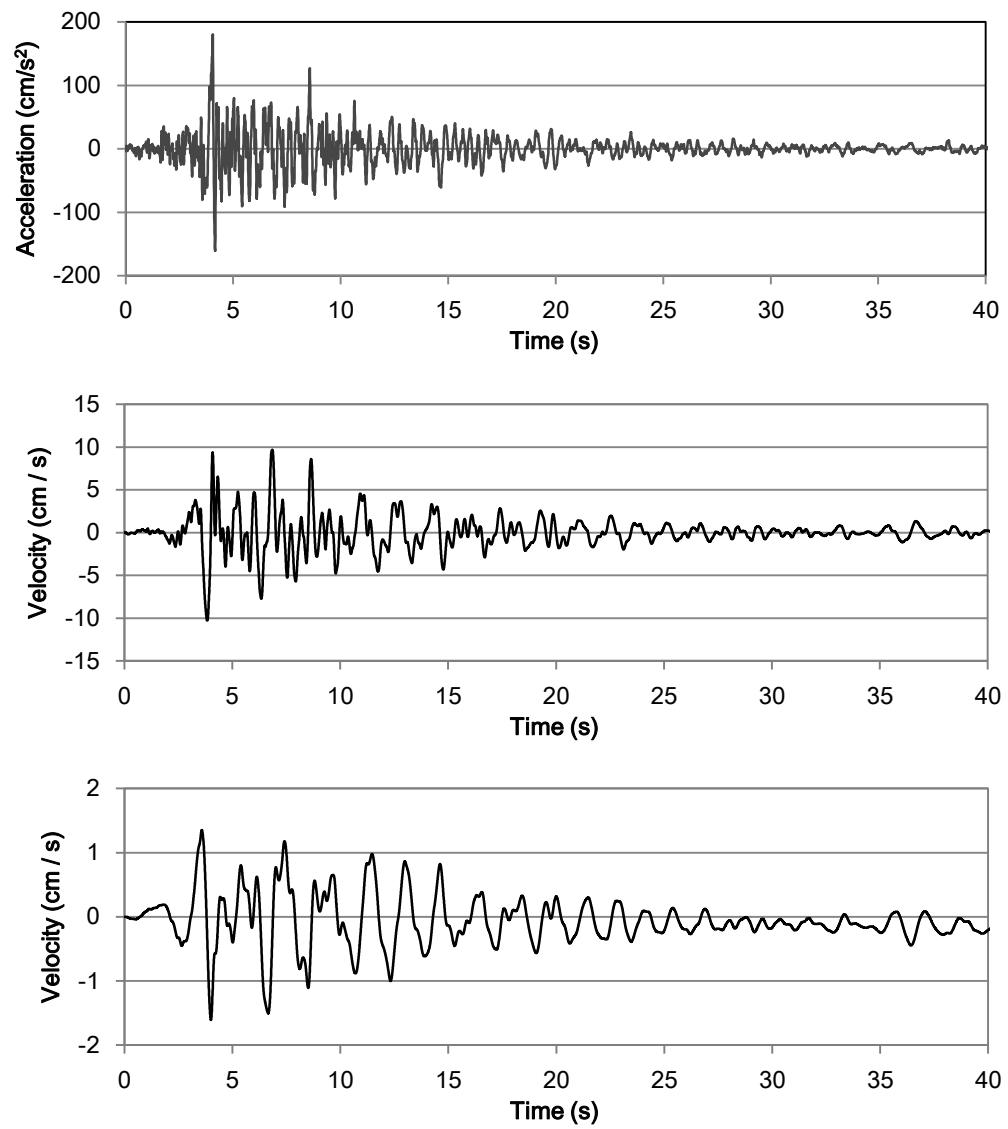
Fig. 5-6 Time histories of A) acceleration, B) velocity and C) displacement of Corinth motion in E-W direction

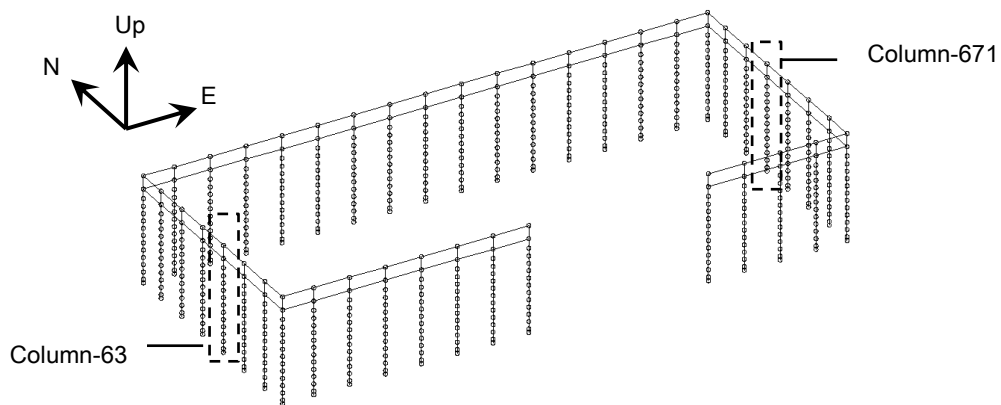
Fig. 5-7 Position of the columns

In the model, the point which showed the maximum response acceleration and displacement was column-63 (see fig. 5-7) for Sep. 2010 motion and column-671 (see fig.5-7) for Corinth motion. Moreover, the distributions of maximum response values along the height of column-63 and column-671 are presented in fig. 5-8 and fig.5-11 respectively. Fig. 5-9 and fig. 5-12 show the response displacement of the column along the height of the column at the time when the column reached the peak displacement during seismic excitation. Figs. 5-10 and fig 5-13 show the maximum shear coefficients of the along the height of the column-63 and column-671, respectively. Maximum shear coefficient was 0.40 while the friction coefficients between the marble drums were 0.36 to 0.80 measured by Y. Mabuchi [6].

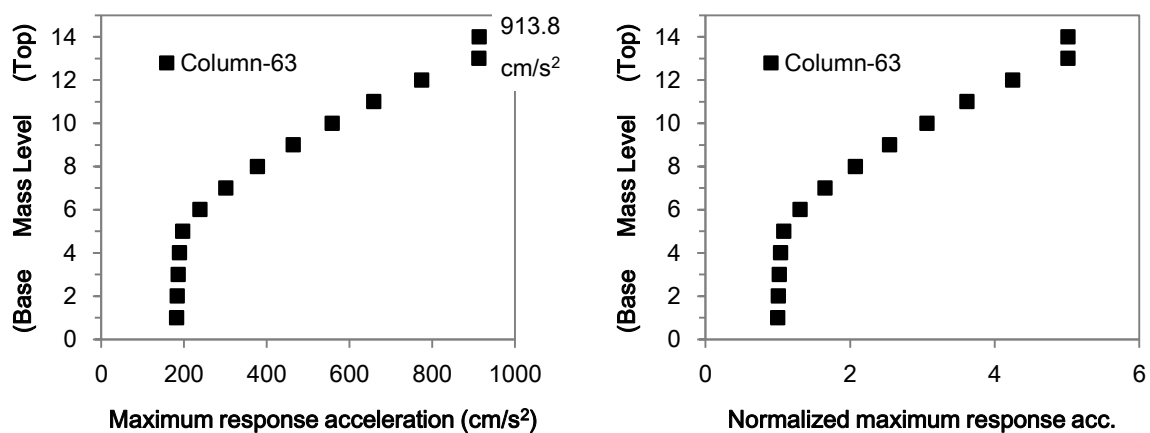
Fig. 5-8 Distribution of the maximum response acceleration at Sep. 2010 motion

The maximum response acceleration was almost the same for 2 input motions. The maximum displacement response at Sep. 2010 motion was larger than one at Corinth motion. This result indicated that the long-period seismic wave cause less displacement of marble members than short-period one. However, in this analysis, the model was elastic one, so it didn't seem to show the actual response of the monument. In the near future, it would be necessary to conduct structural analysis with non-linear model.

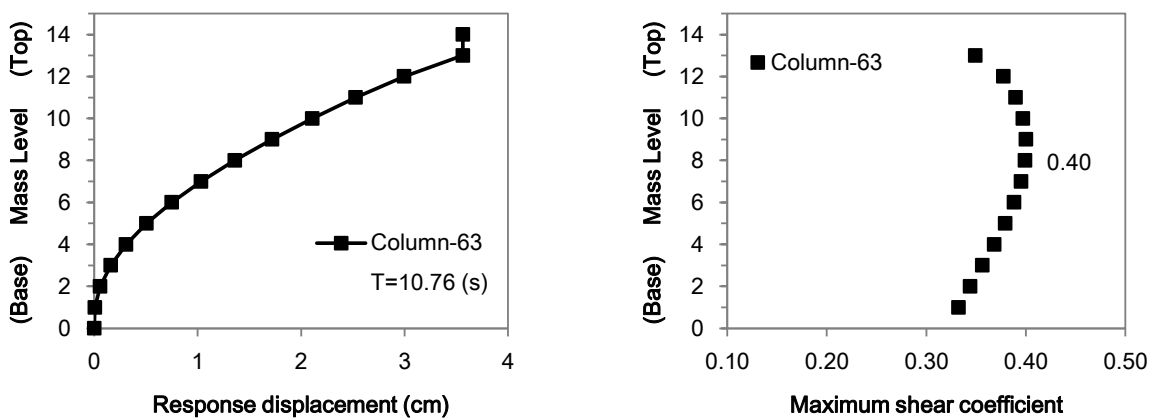
Fig. 5-9 Response displacements along the height of the model at Sep. 2010 motion

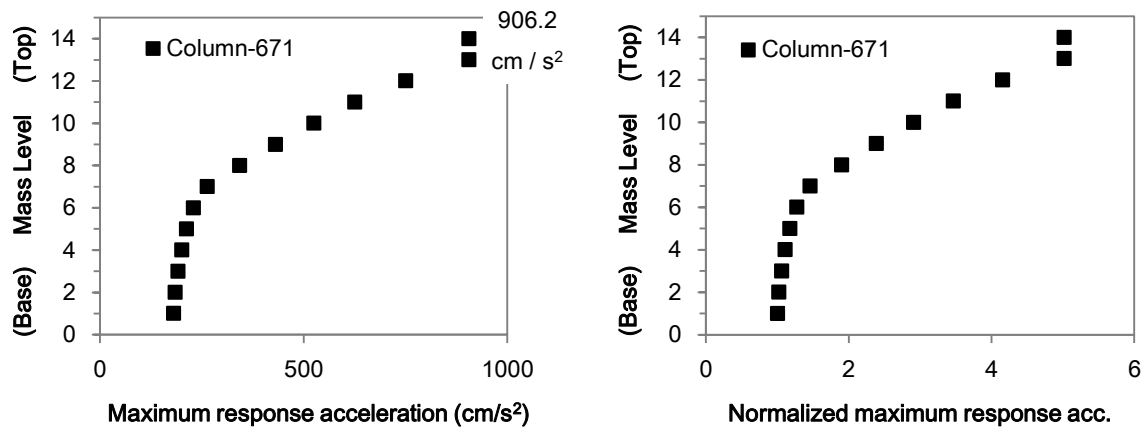
Fig. 5-11 Distribution of the maximum response acceleration at Corinth motion

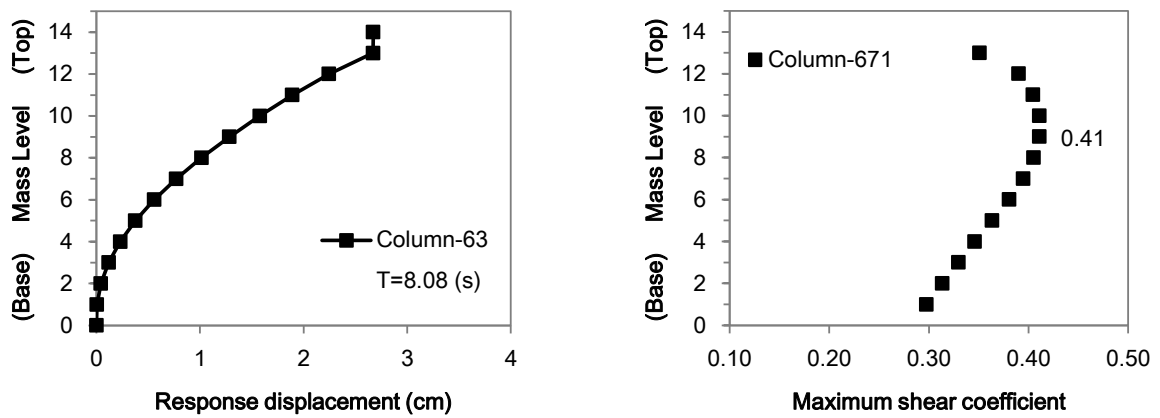
Fig. 5-12 Response displacements along the height of the model at Corinth motion

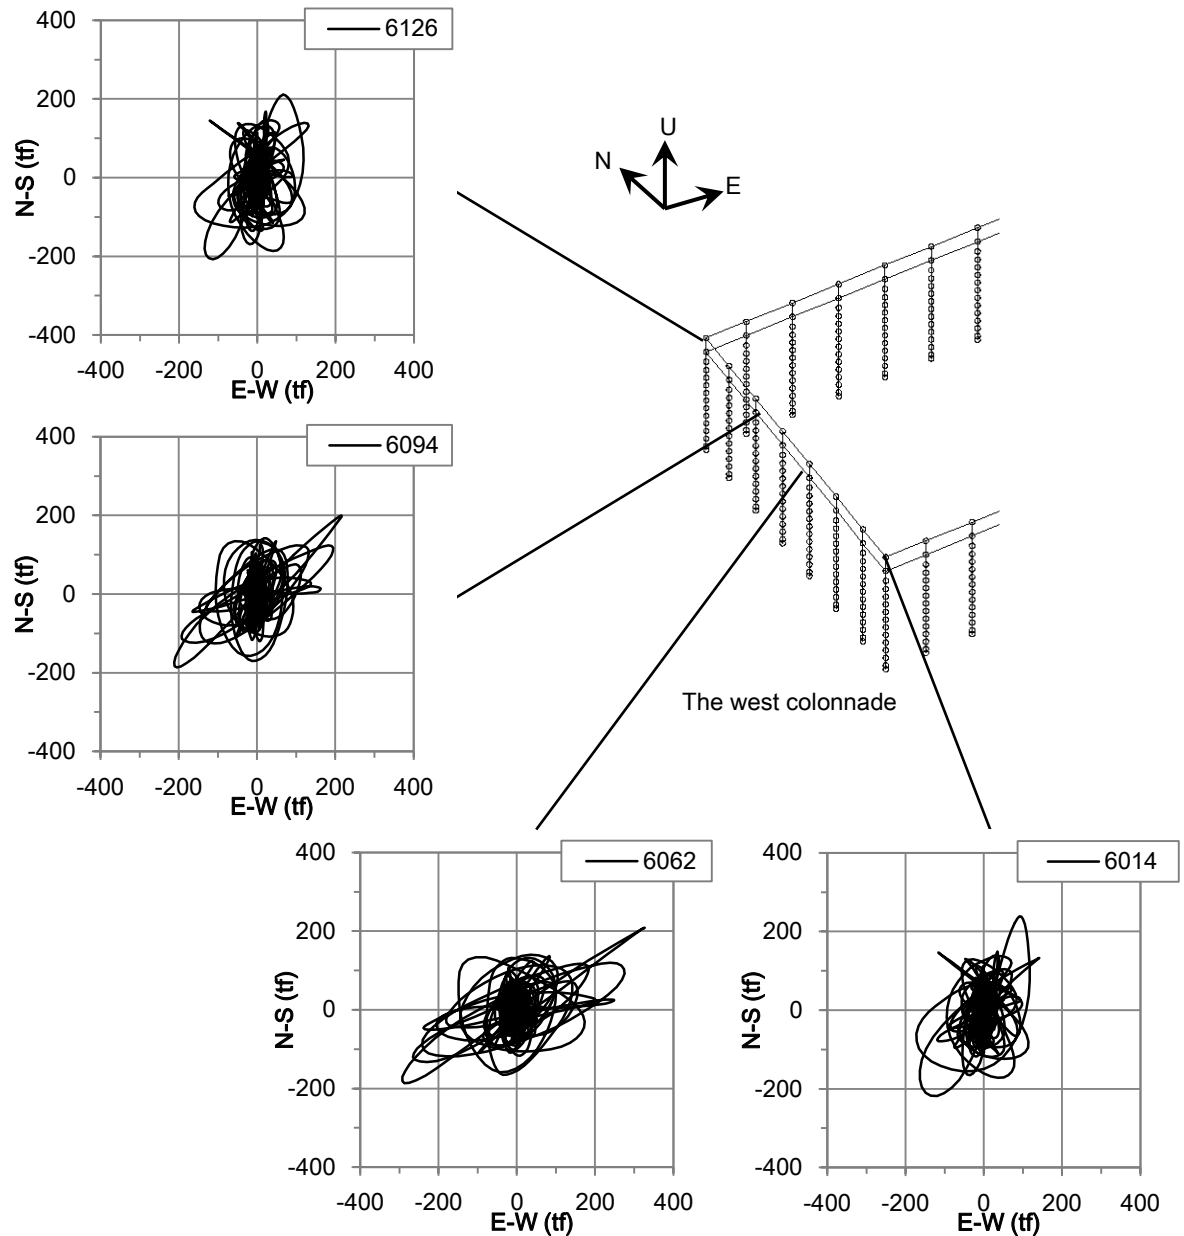
Fig. 5-14 Shear forces acting on the west colonnade at Sep. 2010 motion

Following figs 5-14 and 5-15 show the shear forces acting on the springs between architrave and frieze. The shear force at the northwest and southwest corners mainly acted on N-S direction while the Sep. 2010 motion caused larger excitation in E-W direction than in N-S direction or while Corinth motion caused almost the same excitation in E-W and N-S direction. These forces at the corners might affect the behavior of the corners toward outside of the model.

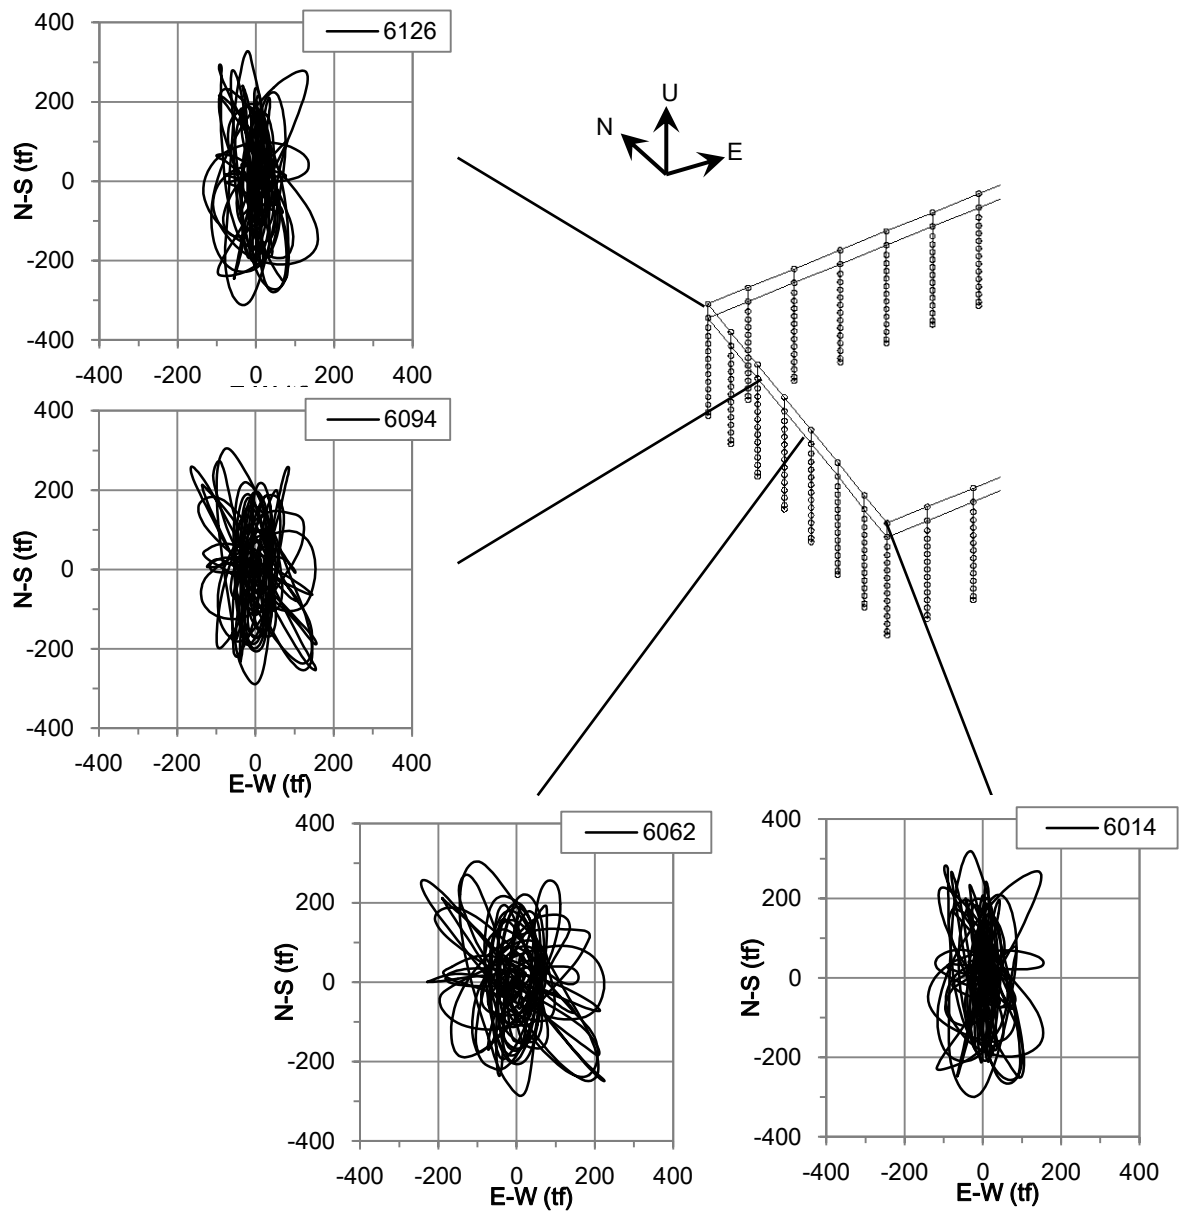
Fig. 5-15 Shear forces acting on the west colonnade at Corinth motion
