修 士 論 文

Fundamental Study on Dynamic Behaviors of the Parthenon Athens

三重大学大学院工学研究科
建築学専攻

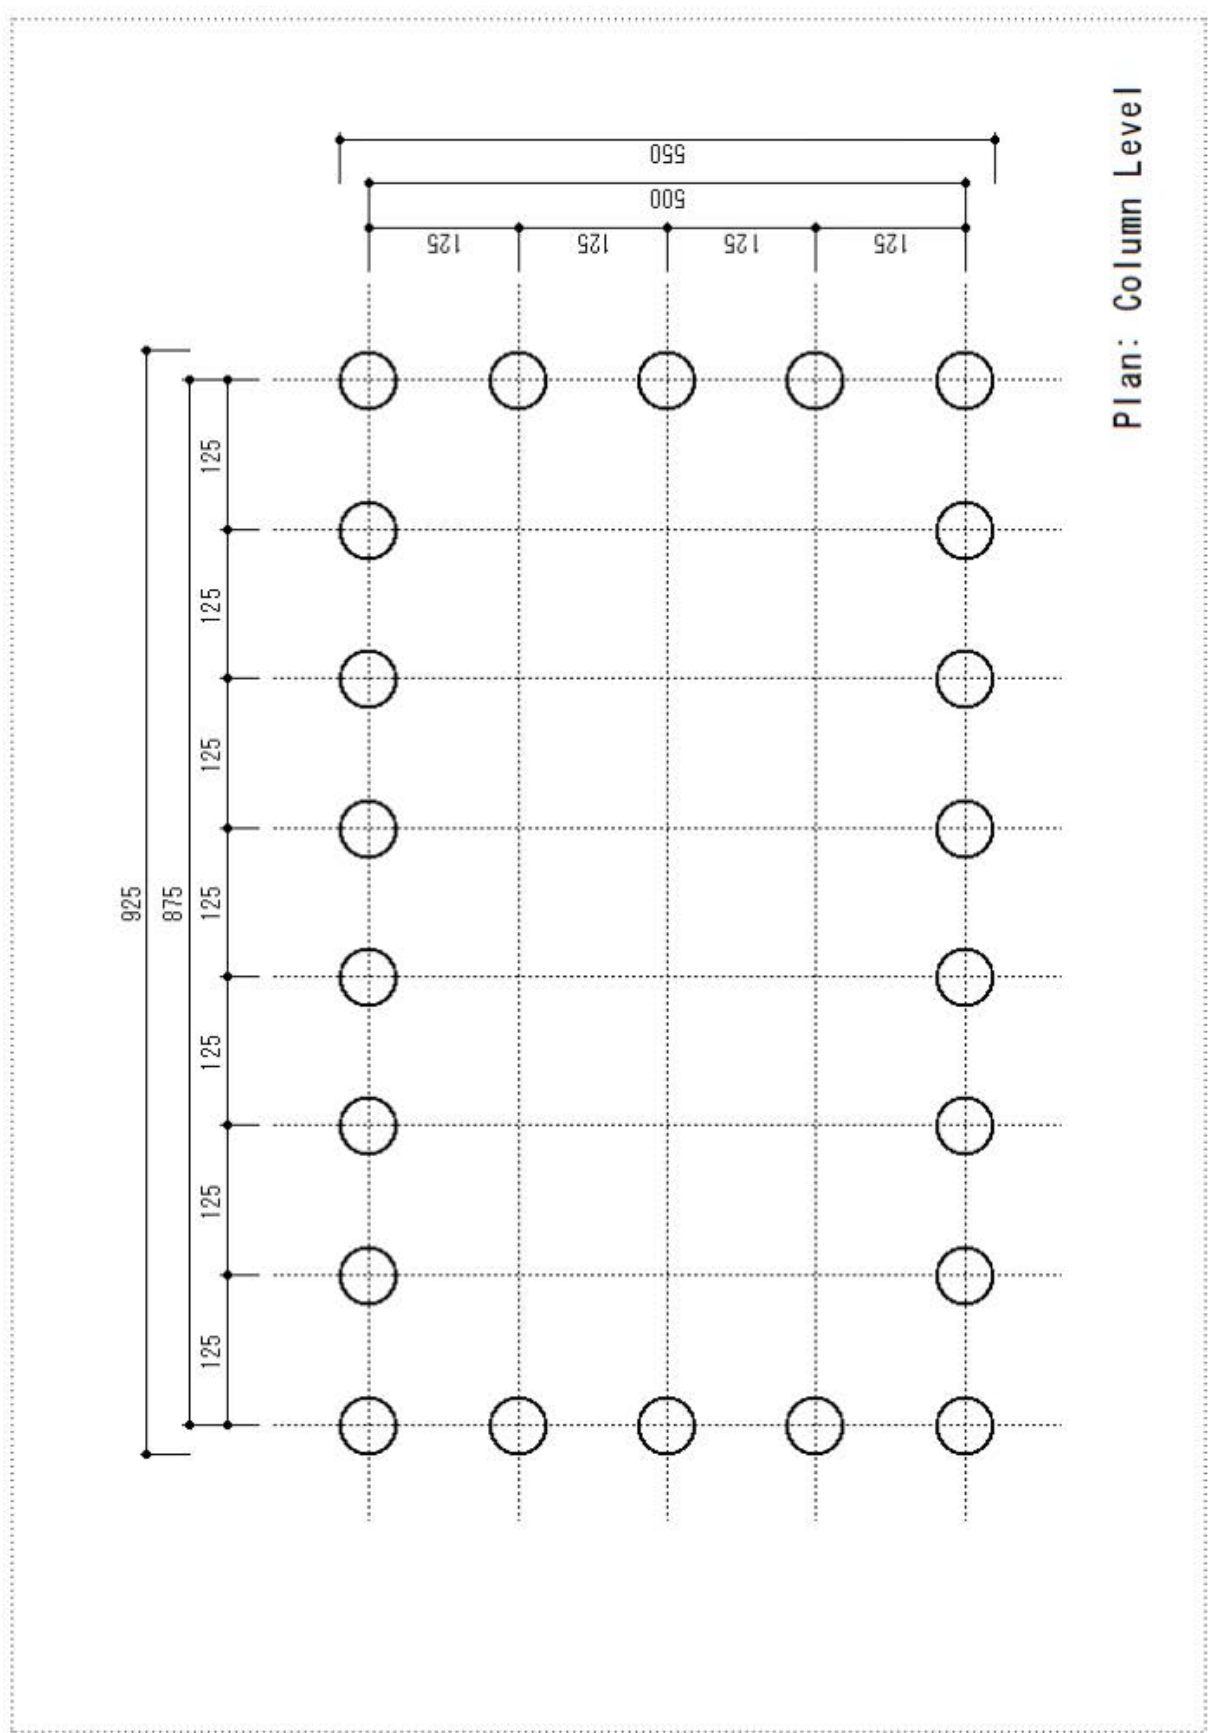
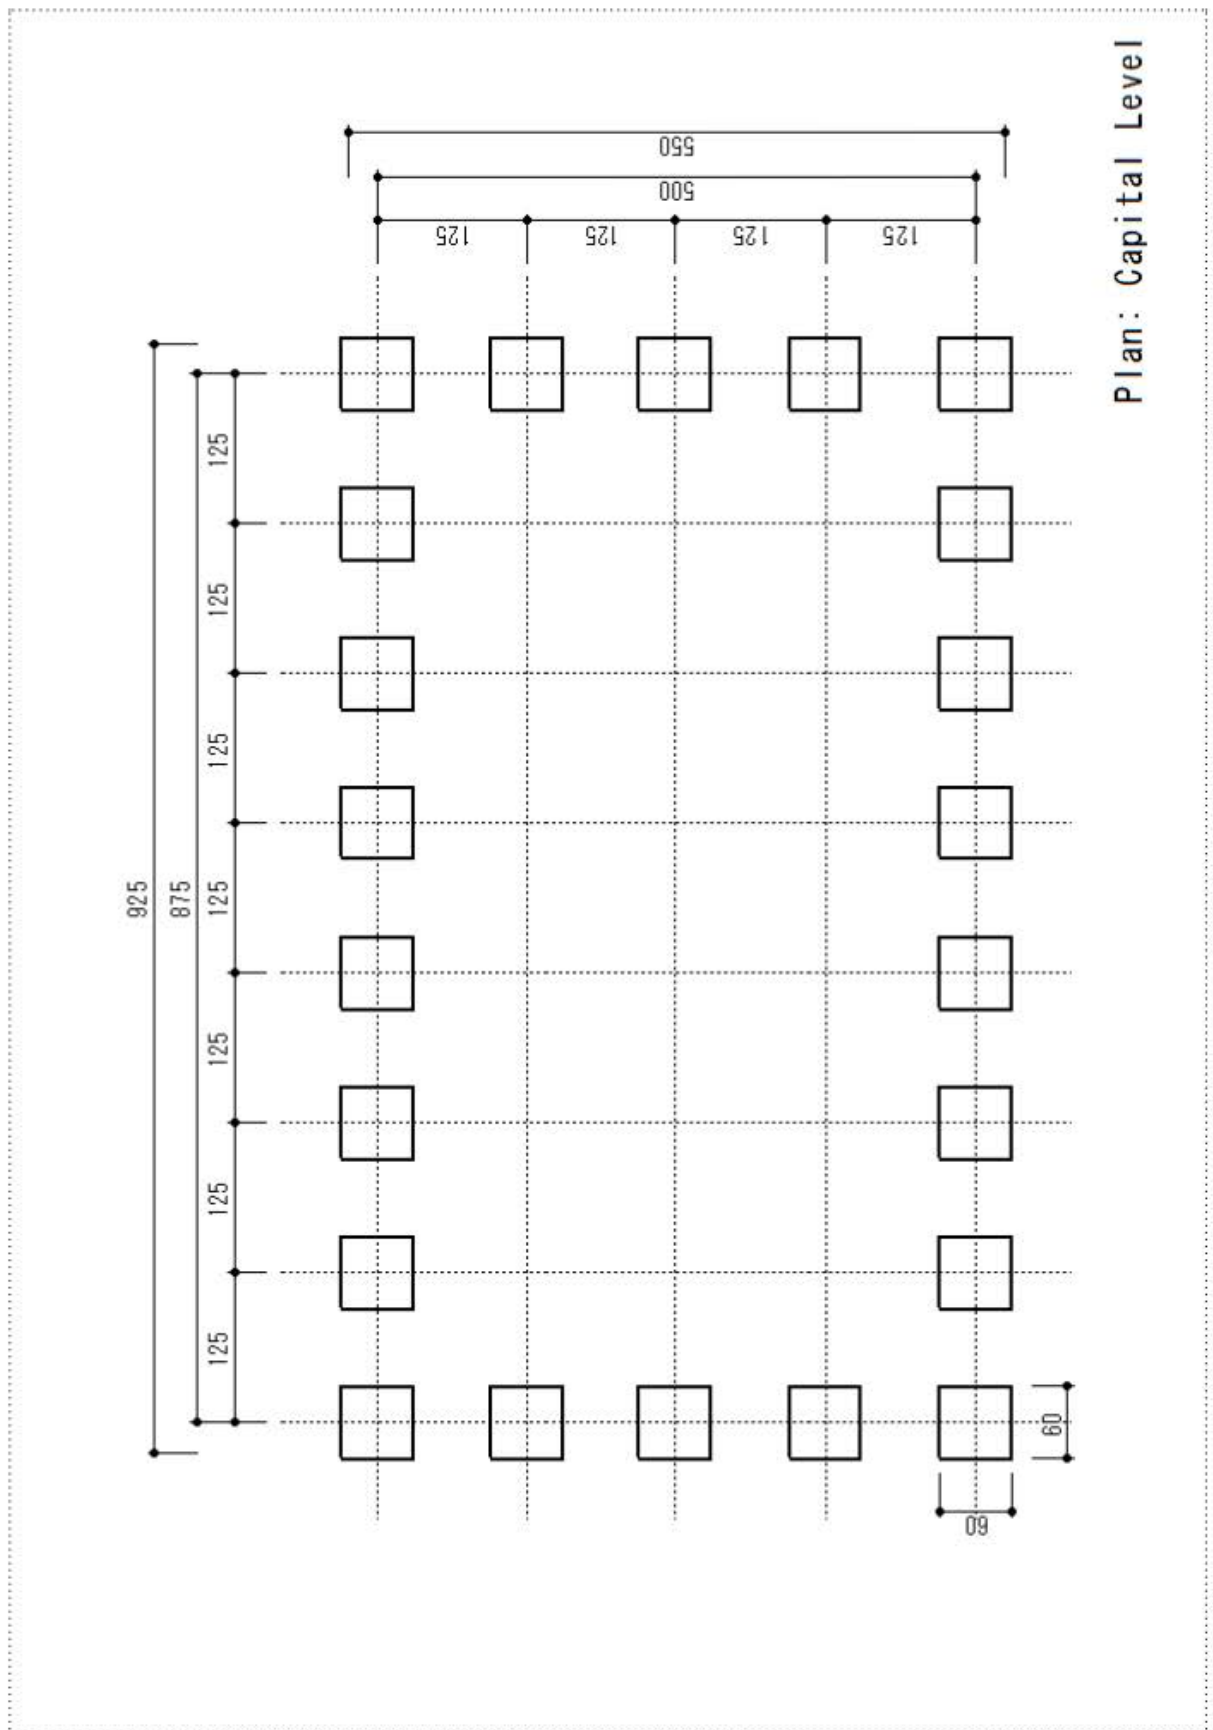
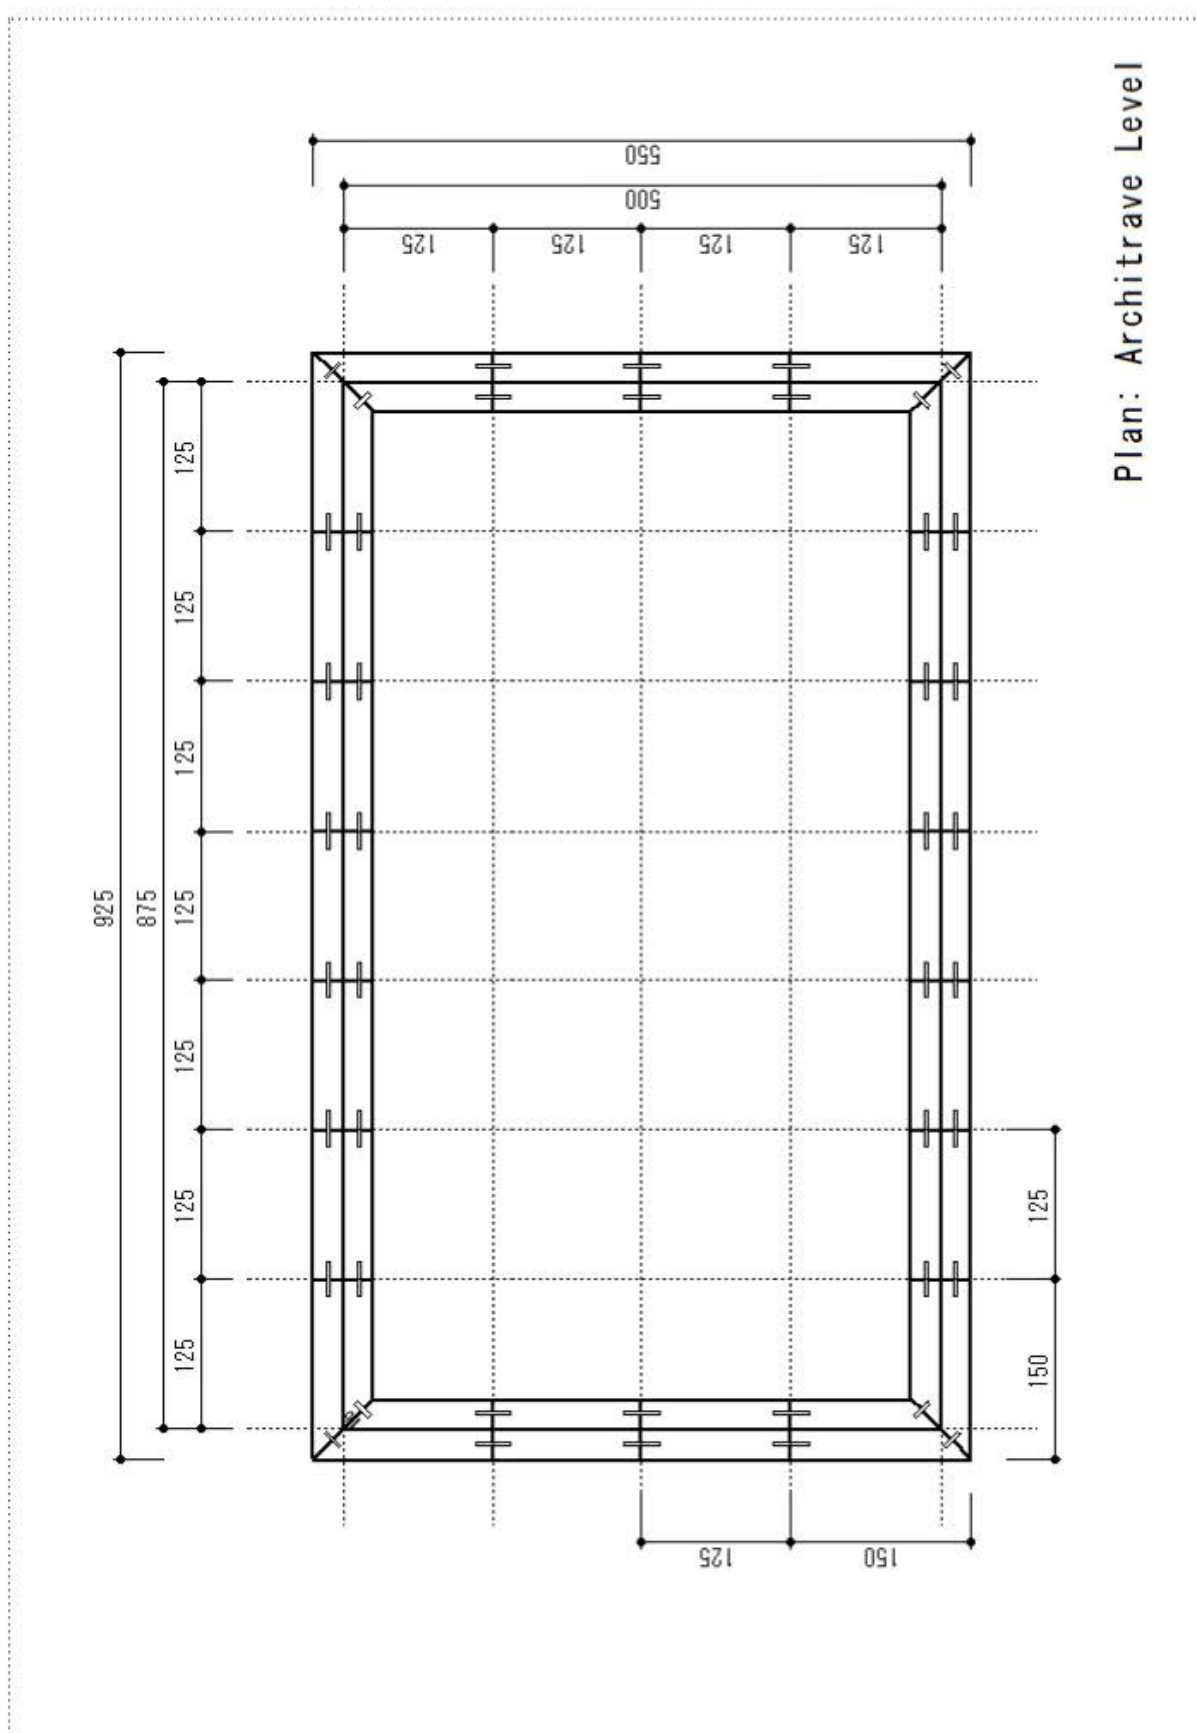
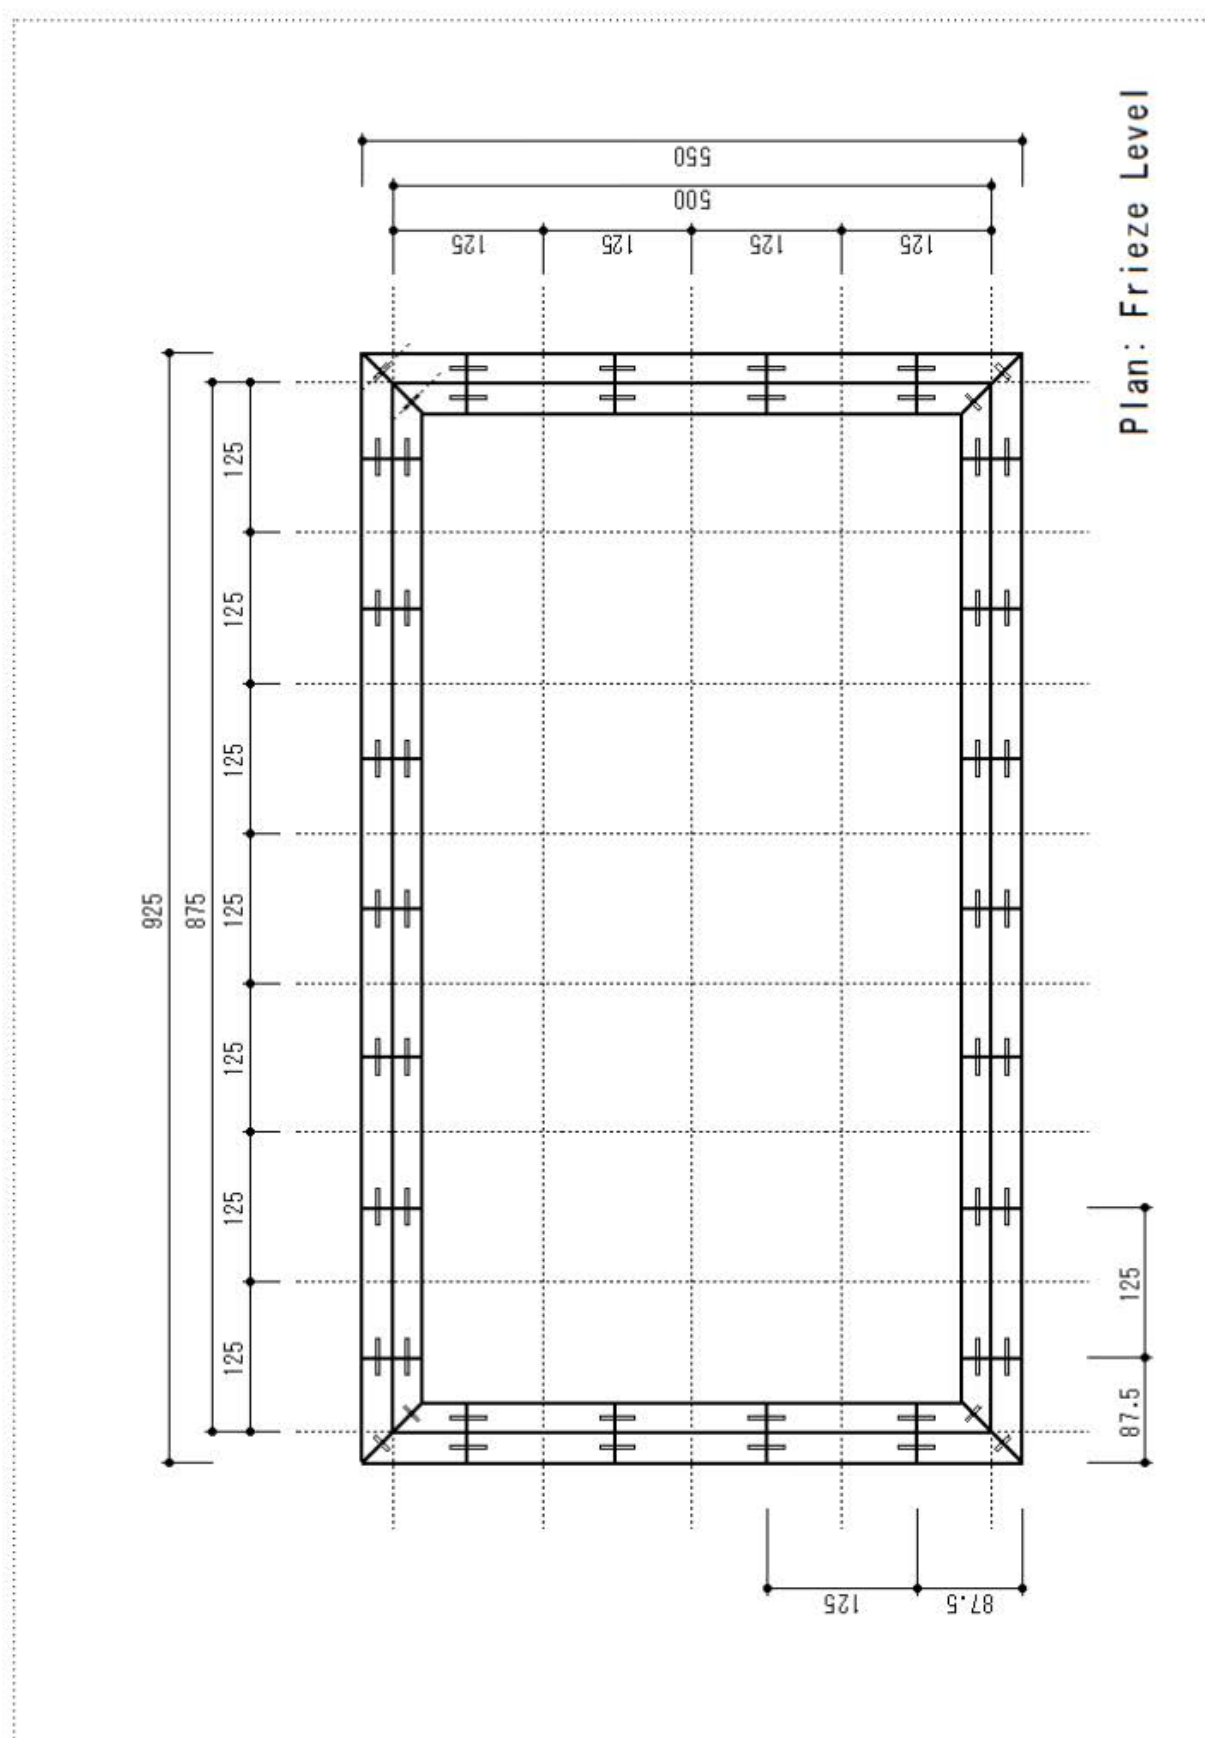
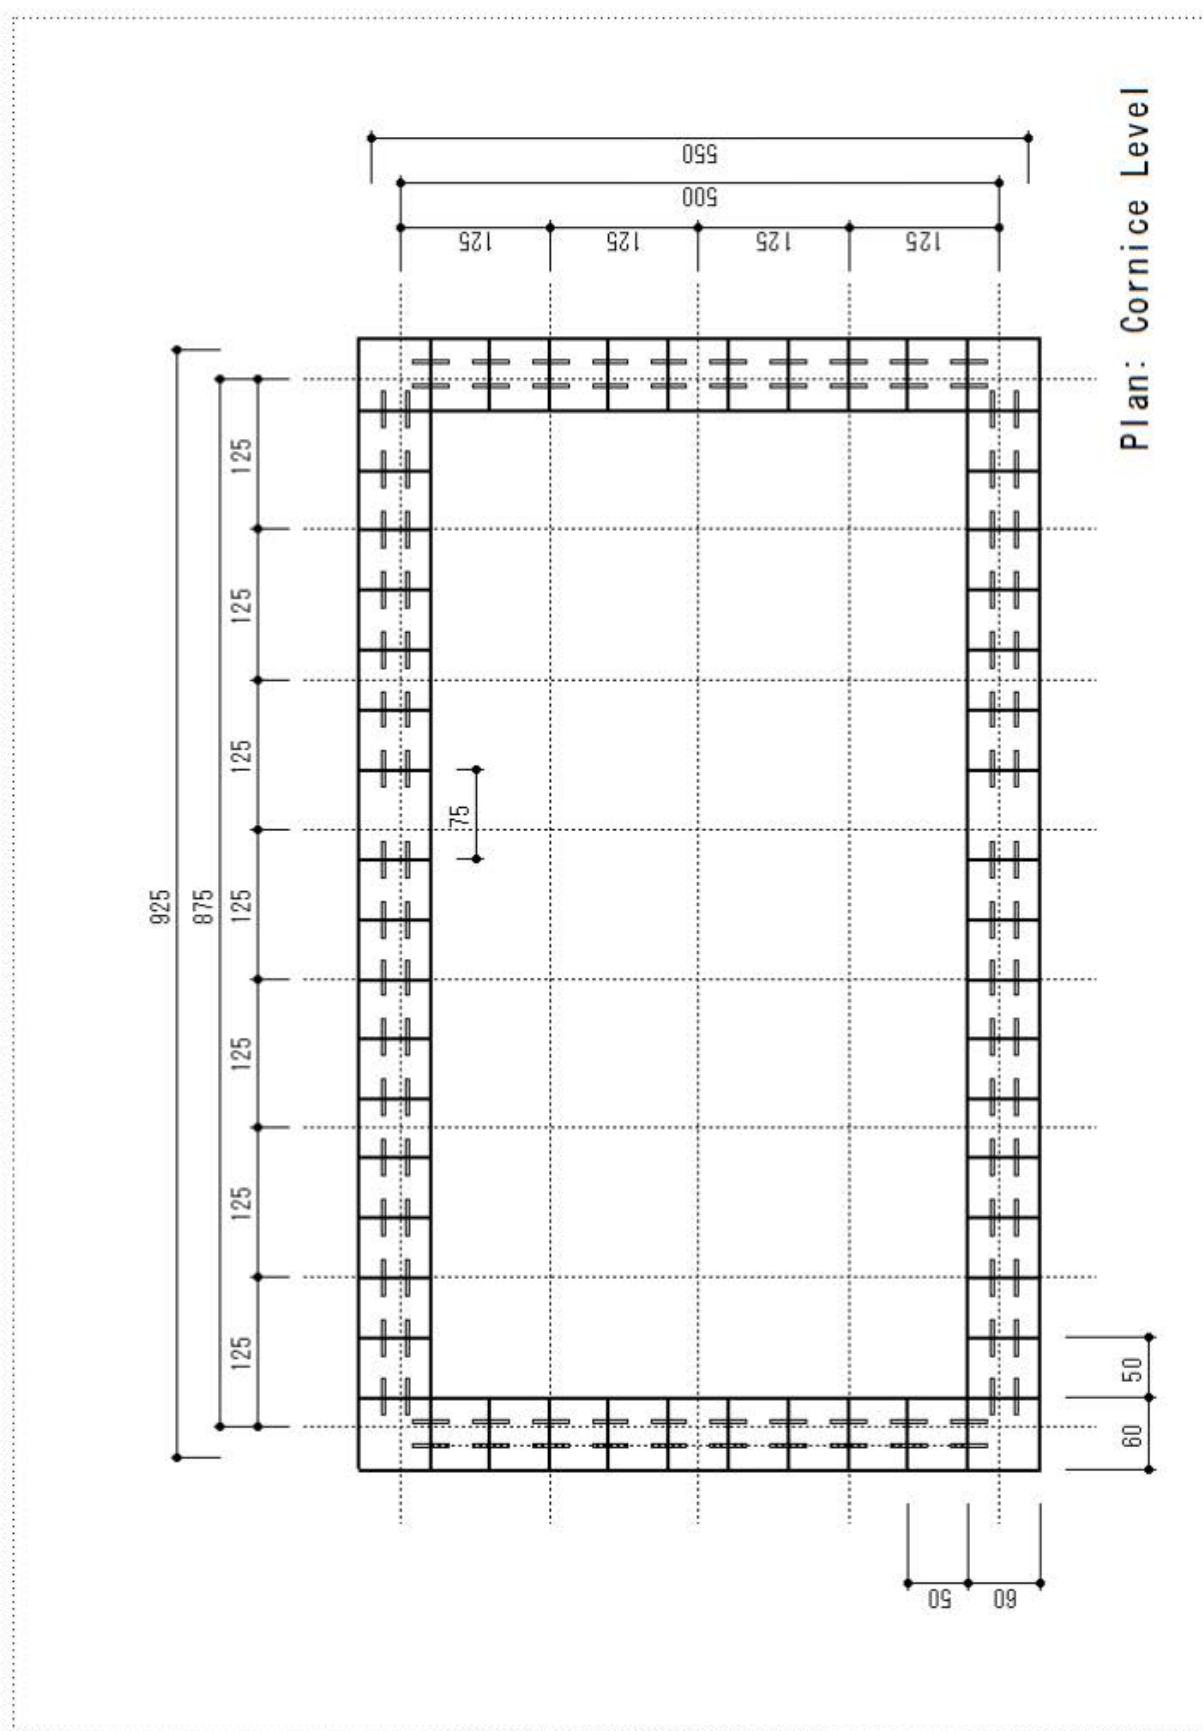
Fig. 84 Plan of the simplified miniature model (Dimension in *mm*)

Fig. 85 Plan of the simplified miniature model (Dimension in *mm*)

Fig. 86 Plan of the simplified miniature model (Dimension in *mm*)

Fig. 87 Plan of the simplified miniature model (Dimension in *mm*)

Fig. 88 Plan of the simplified miniature model (Dimension in *mm*)
