修士論文

Structural Characteristics of Groups of Traditional Wooden Houses in South Nias, Indonesia

三重大学大学院工学研究科
建築学専攻

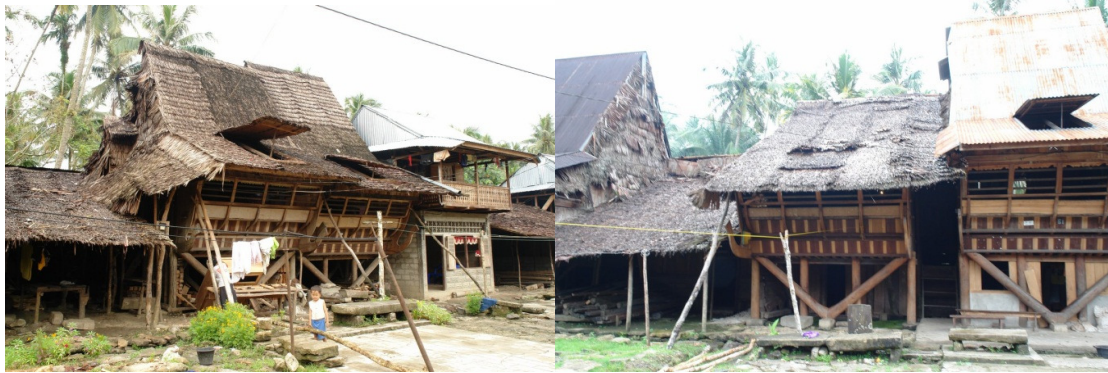
Photo.1-9 Traditional houses damaged by earthquakes leaned to front

On March 28, 2005, another major earthquake occurred near the Nias Island shown in Fig.1-4. As a result, approximately 900 people dead and 70000 houses damaged or destroyed by the earthquake. More than 400 people were dead around the Gunung sitoli (: main city of North Nias), and 50 people were dead in Teluk dalam (: main city of South Nias). Most of masonry houses completely collapsed, which injured many people. In contrast, the traditional wooden houses in South Nias did not completely collapse by the earthquake. Those houses were damaged only the roof-frame particularly in the village of Bawogosari and Hilisimaetano. Some traditional houses leaned to front, being supported by temporary members, shown in Photo.1-9. In consequence, it could be considered that the traditional wooden houses have seismic consideration. The interesting point is why the traditional houses could survive against great earthquakes.

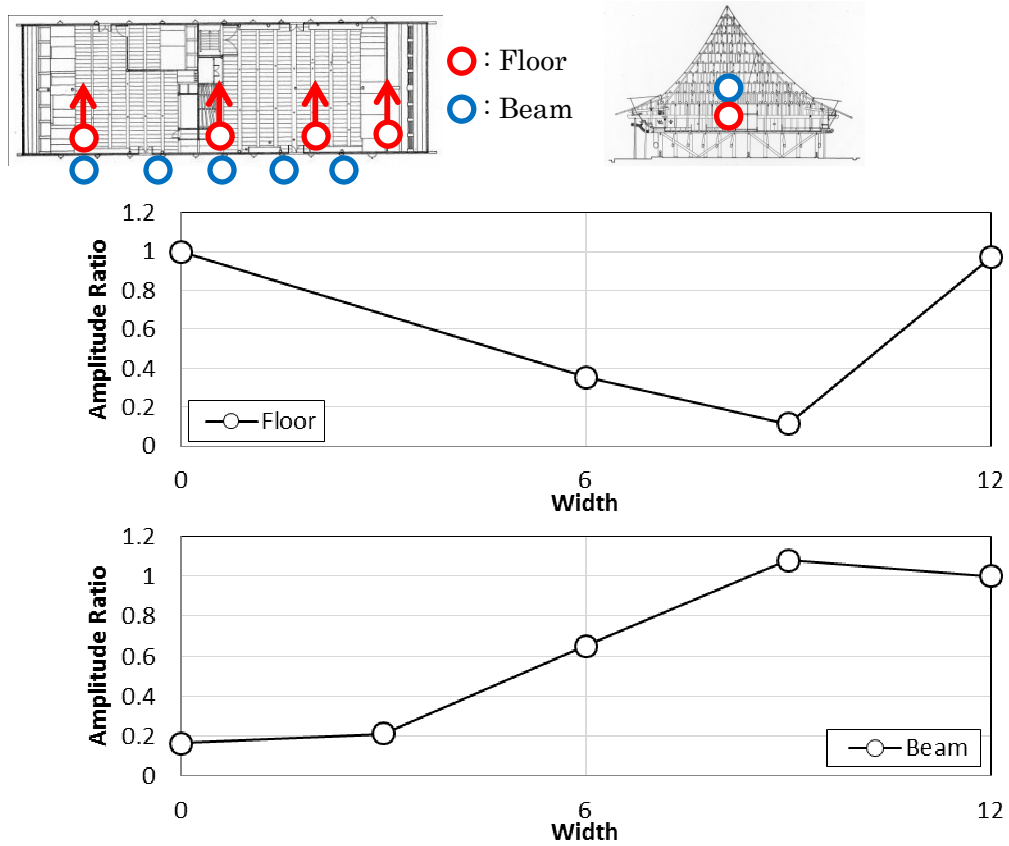
Fig.2-22 Vibration mode of Span direction (2 Hz)
 (Upper: Floor level, Lower: Beam level)

Fig.2-22 and 2-23 show the vibration mode in horizontal in-plane of floor level and beam level calculated from the amplitude of the transfer function measured in case1-1', 1-2', and 1-7. It seems that the large displacement at middle structure in Y direction (=ridge direction) is caused by thick walls. On the other hand, there are differences in vibration mode between floor level and roof level in X direction (=span direction). It can be considered that horizontal in-plane rigidity of the floor was insufficient. The vibration mode of beam level was affected by walls in span direction at backside of *omo sebua*. However, further study should be needed to evaluate the differences between floor level and roof level.

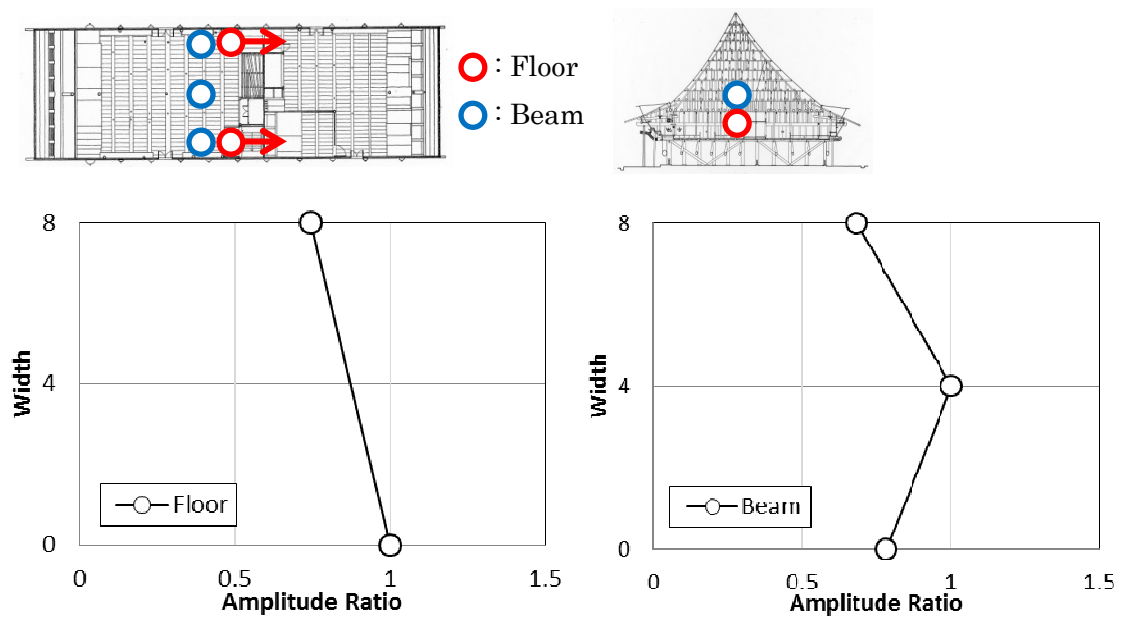
Fig.2-23 Vibration mode of Ridge direction (3 Hz)
 (Left: Floor level, right: Beam level)

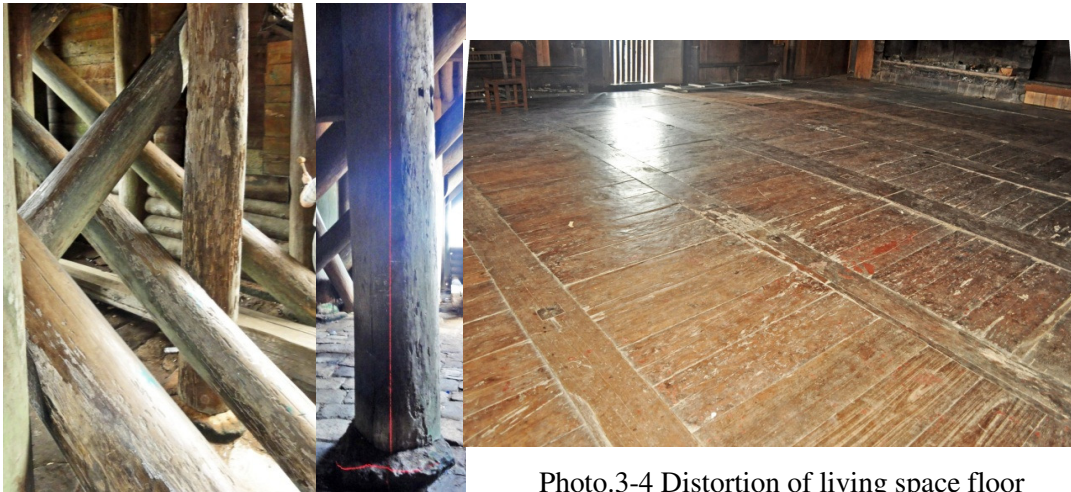
Photo.3-4 Distortion of living space floor

Some of the side columns tilted toward inside, of which maximum inclination was 6/100. Irregular settlement of floor line was also found as deterioration. The floor was not horizontally flat, but it was curved as the center was higher than the side end of the room in span direction. There was 16 cm difference in height between the center and the end. This deformed floor was originally designed as the present traditional wooden houses were originated from ships. Harms by termite were found in the living space particularly at the back room.

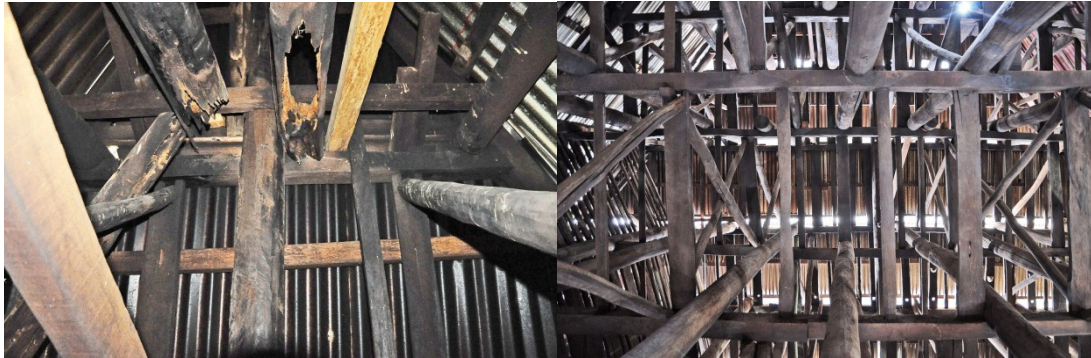
Photo.3-5 Harms by termite and roof frame

The Nias offshore earthquake of 2005 caused damages to the roof frame and roofing material (cf. chapter1). The roof frames decayed in several places because of rain leaking from roof apertures caused by the earthquake. Harms by termite were also found at the roof frame. (see Photo.3-5) It could be considered that the roof frames of traditional house were damaged by earthquake because of those deteriorations.

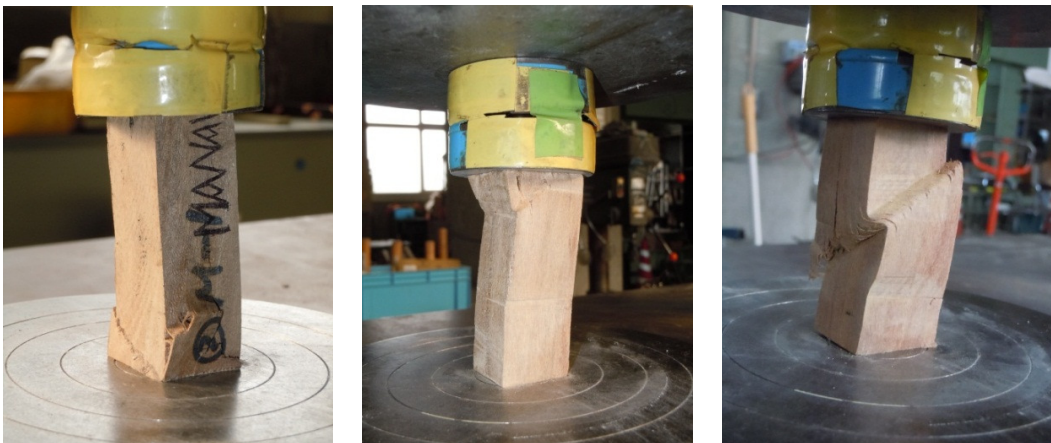
Photo.5-3 Failure mode of Manawadano (from the left: M-1, M-2, M-3)

The upper part of A-1, M-2 and B-1 were smashed, on the other hand, the lower part of A-3 was compressed and splitted lengthwise. A-2 and M-3 showed shear failure behavior. The upper part of B-2 and M-1 embedded in the bottom. B-3 indicated the maximum load in a short time and cracked lengthwise because of knot the test specimen has. The condition of test pieces affected the failure mechanism.

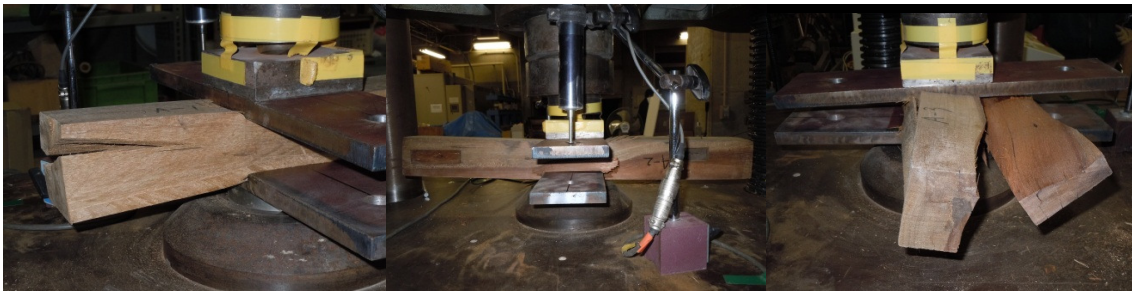
Photo.5-8 Failure mode of *Afoa* (from the left: A-1, A-2, A-3)

The wooden members for the test were collected from Nias Island. Those members were used as a part of the house before, therefore, some defects could be found. Because A-1 was not loaded at the center of the member to avoid a defect, it was split for grain direction at one side. Though B-1 which affected by a knot indicated exceptionally large maximum load, no differences could be found in rigidity. B-3 happened to split before the displacement became 20mm. The shape condition or grain condition of test pieces affected the failure mechanism.

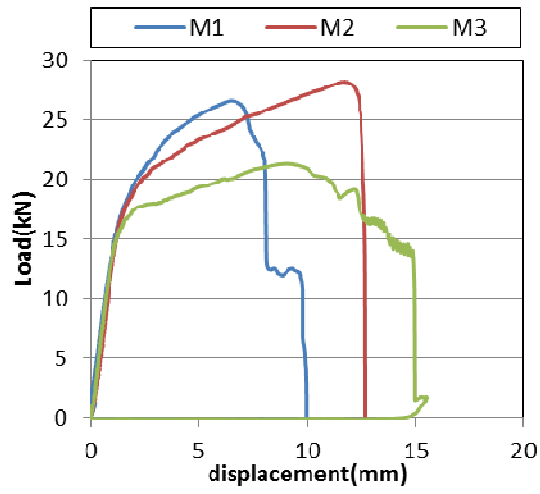
Fig.5-8 Load-displacement relations

Fig.5-8 shows Load-displacement relation. Test piece No.M1, M2 and B1 suddenly split open, so that the load was reduced suddenly. Each test piece failed in various modes depends on the grain type or the size of test piece.

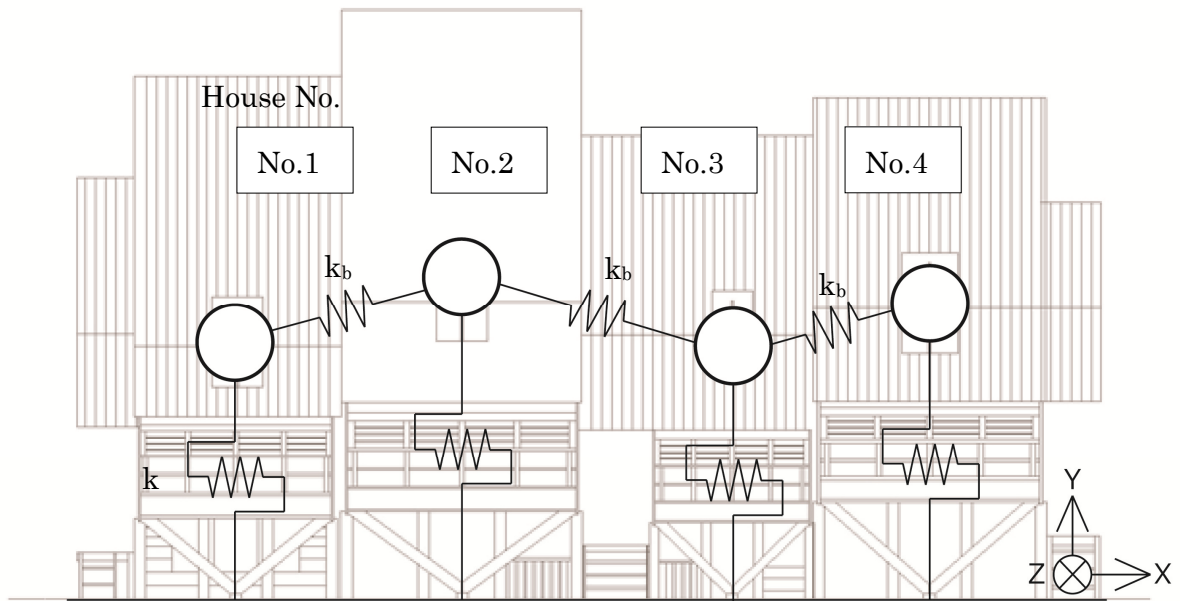
Fig.6-1 Lumped mass system (Model A)

The earthquake response of the model connecting each single mass system (which called “Model A” below) was compared with 2 models. Model 1 was the single mass system of each house which independently responded to the grand motion (See Fig.6-2). On the other hand, Model 2 was the lumped mass model connecting four same single mass systems (See Fig.6-3). Parameter analysis was performed to examine the spring constant (k_b) between the house’s models, shown in Table 6-2 and 6-3.
