修 士 論 文

**Seismic Structural Monitoring
of World Heritage Masonry Monuments
in Earthquake-prone Countries**

三重大学大学院工学研究科
建築学専攻

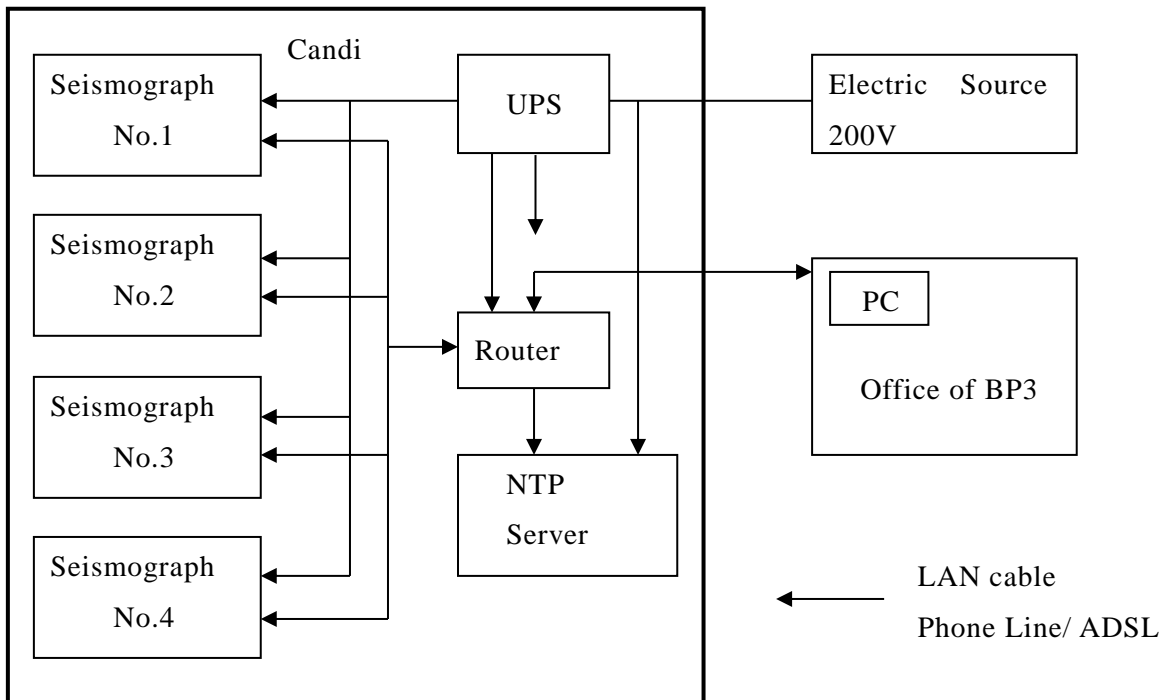
Fig. 3-4 Earthquake monitoring system

A total 4 seismographs connect up a power cable and a LAN cable these length are less than 60 cm, as shown in Fig. 3-4. NTP server and UPS were installed in the interior room. Electric power has been already supplied for monitoring of crack there. Components of these seismographs are Tri-axial.

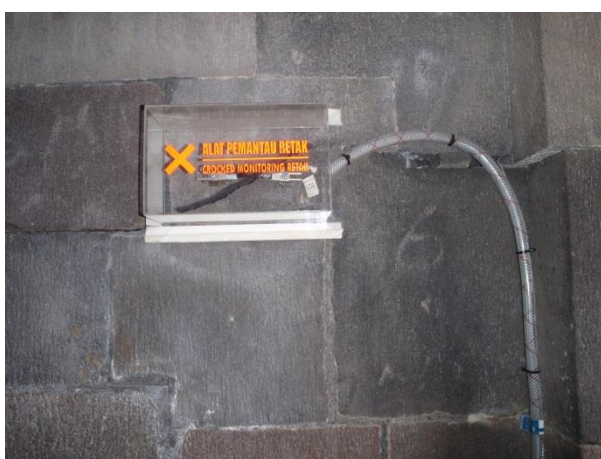
Fig. 3-108 View of a displacement transducer with cover

Since October of 2011, the north, south room and the corridor of Chandi Shiva have been open to the public with limited entry. Covers were installed for displacement transducers in order to prevent disturbing, shown in Fig. 3-108.

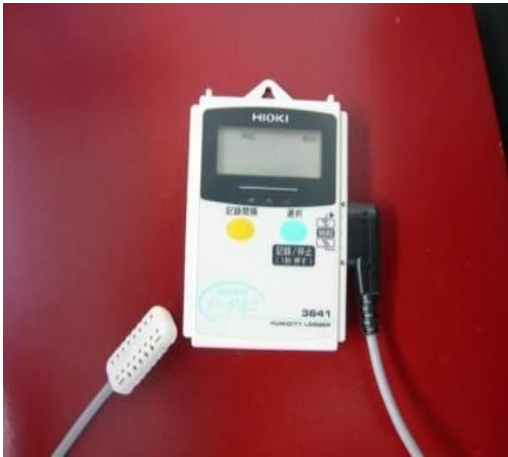
Fig. 3-110 Temperature and humidity logger

Temperature and humidity were recorded every 1 hour in the devices (loggers) that were separately installed (see Figs. 3-110 and 3-111). To transfer data to a computer, Communication base was used. In the end of October 2012, four devices were replaced with new ones. Fig. 3-112 shows one of new temperature and humidity loggers.

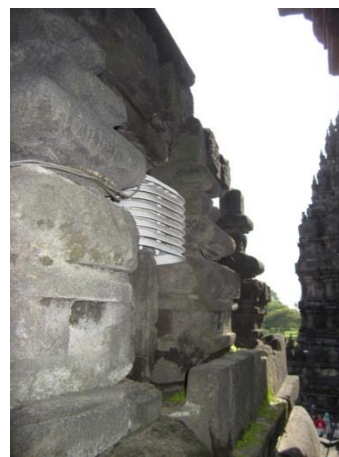
Fig. 3-113 View of the temperature and humidity logger at the outside

Another type of temperature and humidity logger was set by one of members of Japanese experts, shown in Fig. 3-113. A diamond shape in Fig. 3-117 shows the location of this logger.

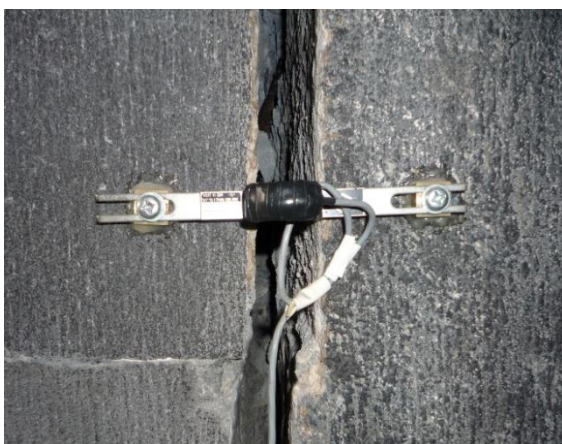
Fig. 3-114 View of displacement transducer (PI-2-100)

Crack displacements have been monitored with displacement transducer (PI-2) at 14 points both of inside and outside the monuments. Fig. 3-117 shows the location of the data logger, displacement transducers, thermocouples and temperature/humidity loggers. Additional dummy equipment was installed at the outside 4 point, where the differences between daytime and nighttime temperatures are extreme, to revise the influence by swelling and shrinking of stone itself. A total 18 components of crack displacement have been recorded. Temperature and humidity also has been monitored with temperature and humidity logger at 4 points inside of each room. Furthermore, temperature has been recorded by two thermocouples outdoors and indoors. The data logger was set in the central room which has electricity, and connected with cables from crack transducers and thermocouples. The settlement method of displacement transducers (PI-2) was mentioned as the following.

- i. Wash the stone where equipment would be installed with teeth brush and dry.
- ii. Give an undercoat smooth on the stone with consideration to a space for screws and left for 24 hours.
- iii. Glue both of the stone and baseplate and keep them for 1 minute after that stick together and keep under pressure for approximately 3 or 5 minutes until the glue dries. Leave them for 24 hours after filling the gap with glue.
- iv. Attach the displacement transducer (PI-2) with screws on the baseplate (see Figs. 3-114 and 3-115).
- v. Connect the displacement transducer and the data logger by using cable. Check the monitor of data logger for correct connection. (see Fig. 3-116)
- vi. Cover connecter from dust and water along the wall not to interrupt passing. Be careful especially outside connecter with waterproof tape and vinyl tape.
